Re: Annual Site Activity Summary Report—2021

Zidell Waterfront Property, 3121 SW Moody Avenue, Portland, OR

**ECSI No. 689**

RE: 2021 Annual Site Inspection Summary

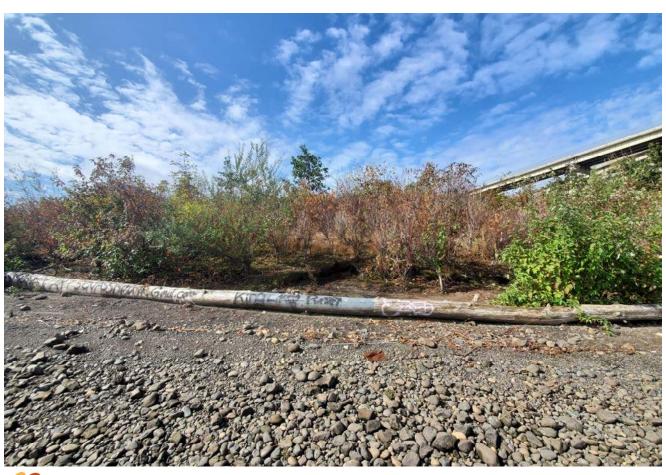
STA: 25+50 - Edge of water looking east

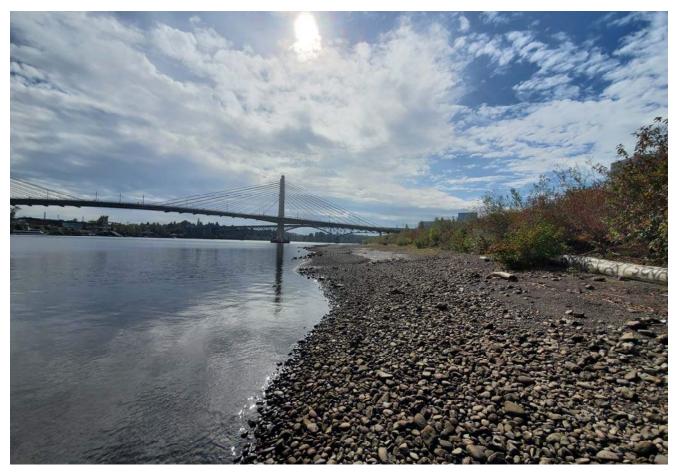
STA: 25+50 - Edge of water looking west

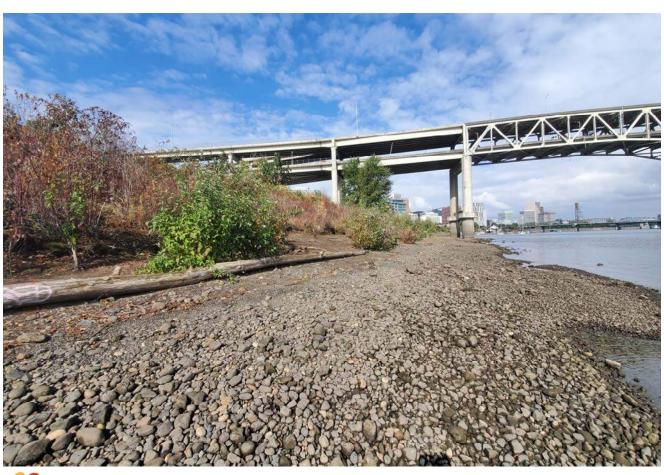
STA: 25+50 - Edge of water looking upstream

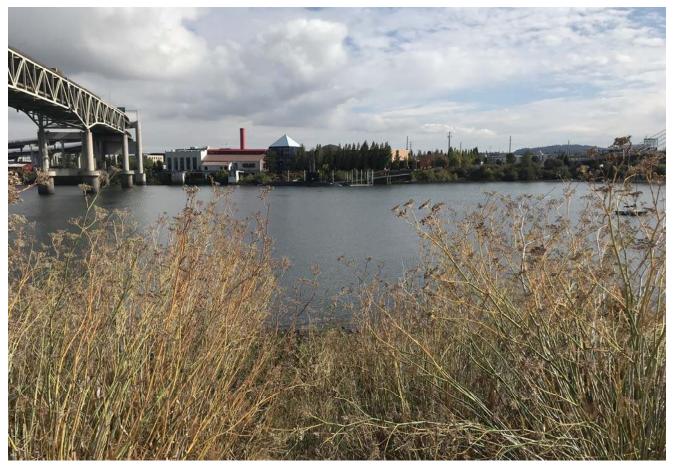
STA: 25+50 - Edge of water looking downstream

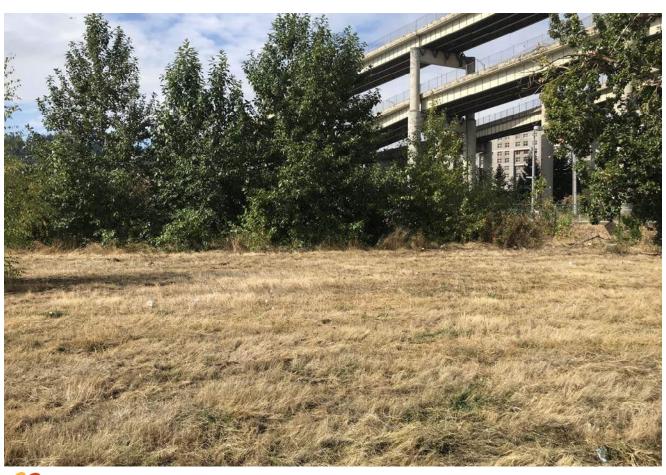
STA: 26+50 - Top of bank looking east

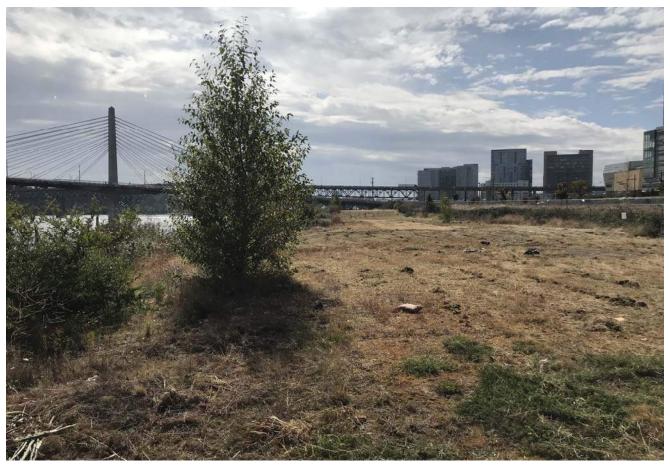
STA: 26+50 - Top of bank looking west

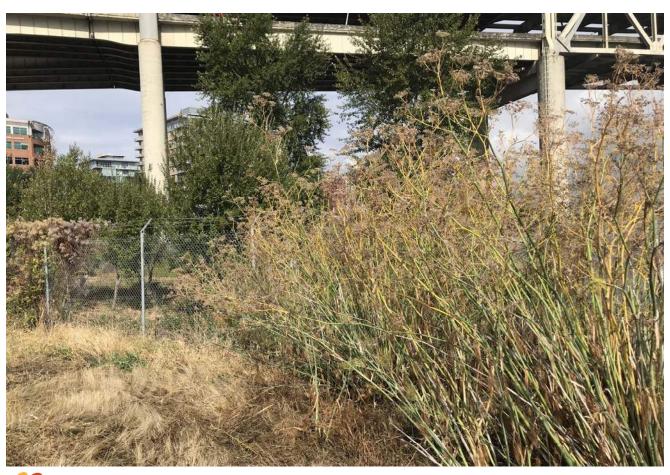
STA: 26+50 - Top of bank looking upstream

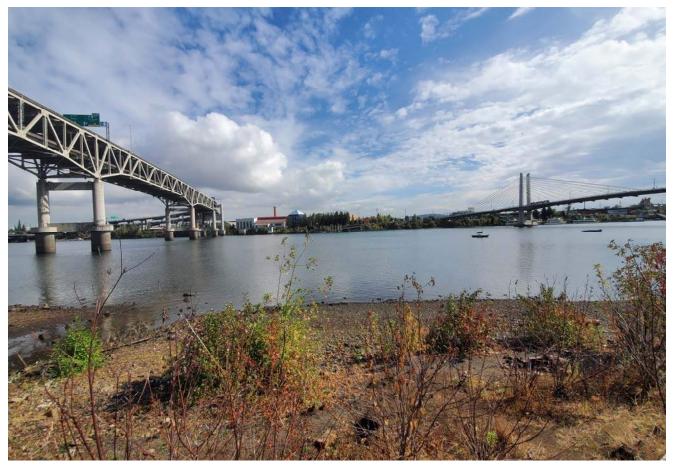
STA: 26+50 - Top of bank looking downstream

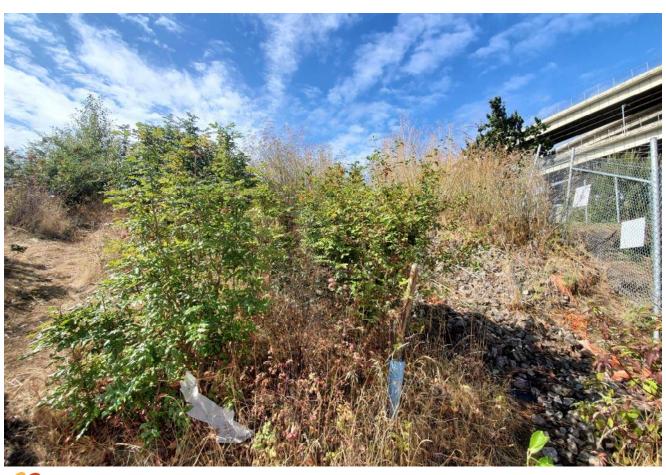
STA: 26+50 - Toe of slope looking east

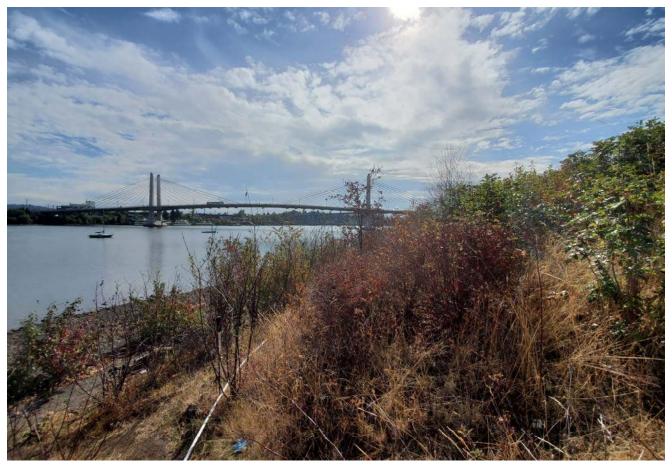
STA: 26+50 - Toe of slope looking west

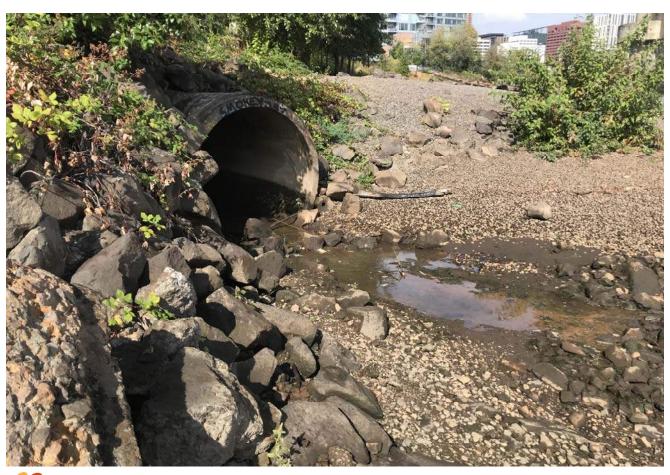
STA: 26+50 - Toe of slope looking upstream

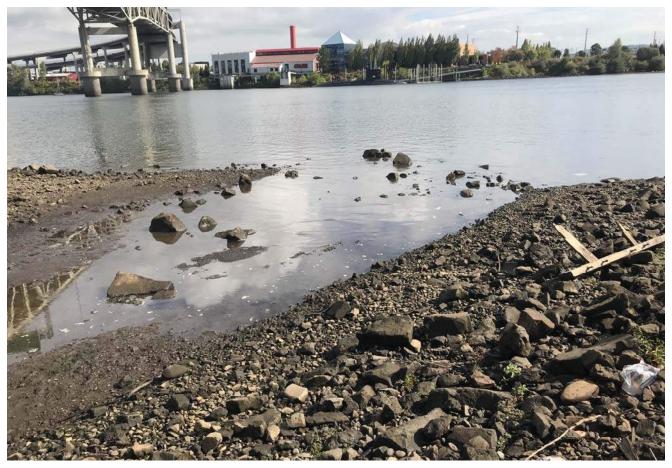
City of Portland stormwater outfall 07b, looking northwest

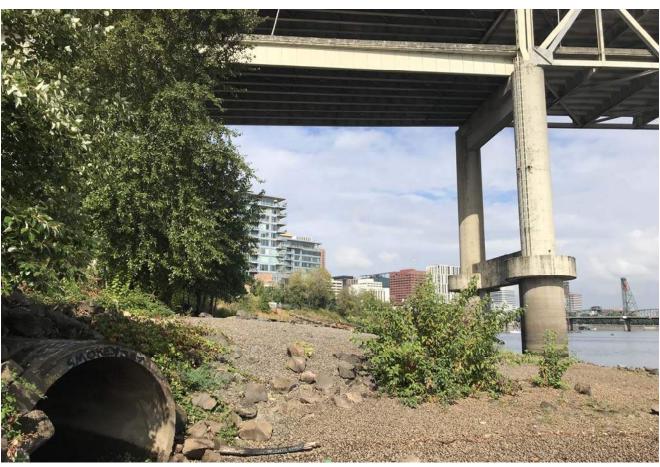
City of Portland stormwater outfall 07b flow path

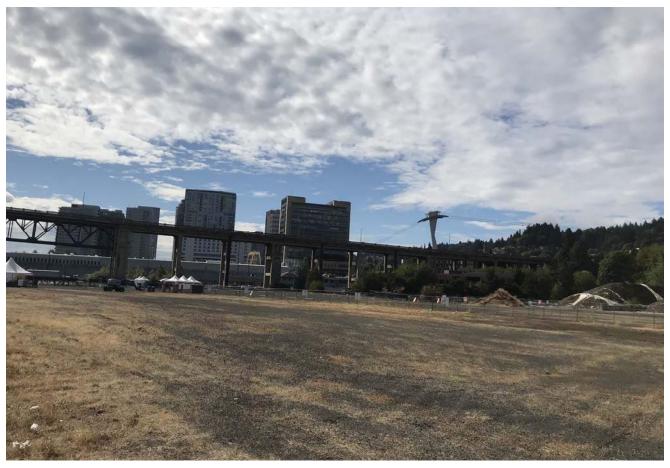
Upland cap, northeast corner looking south

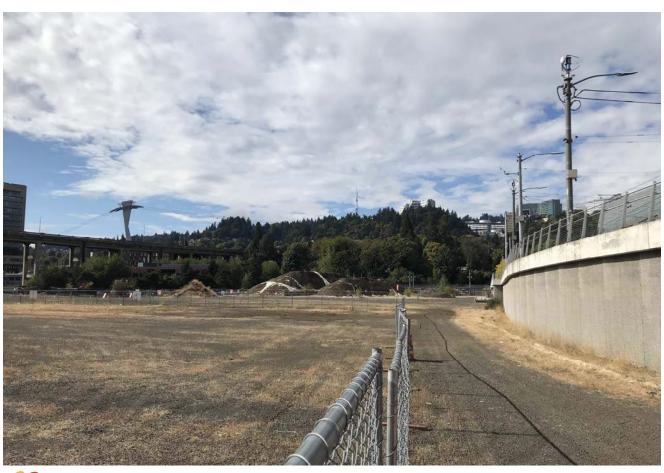
Upland cap, northeast corner looking southwest

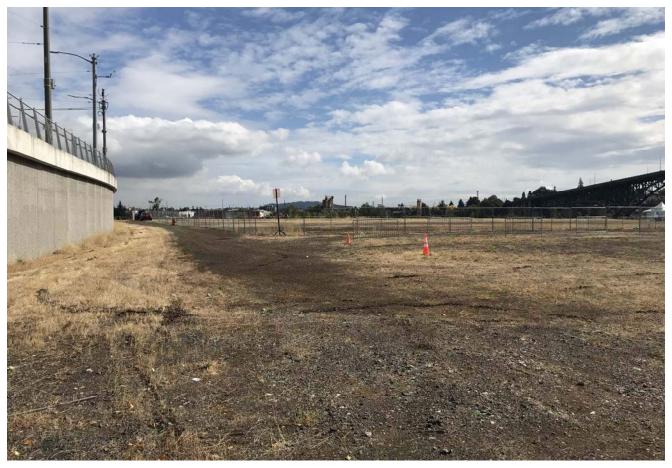
Upland cap, northeast corner looking west

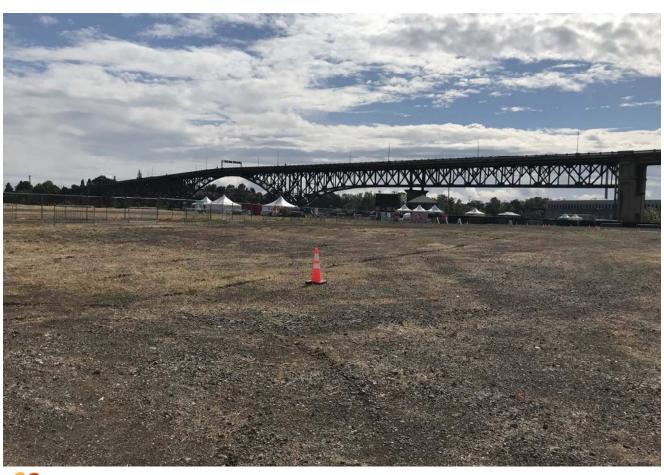
Upland cap, north edge looking east

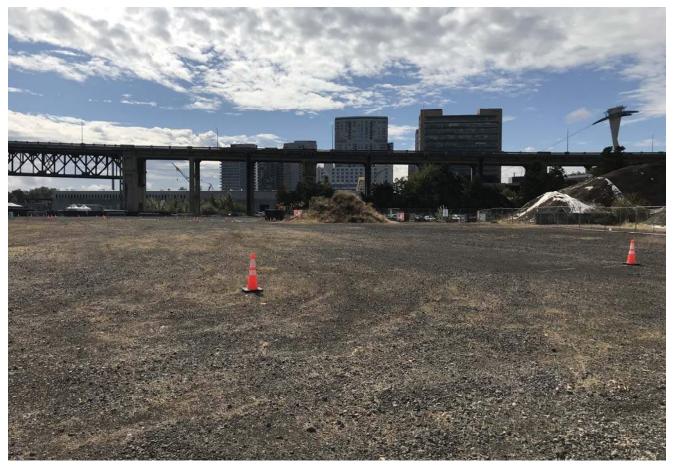
Upland cap, north edge looking southeast

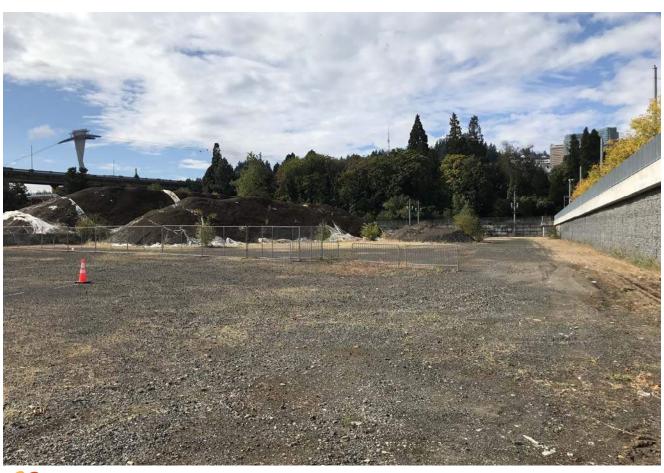
Upland cap, north edge looking south

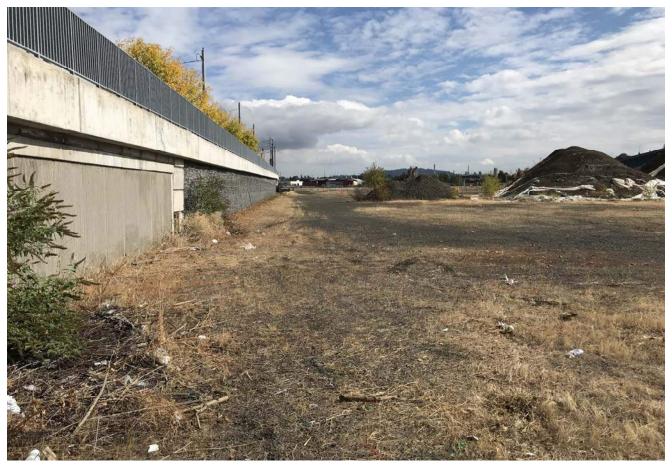
Upland cap, north edge looking west

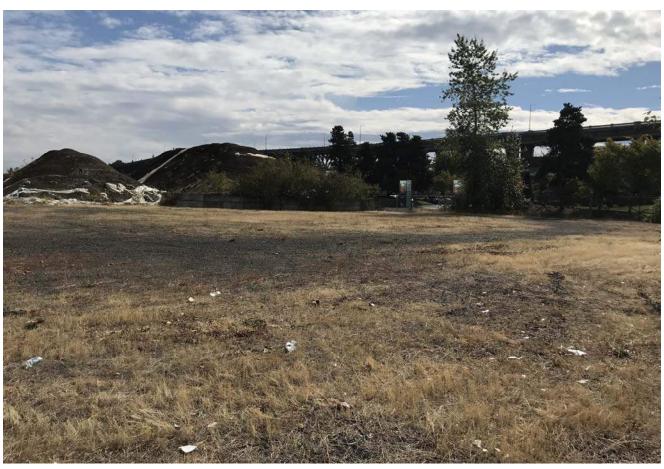
Upland cap, northwest corner looking east

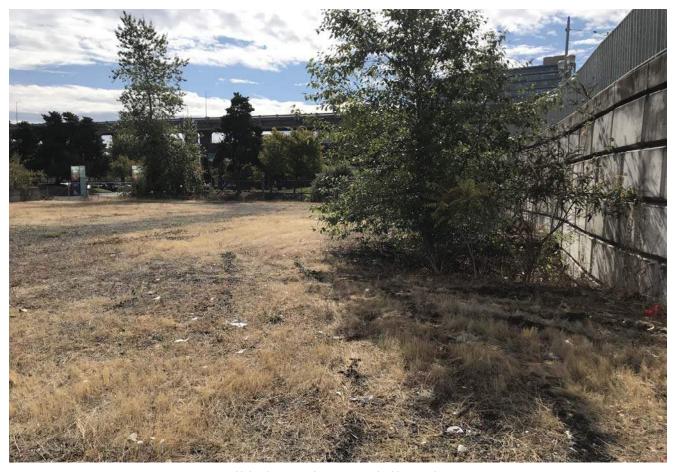
Upland cap, northwest corner looking southeast

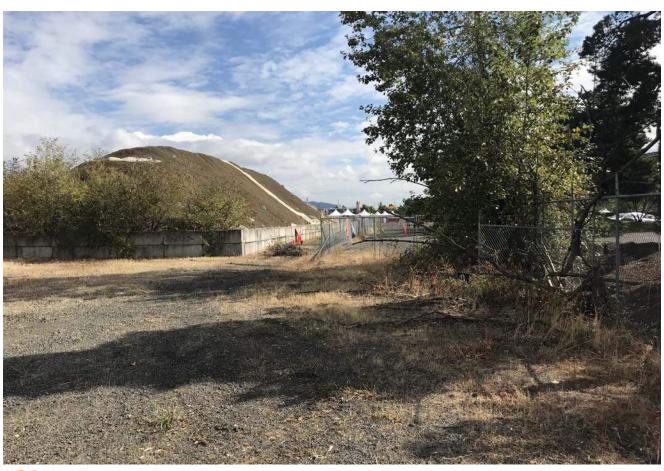
Upland cap, west edge looking northeast

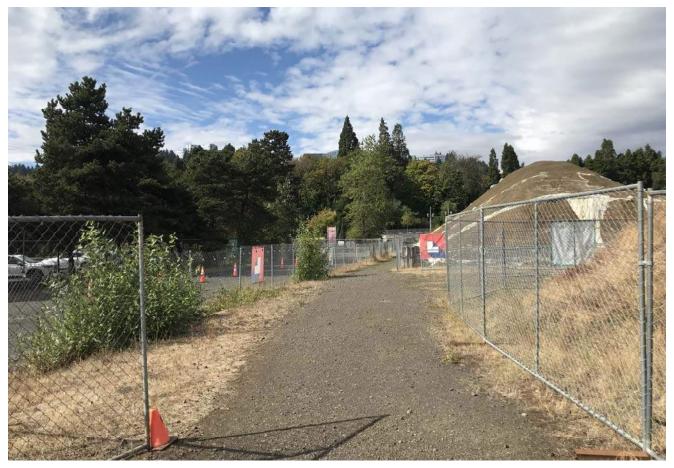
Upland cap, west edge looking east

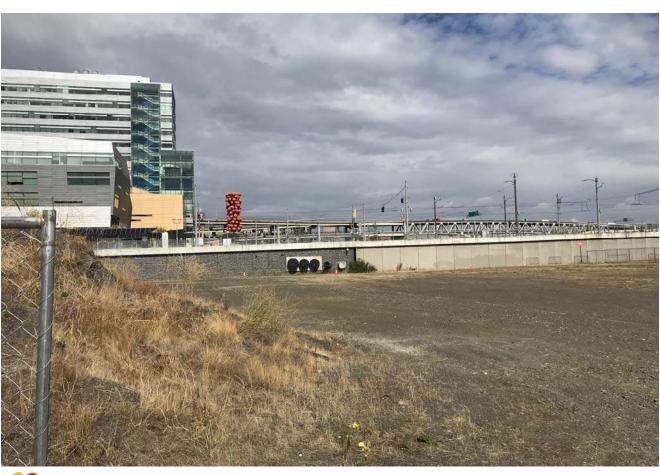
Upland cap, central corner looking west

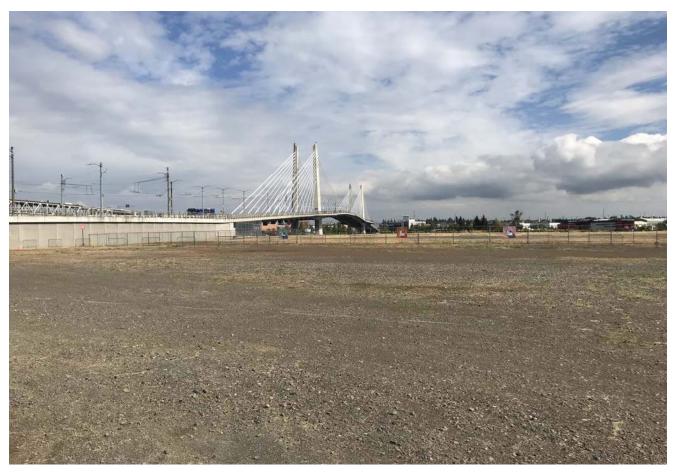
Upland cap, central corner looking north

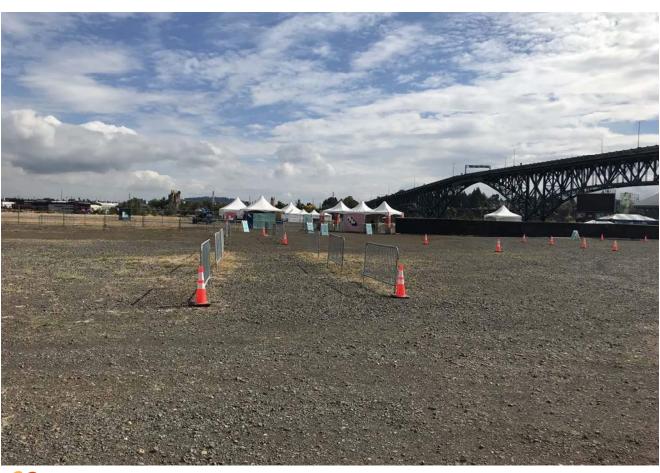
Upland cap, central corner looking northeast

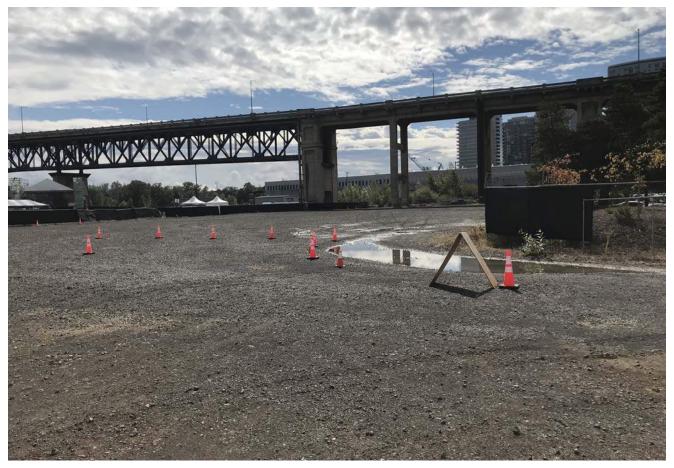
Upland cap, central corner looking east

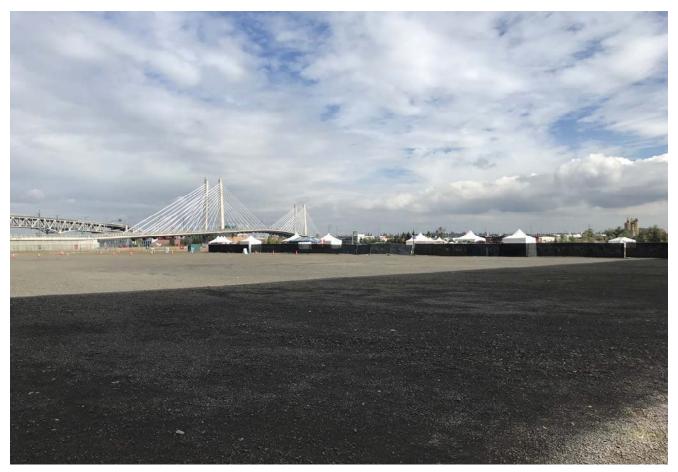
Upland cap, Ross Island Bridge northwest corner looking northeast

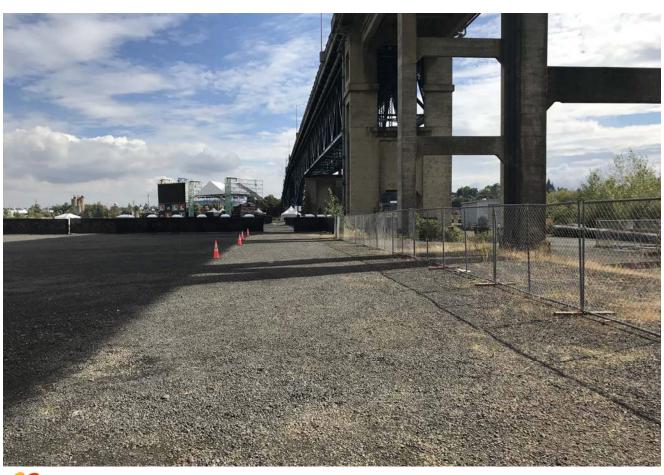
Upland cap, Ross Island Bridge northwest corner looking east

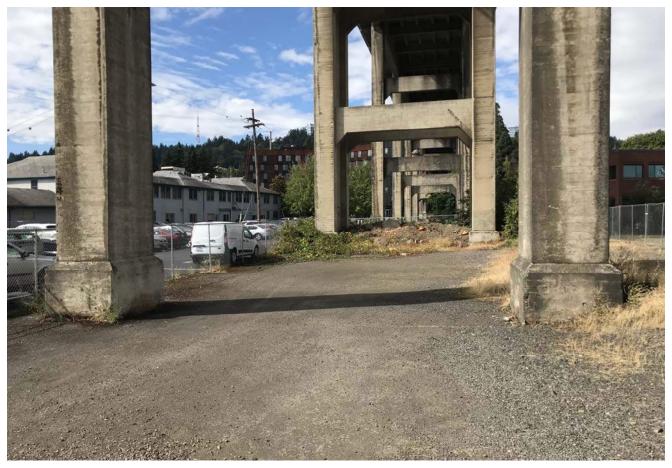
Upland cap beneath Ross Island Bridge, looking west

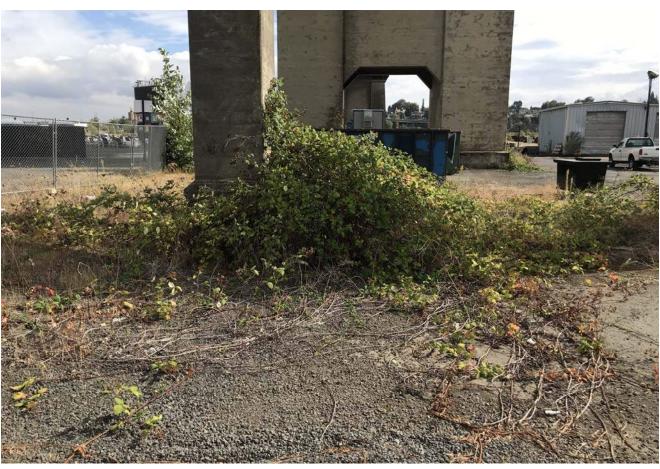
Upland cap beneath Ross Island Bridge, looking east

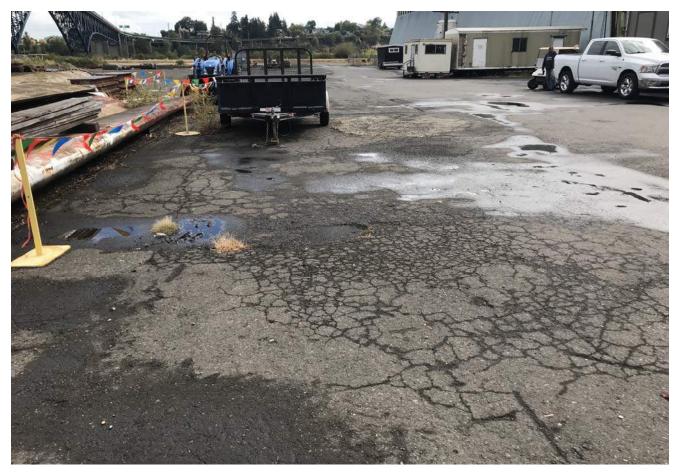
The gravel cap appears in good condition. No changes to the asphalt cap were observed. Equipment and materials were removed from the operational areas following closure of barge building operations. The building's interior is secured and was not accessible during the inspection.

Operational area, looking east

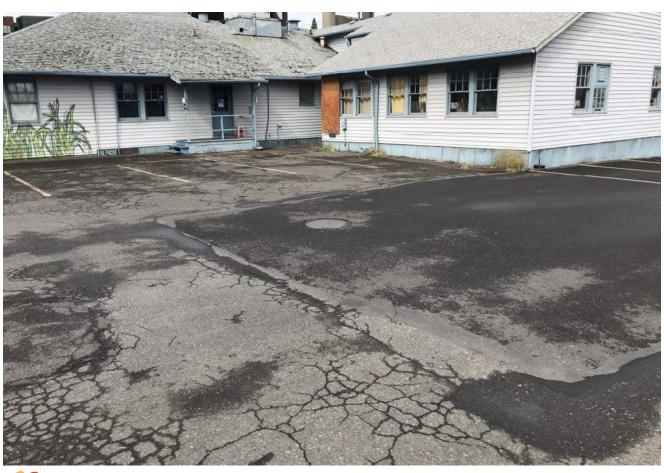
Operational area and office building, looking northwest

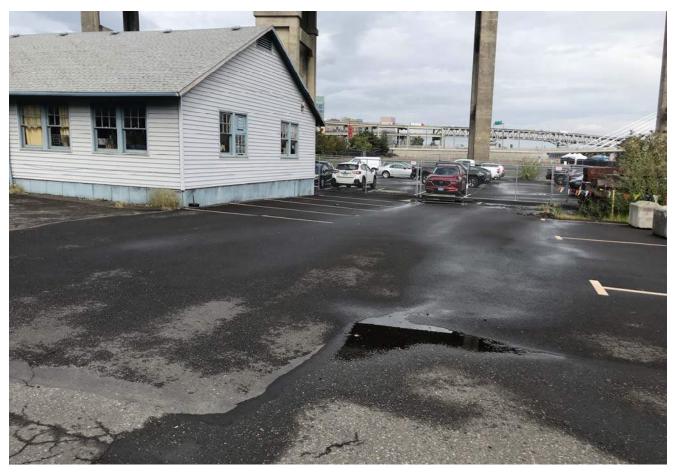
Operational area and office building, looking north
