Operation and Maintenance Report January 2019 to December 2019

McCormick and Baxter Superfund Site Portland, Oregon ECSI Site No. 74

Prepared for Oregon Department of Environmental Quality

July 22, 2020 150-002-005/Task 3

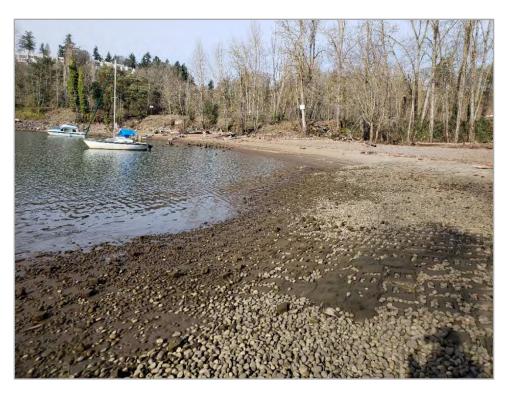
Photograph A1: View facing north of Willamette Cove shoreline and derelict boats anchored within the cove (February 2019).

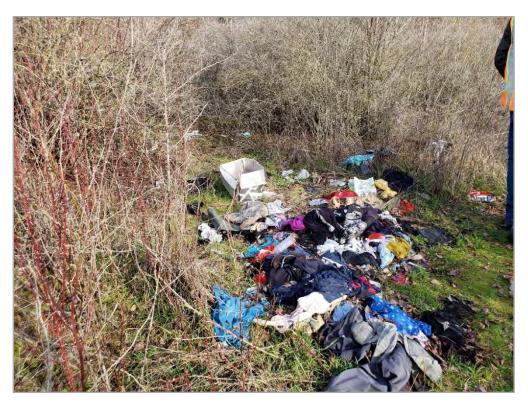
Photograph A2: One of several dumpsites for trash in the riparian area along the Willamette River (February 2019).

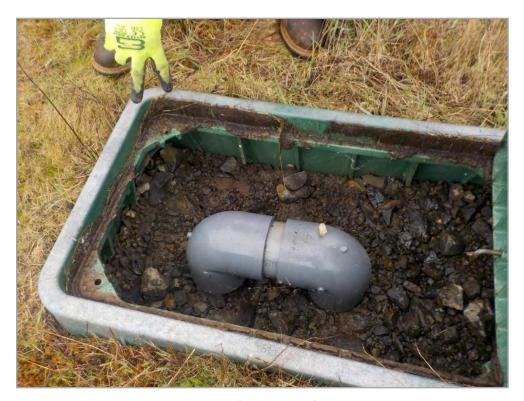
Photograph A8: Gas vent GV-2 with intact vault (March 2019).

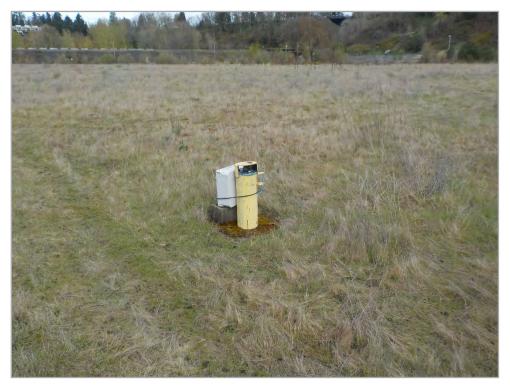
Photograph A10: Impermeable Cap vegetative cover conditions in vicinity of EW-1s. View facing north (April 2019).

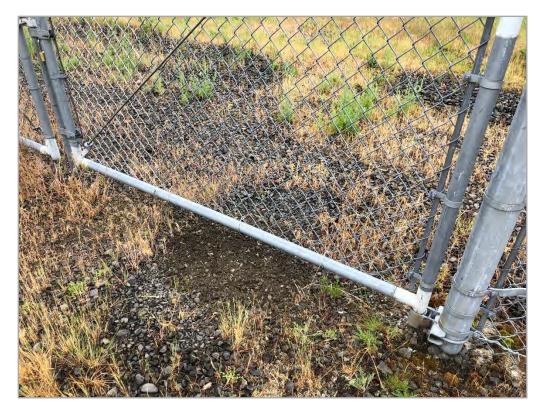
Photograph A11: Filled animal burrow beneath access gate in southwest corner of the site (May 2019).

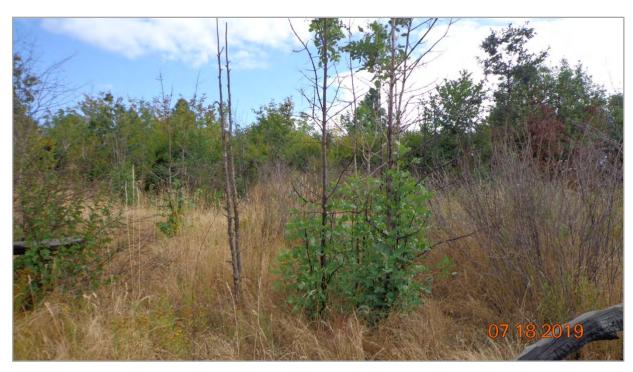
Photograph A13: New growth on trees within the July 2018 riparian fire burn area. Regrowth of grass groundcover is complete (July 2019).

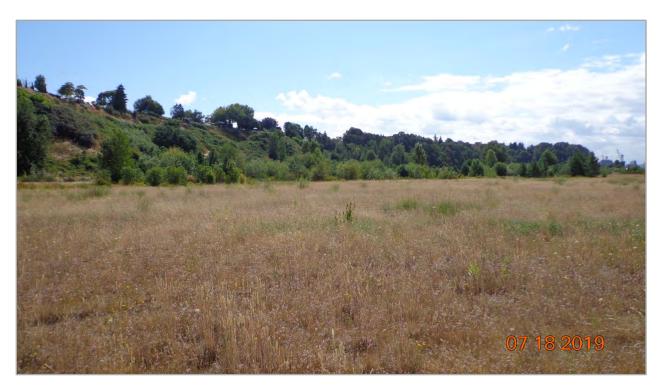
Photograph A15: Upland Cap area cover vegetation conditions (July 2019).

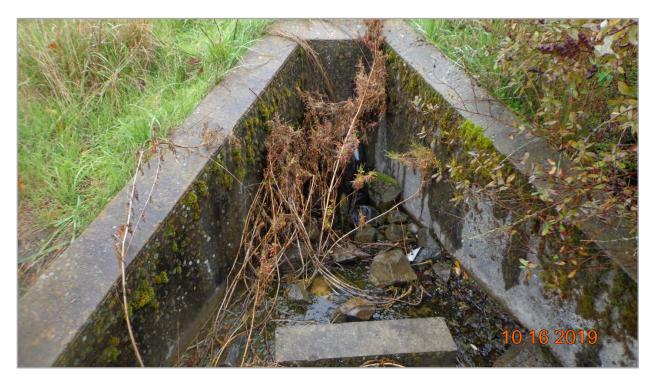
Photograph A20: Water drainage of less than 1 gallon per minute from the storm sewer outfall (October 2019).

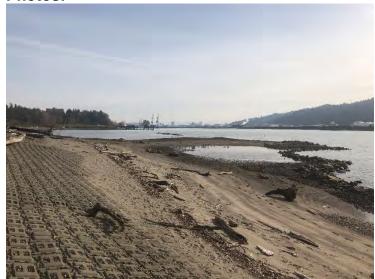
The September 2017 shoreline ACB repairs continue to appear to be in good condition and will be monitored throughout the year. Wildlife (geese, seagulls) were observed along the Willamette River shoreline during site walk (Photo 1).

Photo 1 –View of the bird wildlife along the Willamette River Shoreline.

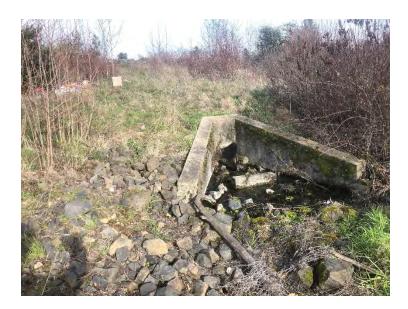
Photo 2 –View of stormwater discharge outfall at approximately 5 gallons per minute.

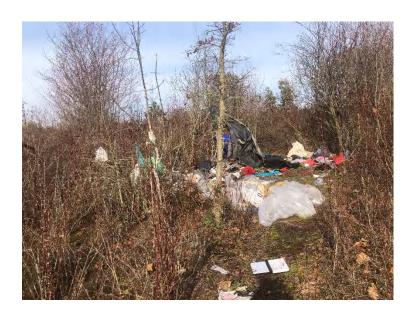
Photo 4 –View of debris from dump site in the riparian area.

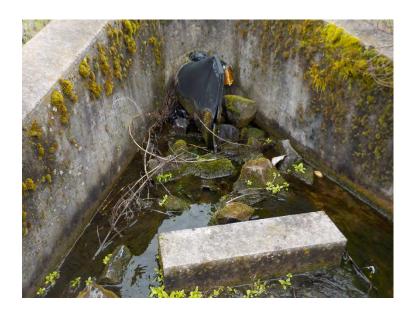
There was discharge from the stormwater discharge outfall (Photo 4) at approximately 5 gallons per minute. The outfall is in good condition. Roughly 50% of the rock armoring below the outfall was washed away from the drainage channel, but the ACB and overlying filter fabric remains in place and erosion of the cap doesn't appear to be a concern. No repairs are planned.

Photo 4 –View of stormwater discharge outfall at approximately 5 gallons per minute.

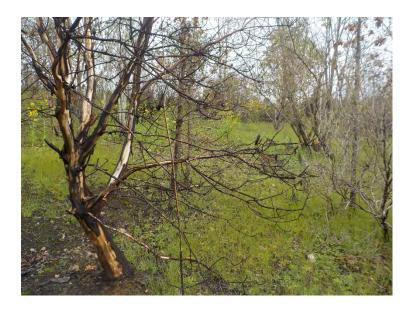
A brush fire in August 2018 burned approximately one acre in the riparian area. Larger/mature trees may have survived as their bark did not appear to be charred; however smaller trees, brush and grass were burned. Vegetation appears to be thriving with evident signs of grass spouting in the undergrowth and new buds appearing on existing brush (Photo 5).

Photo 5 –View of returning vegetation in the riparian area after the fire in August 2018.

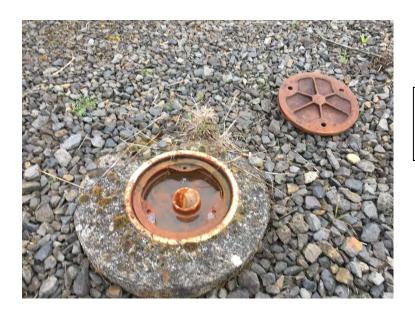
The MW-59s well casing protrudes too high for the monument lid to be installed (Photo 6). It was agreed between DEQ and Hart Crowser that the well casing should be cut down 3-inches. A survey will be completed before and after cutting the well casing.

Photo 6 –View of the inner casing protruding past the monument in MW-59s.

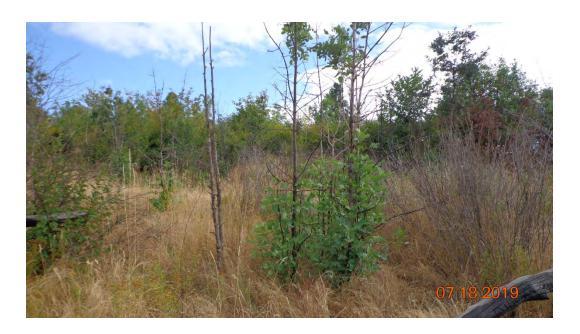
A brush fire in August 2018 burned approximately one acre in the riparian area. Groundcover in the area has recovered with grasses and some noxious weeds present. Larger trees and shrubs show signs of recovery with new leaf development. Most evergreen species of trees have yet to show signs of new growth from charred trunks (Photo 5).

Photo 5 –View of new foliage on tree trunks charred by the August 2018 brush fire.

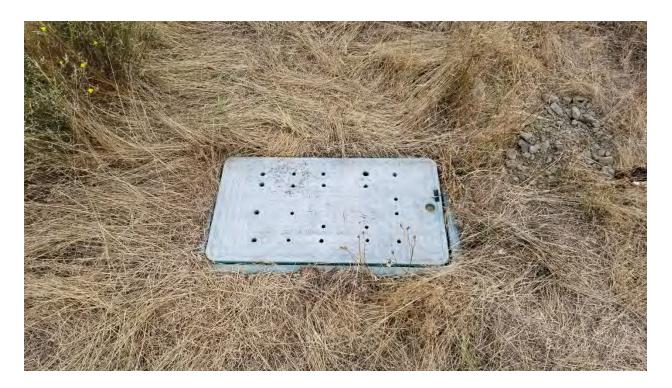
Photo 5: View of gas vent G-2.

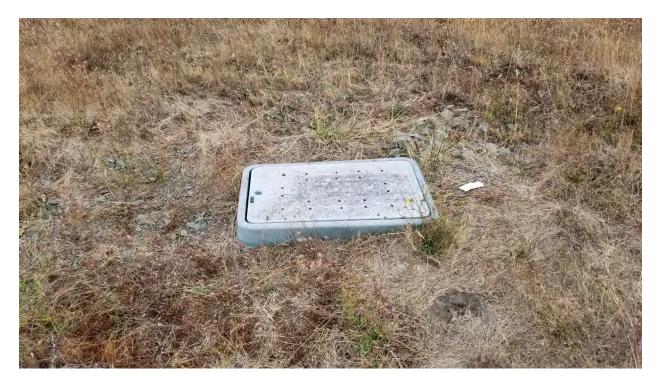
Photo 6: View of gas vent G-3.

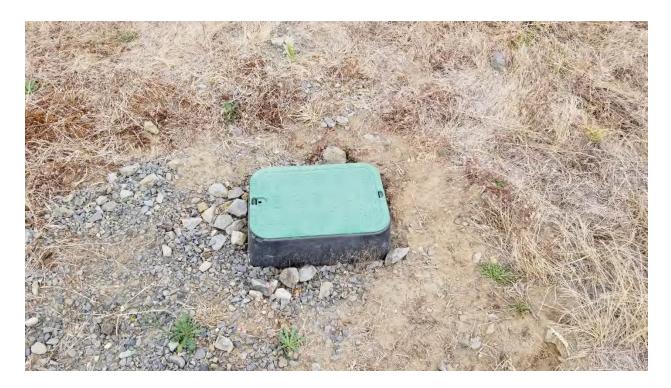
Photo 7: View of gas vent G-4.

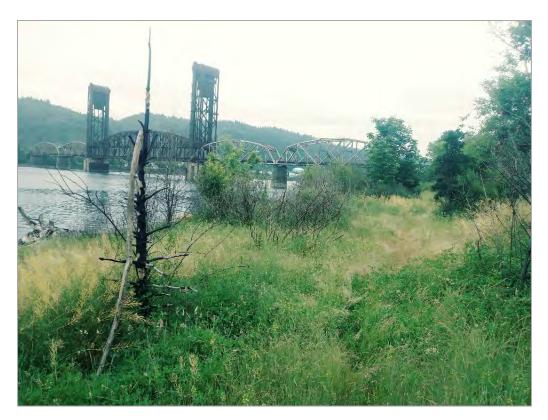
Photograph C21: Dead conifer along with regenerating shrubs (May 2019).

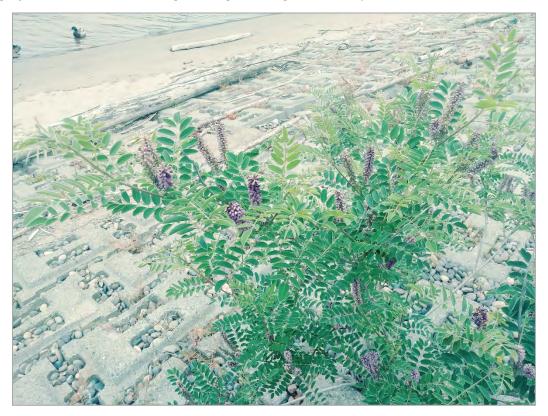
Photograph C22: Indigo bush (Amorpha fruticosa) B-list invasive (May 2019).

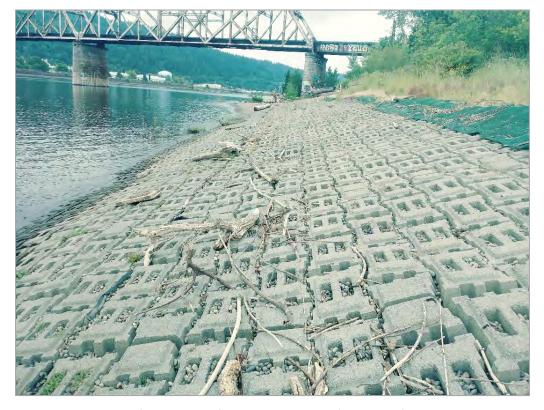
Photograph C24: Same area after shiny-leaf geranium removal (June 2019).

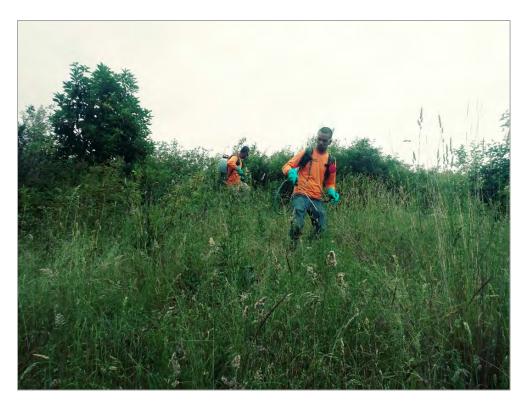
Photograph C25: Herbicide application (June 2019).

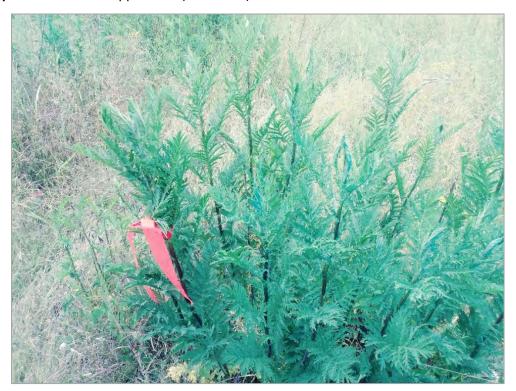
Photograph C26: Many plants or patches were tagged for herbicide application. Foliar spray was used for most species, including tansy (Tanacetum vulgare) (June 2019).

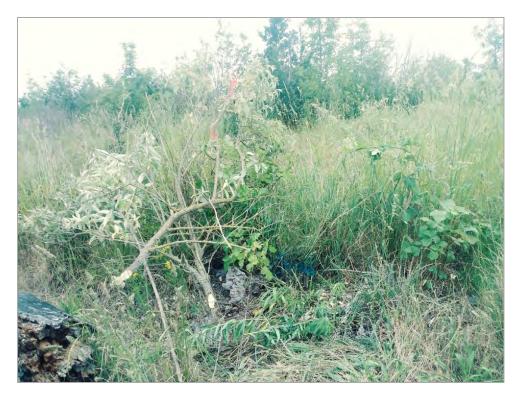
Photograph C27: Removal of butterflybush (*Buddleja davidii*) using cutting and stump treatment (June 2019).

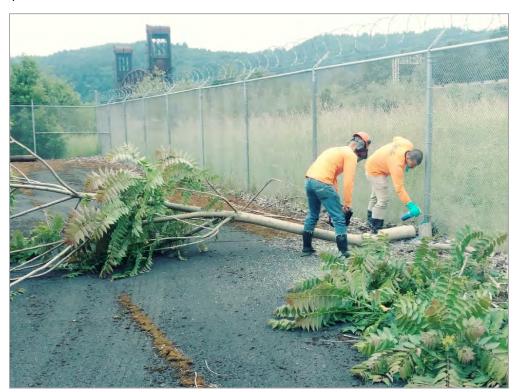
Photograph C28: Removal of tree of heaven (*Ailanthus altissima*) using cutting and stump treatment (June 2019).
