APPENDIX B

Daily Field Reports Continued

Phase II RA

OFFSITE REMOVAL ACTION - DAILY FIELD REPORT
JH BAXTER OFFSITE REMEDIAL ACTION
EUGENE, OREGON

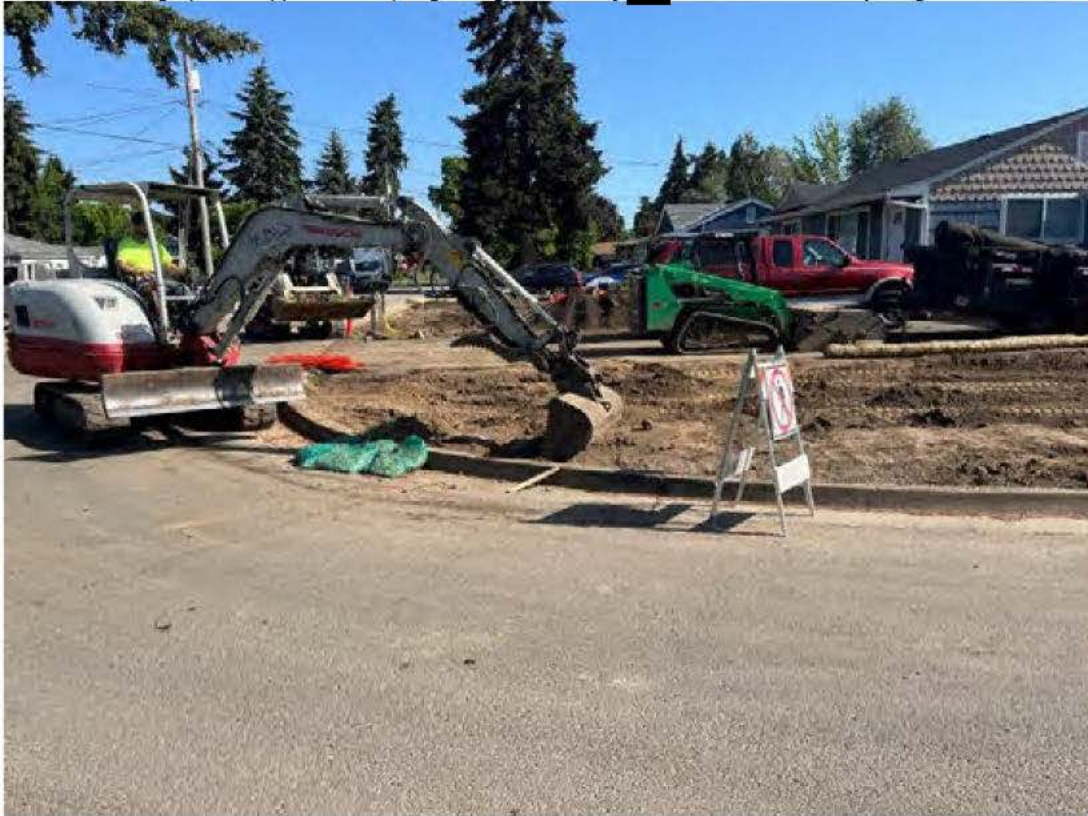
Photograph 1. Supplemental spot grading in ROW by [REDACTED] Baxter. Photo taken facing north.

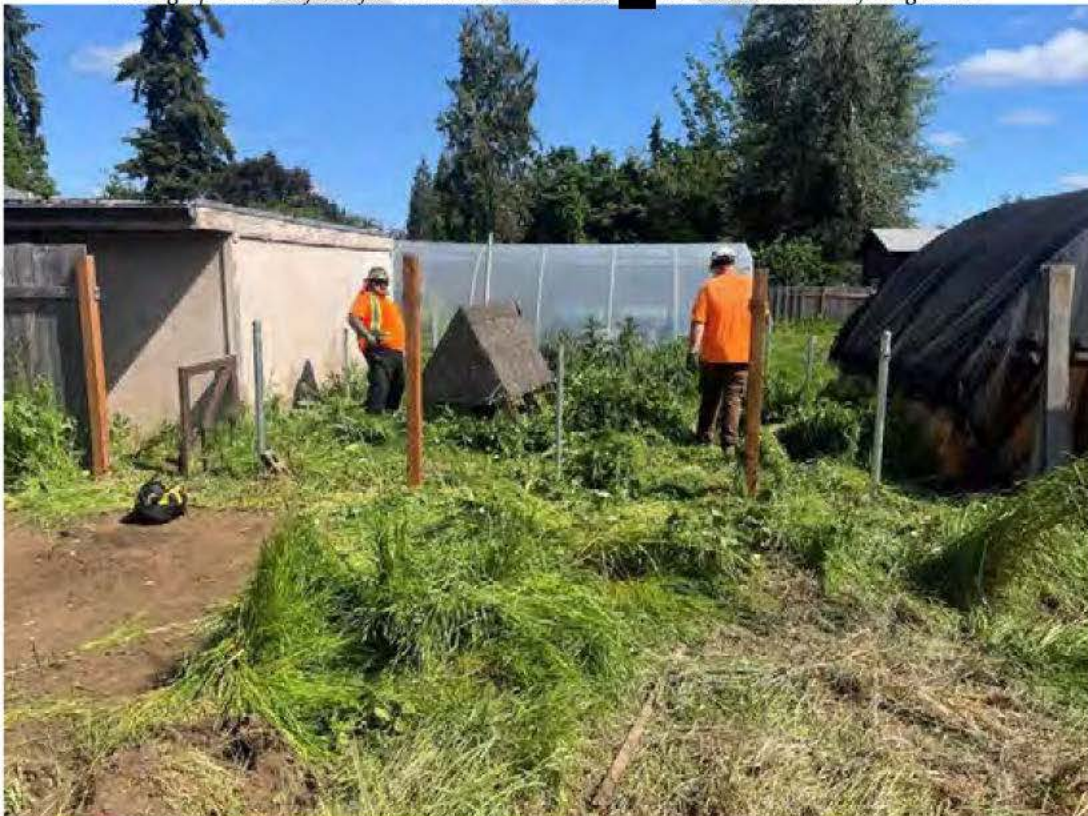
Photograph 2. Steel fence for chicken run removal at [REDACTED] Baxter. Photo taken facing north.

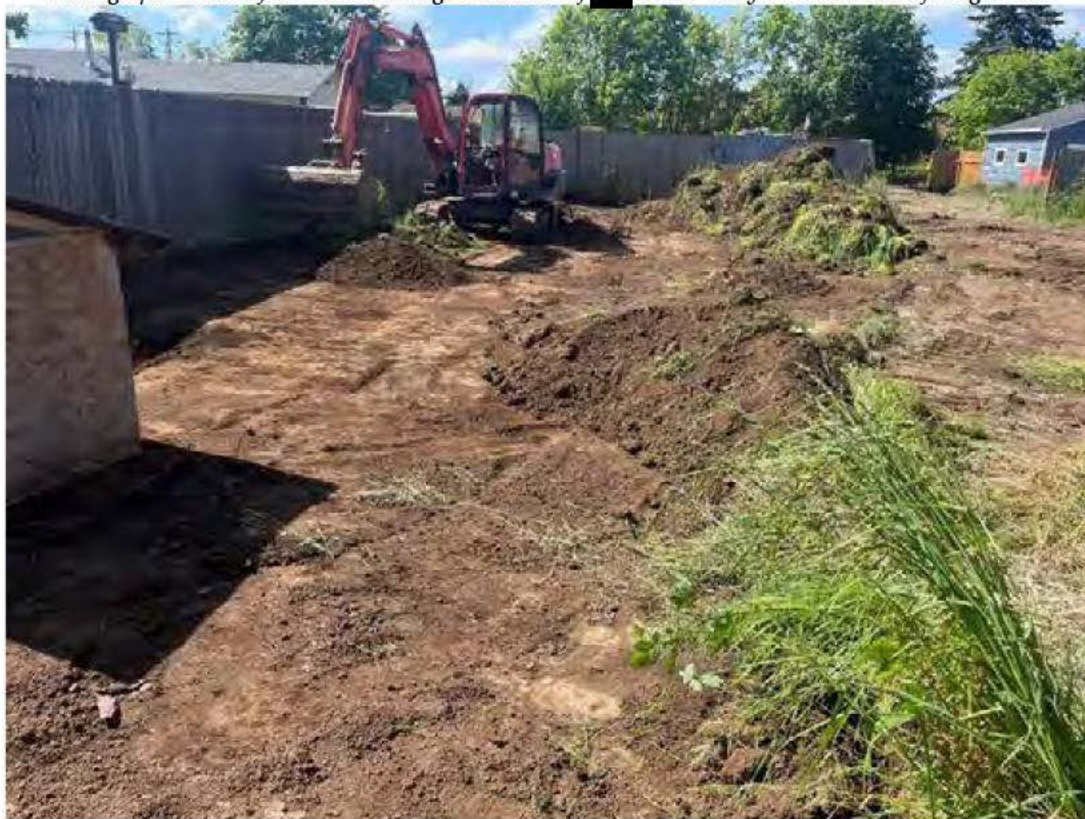
Photograph 3. Start of excavations along eastern side of [REDACTED] Baxter backyard. Photo taken facing south.

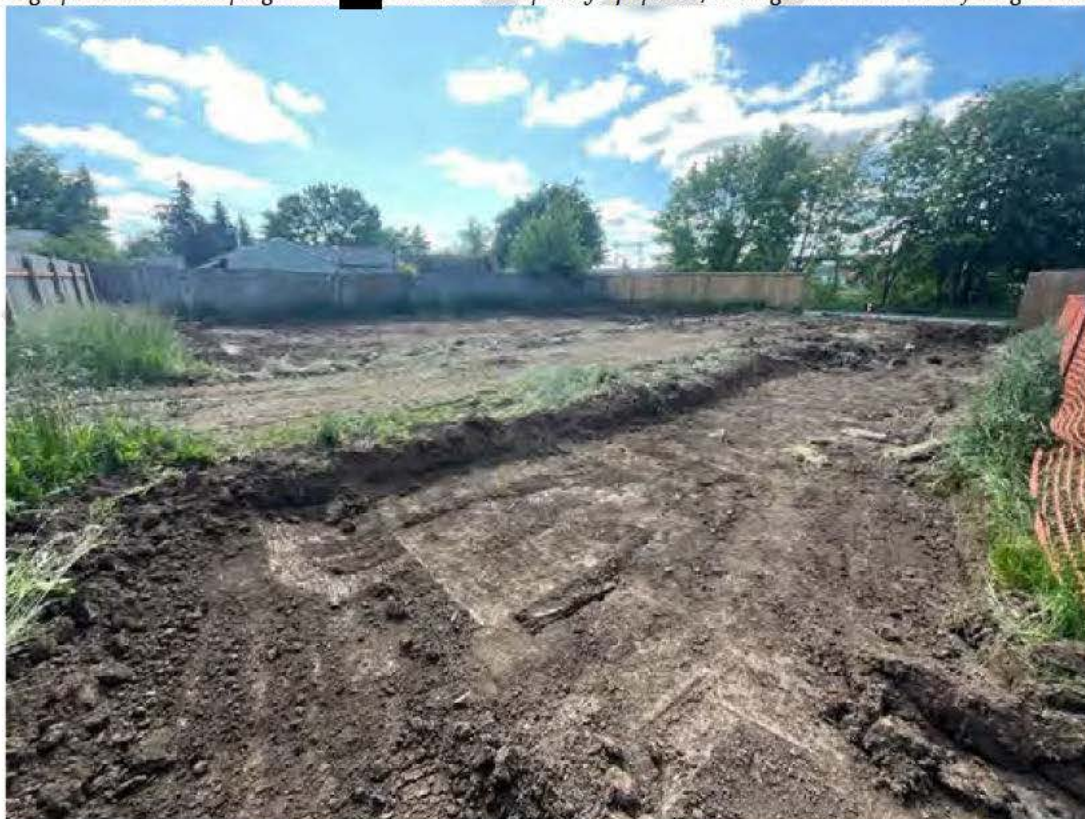
Photograph 4. Excavation progress at [REDACTED] Baxter and temporary equipment/loading road. Photo taken facing southeast.

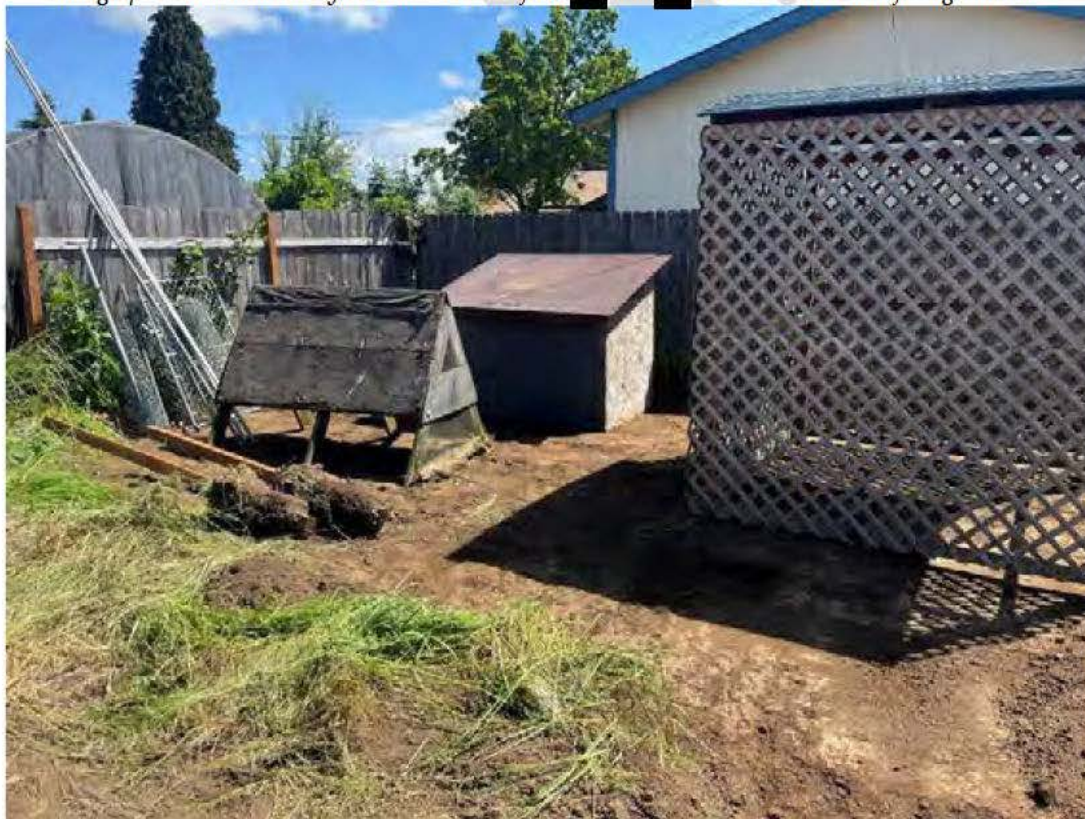
Photograph 6. Miscellaneous yard items set aside from [REDACTED] and [REDACTED] Baxter. Photo taken facing northeast.

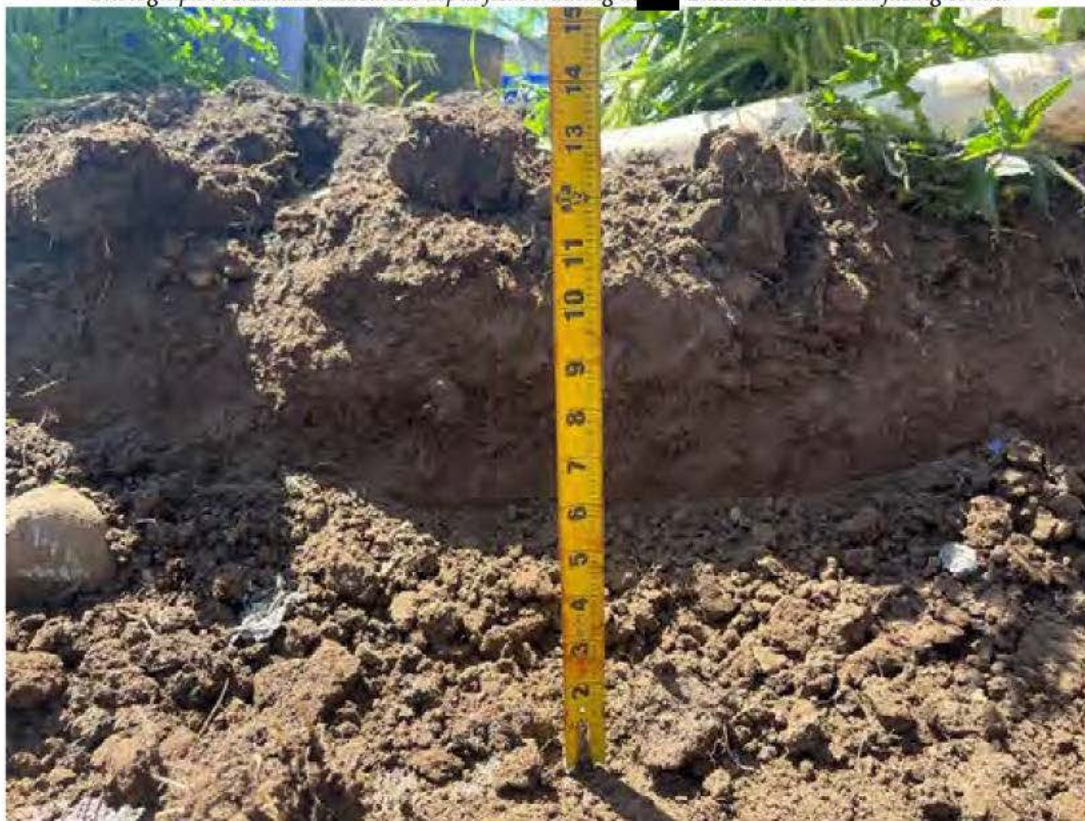
Photograph 7. Manual excavation depth field truthing at [REDACTED] Baxter. Photo taken facing south.

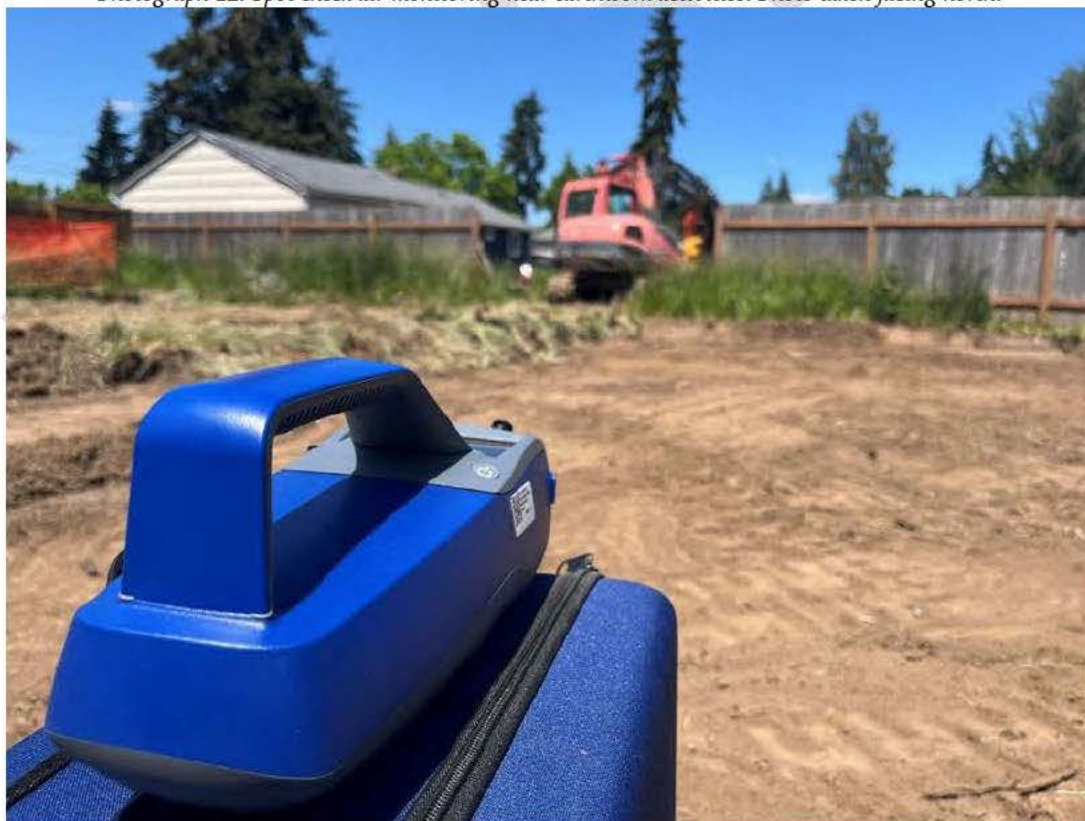
Photograph 12. Spot check air monitoring near earthwork activities. Photo taken facing north.

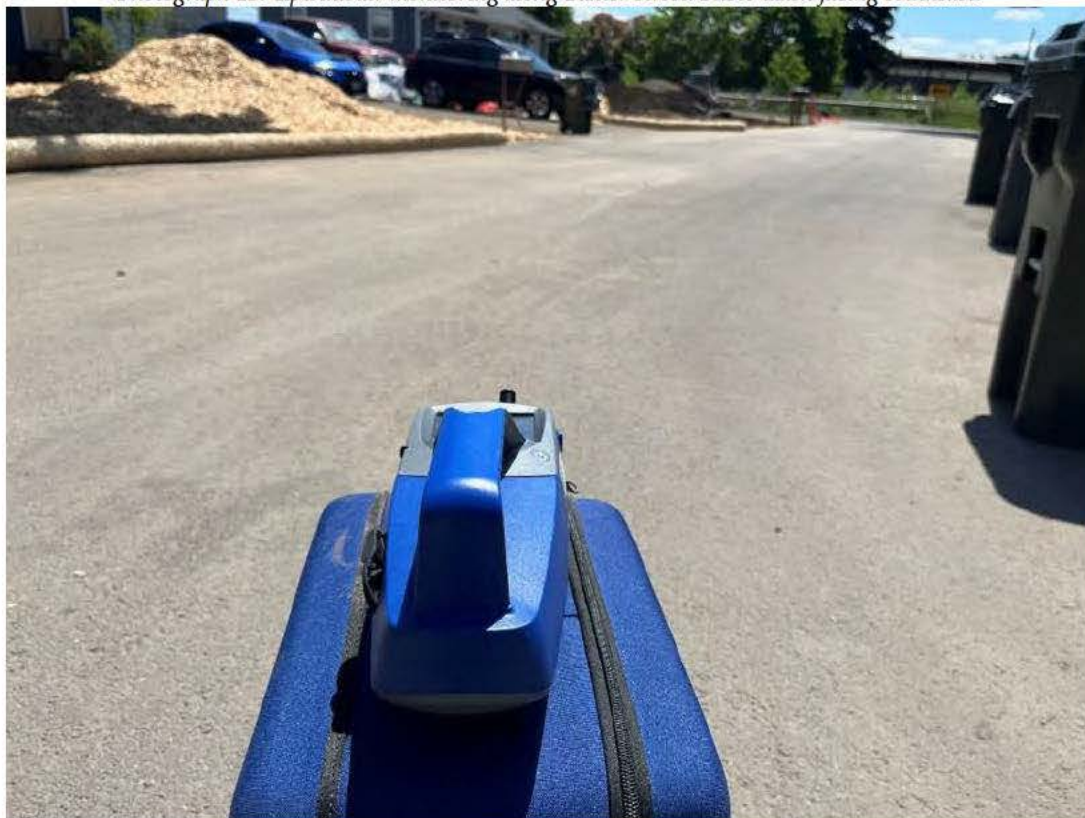
Photograph 13. Upwind air monitoring along Baxter street. Photo taken facing southeast.

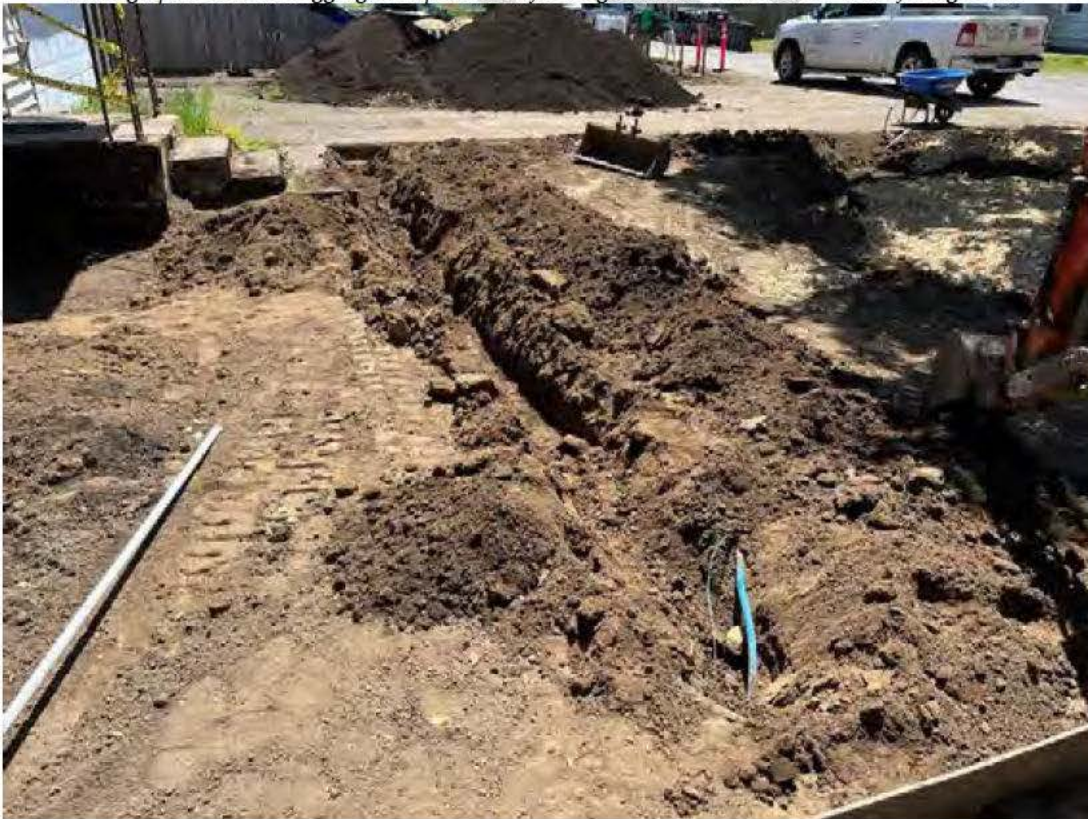
Photograph 16. Trench digging in imported soil for irrigation line install. Photo taken facing south.

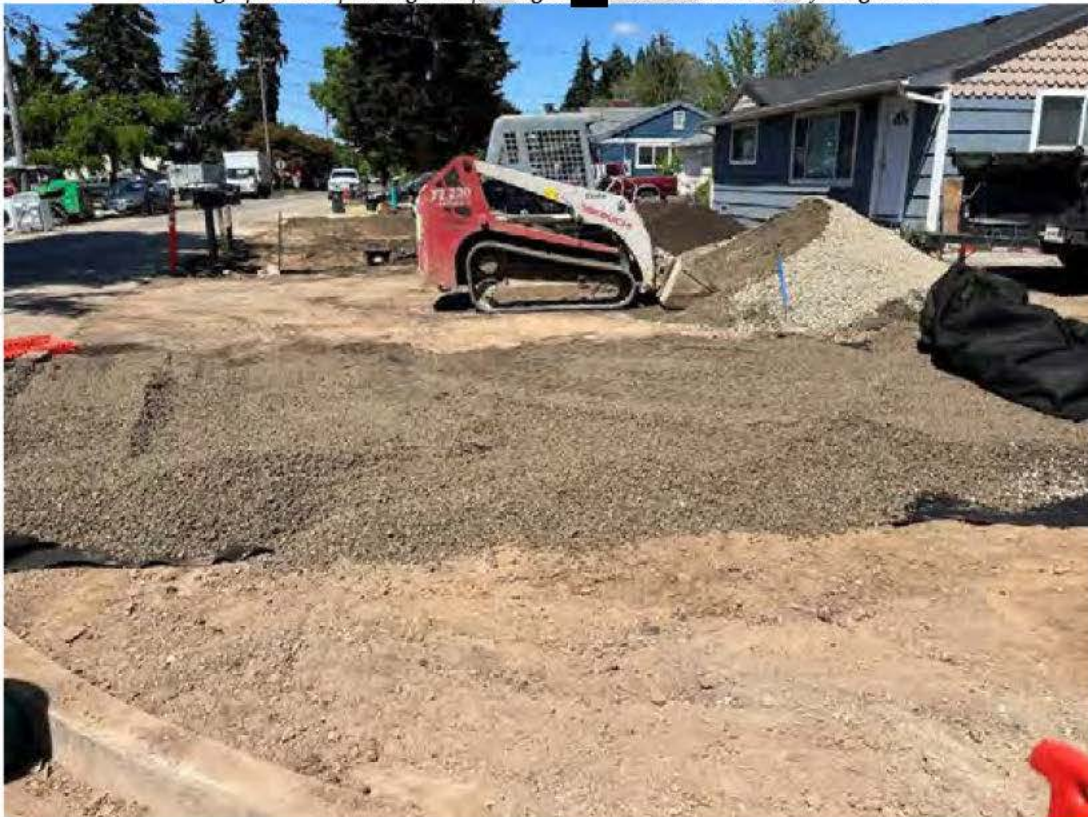
Photograph 18. Imported gravel placing at [REDACTED] Baxter. Photo taken facing north.

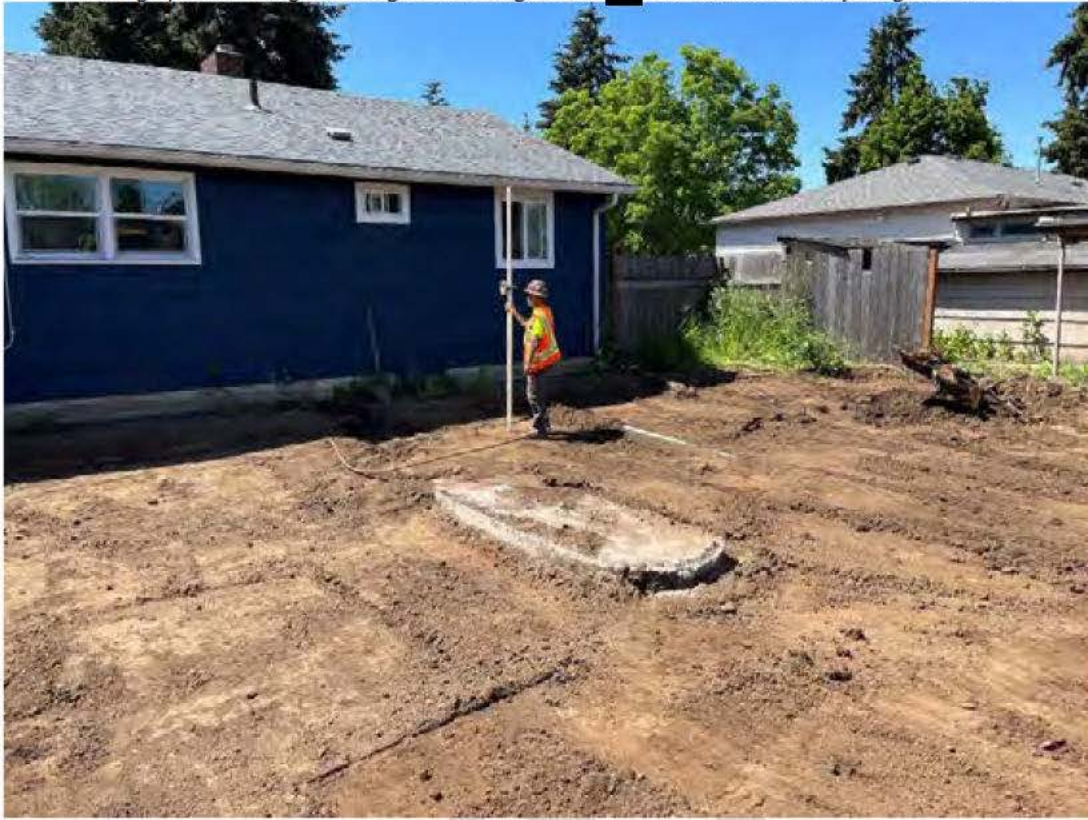
Photograph 19. 3 Kings checking excavation grades at Baxter. Photo taken facing northwest.

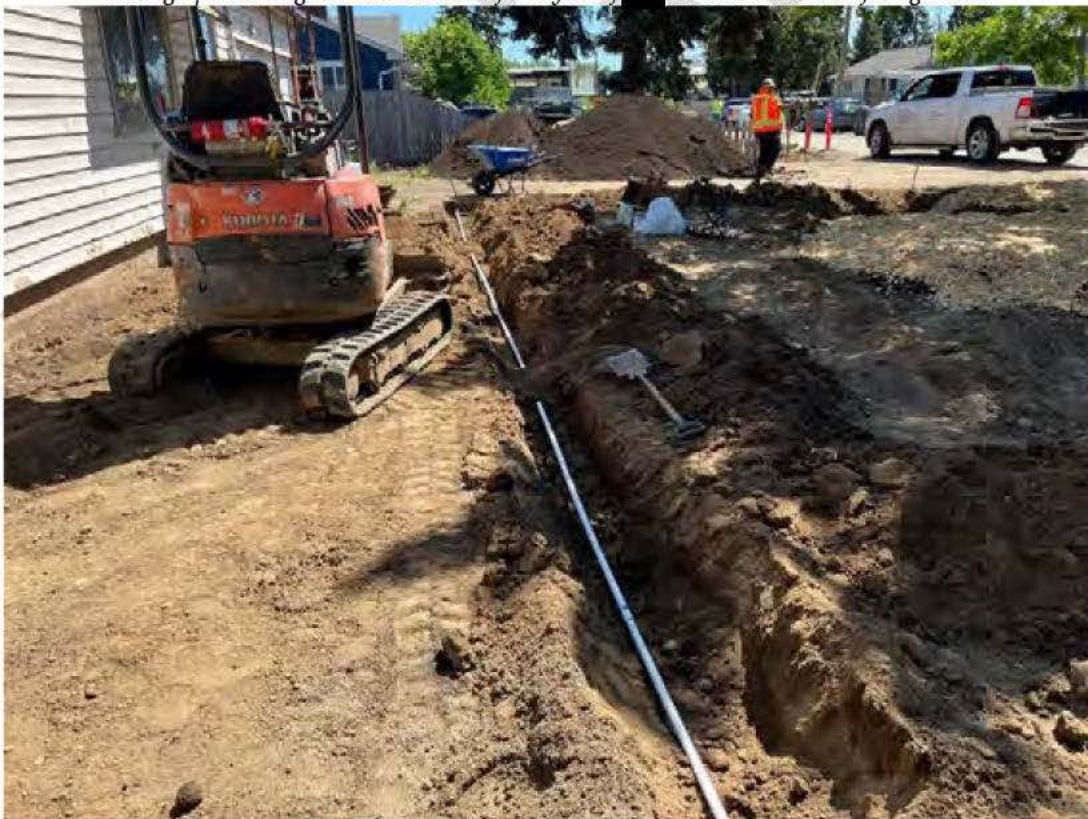
Photograph 20. Irrigation line install in front yard of Baxter. Photo taken facing south.

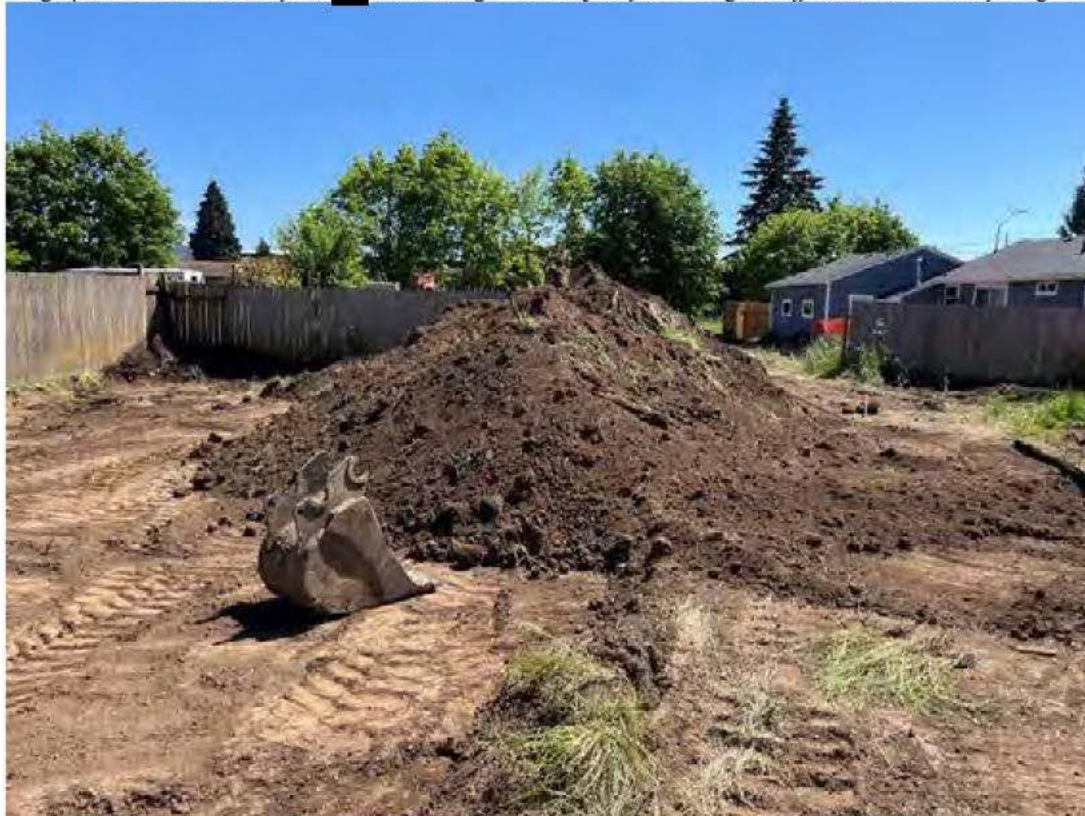
Photograph 21. Excavated soil from [REDACTED] Baxter staged in backyard for loading and off haul. Photo taken facing south.

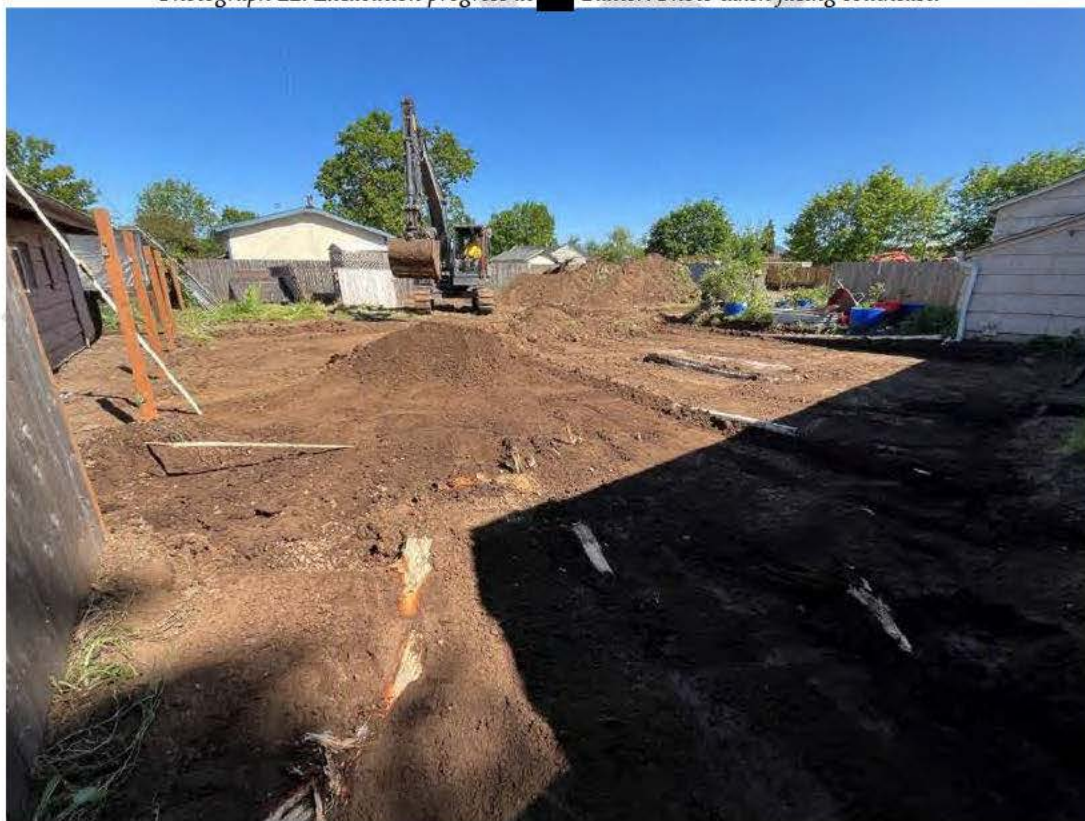
Photograph 22. Excavation progress at [REDACTED] Baxter. Photo taken facing southeast.

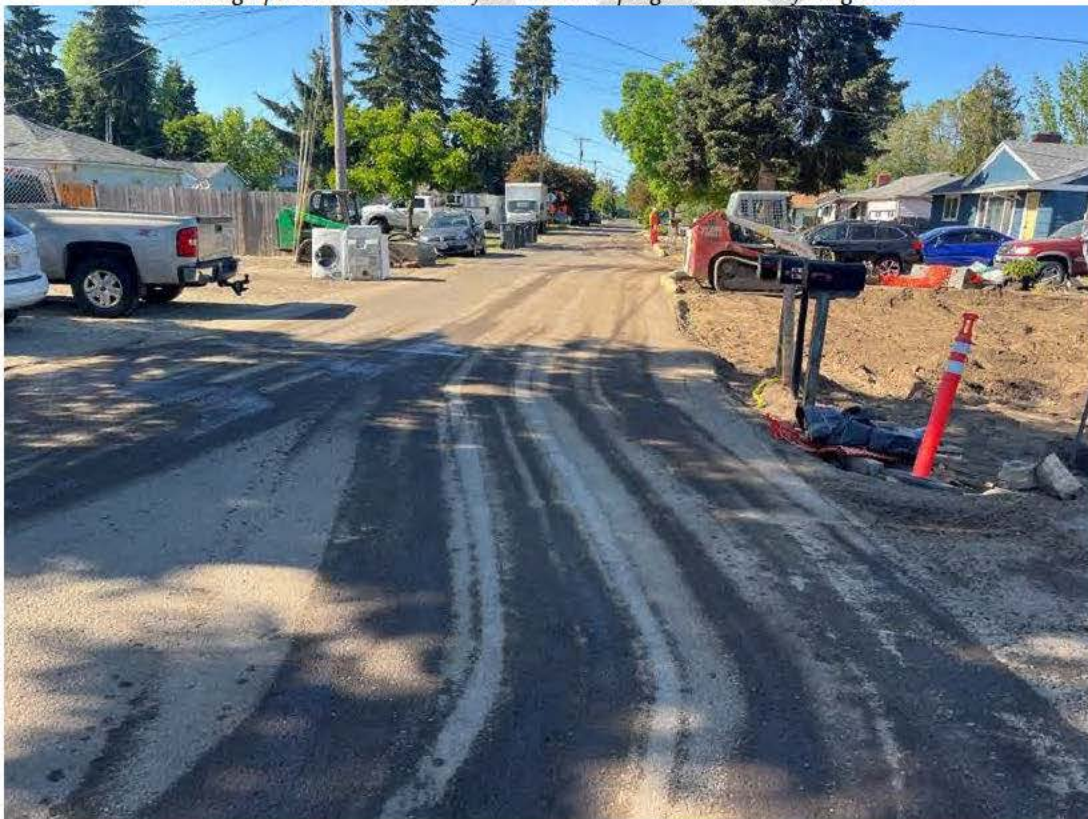
Photograph 24. Baxter ROW after street sweeping. Photo taken facing north.

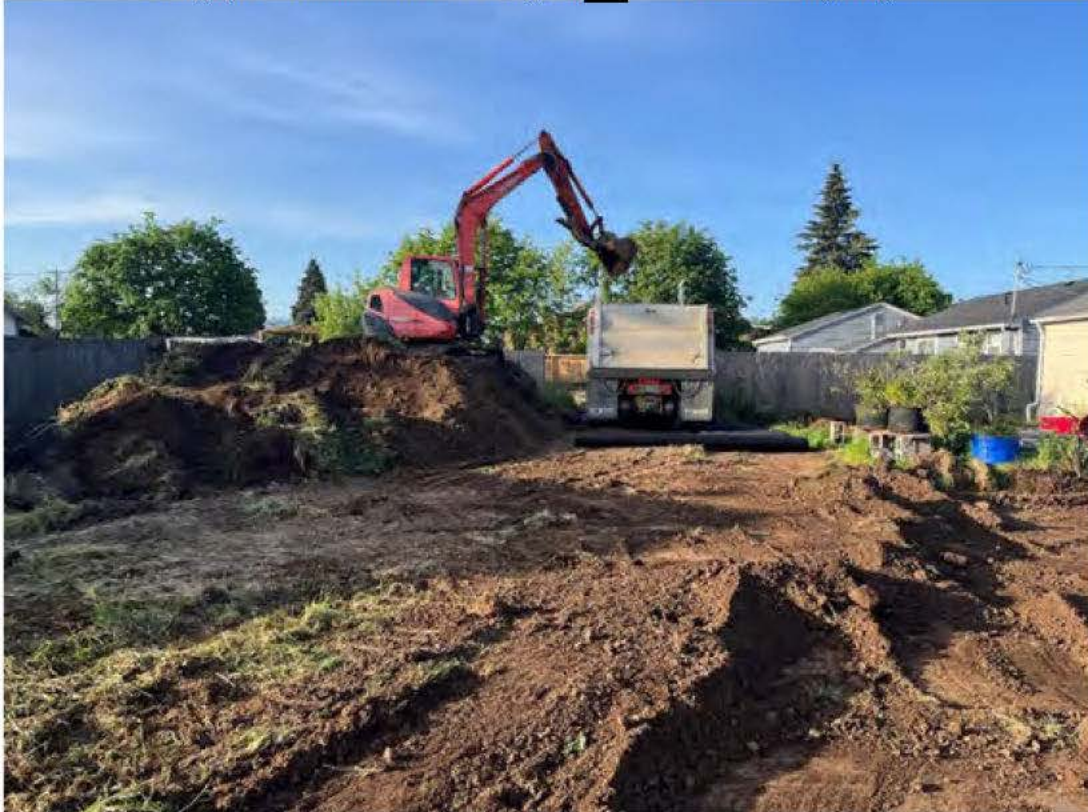
Photograph 1. Contaminated soil loading from [REDACTED] Baxter. Photo taken facing south.

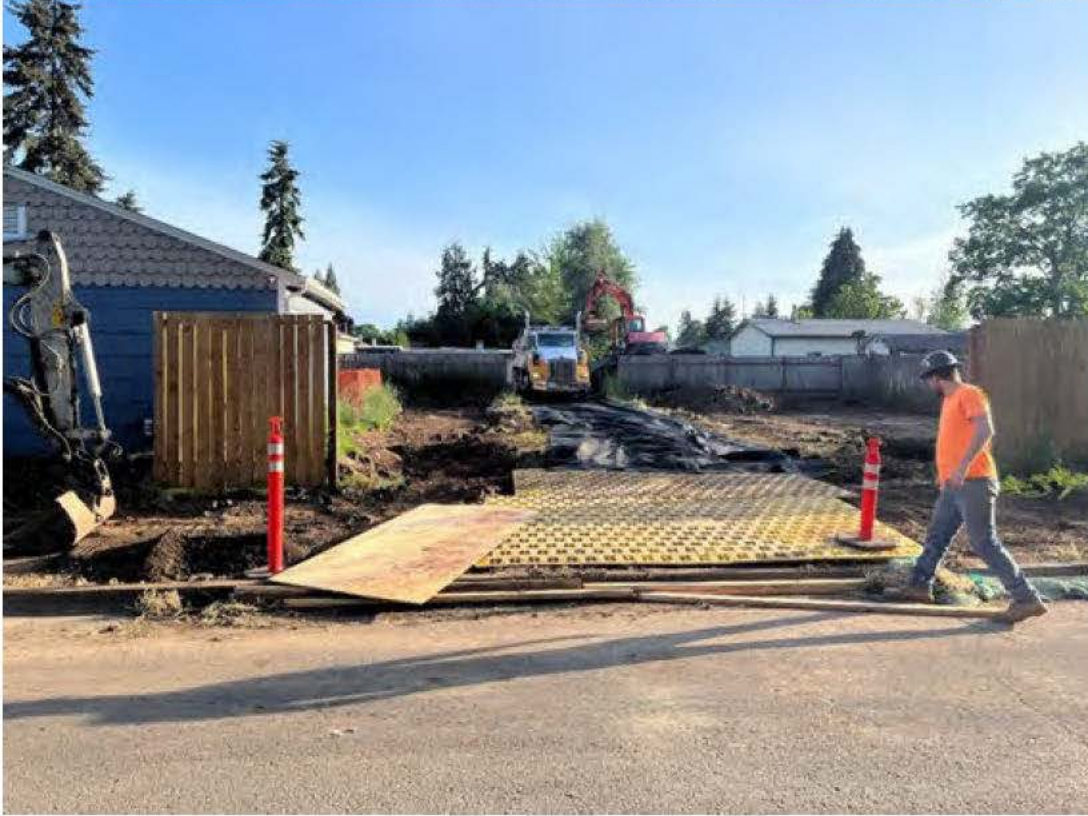
0715 - GSI observed 3 Kings had placed demarcation fabric along loading area in property back yards and track out pads/curb protection via wooden boards. GSI indicated to 3 Kings operator that BMPs installed at

Photograph 2. Loading road lined in fabric and track out/curb protection installed. Photo taken facing north.

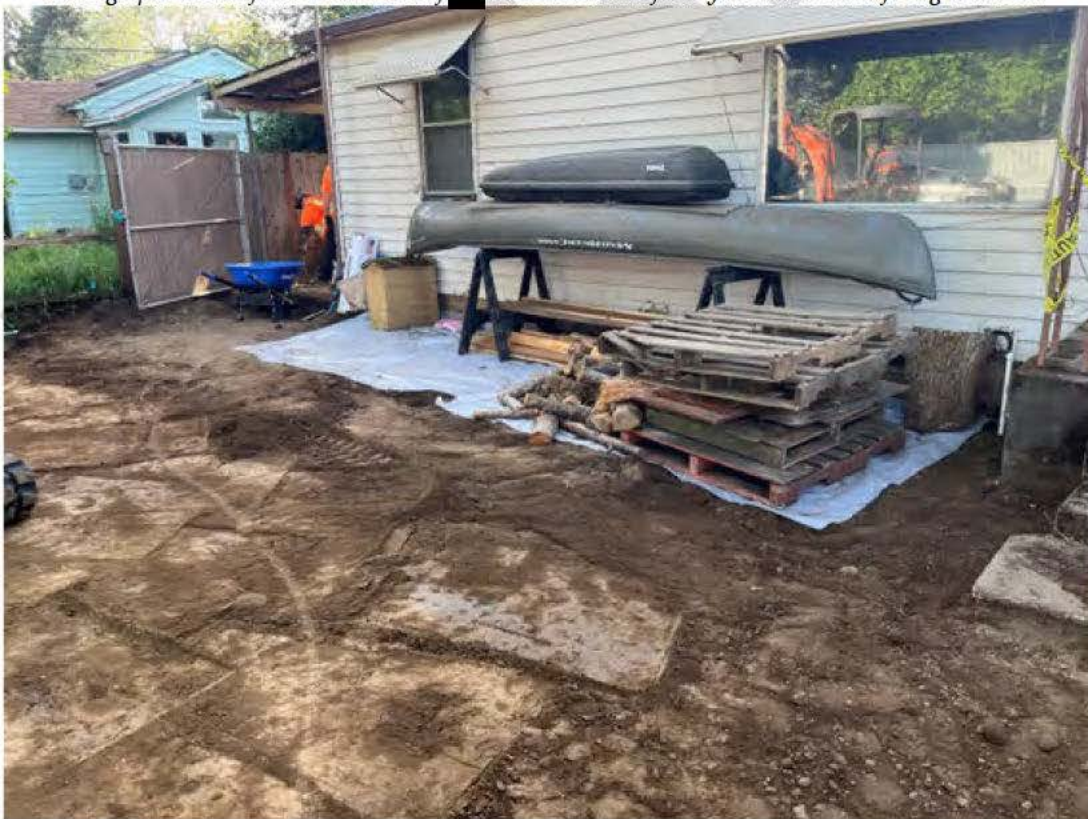
Photograph 3. Items from covered area of [REDACTED] Baxter stored in front yard. Photo taken facing northeast.

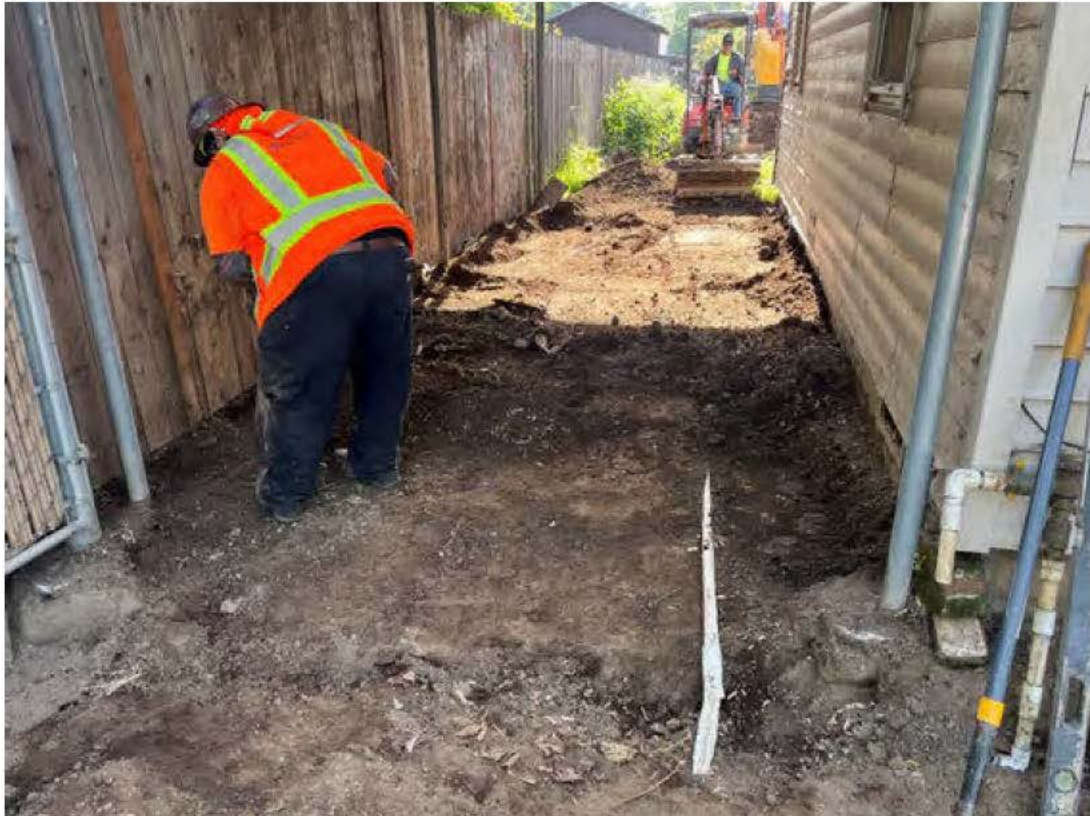
Photograph 4. Hand tools and mini-excavator used to remove soil from covered area at [REDACTED] Baxter. Photo taken facing east.

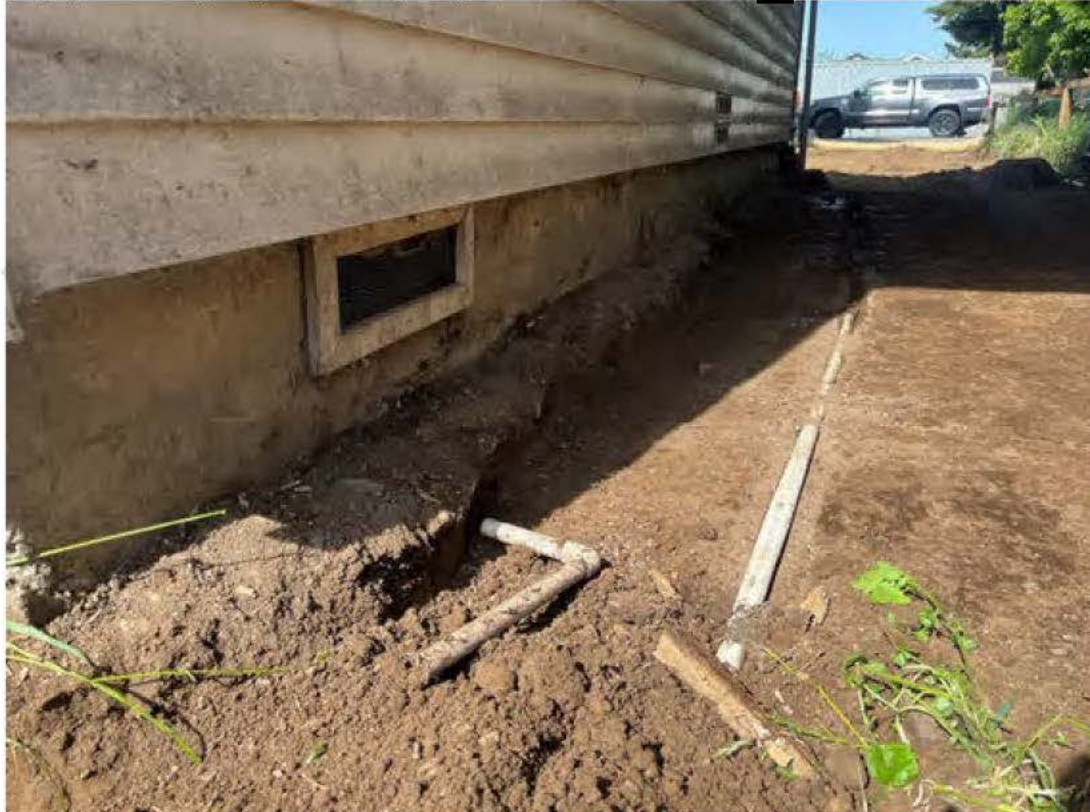
0950 – A-1 Auto Glass (1 crew) onsite to repair Toyota Tundra window damaged at [REDACTED] Baxter during earthwork. 3 Kings using hand tools to dig trench for drain line at [REDACTED] Baxter. GSI/3 Kings discussed footing excavations at [REDACTED] Baxter. 3 Kings indicated that the footing appeared to terminate around 6 inches below grade. GSI indicated that 3 Kings could remove the full six inches in accordance with project specifications as they were careful not to undermine the footing.

Photograph 5. Existing irrigation line and footing excavation in covered area at [REDACTED] Baxter. Photo taken facing west.

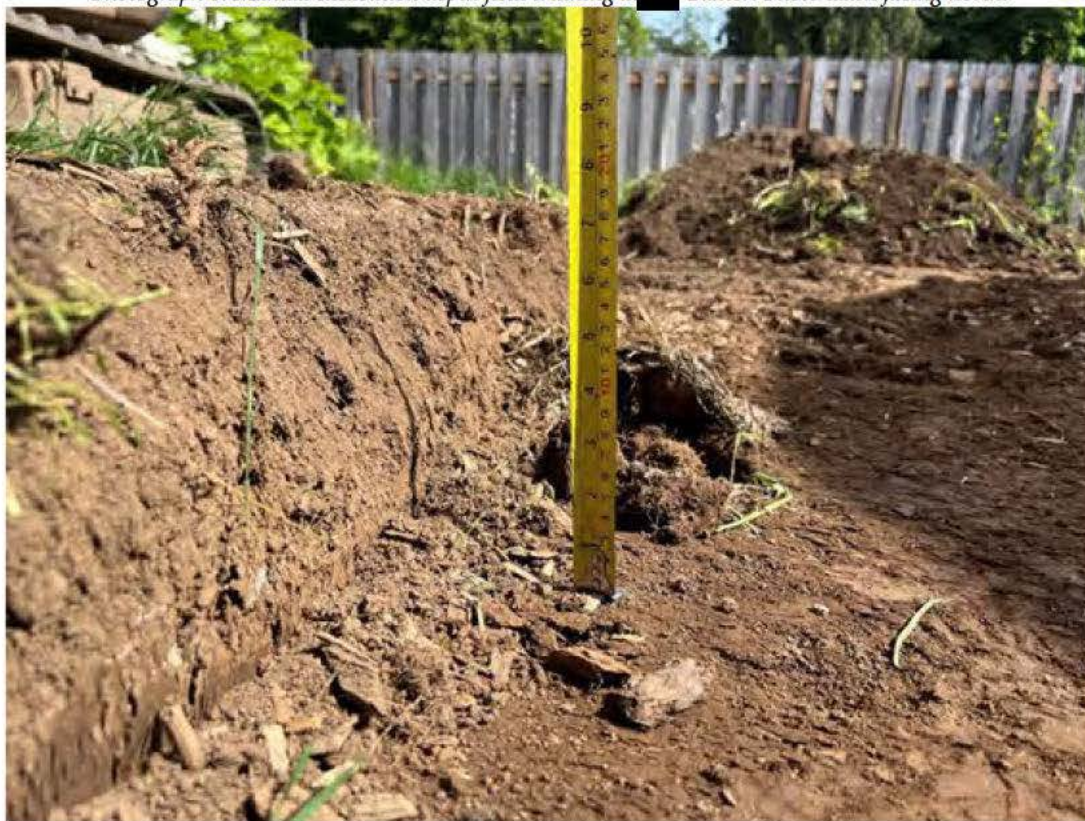
Photograph 6. Manual excavation depth field truthing at [REDACTED] Baxter. Photo taken facing north.

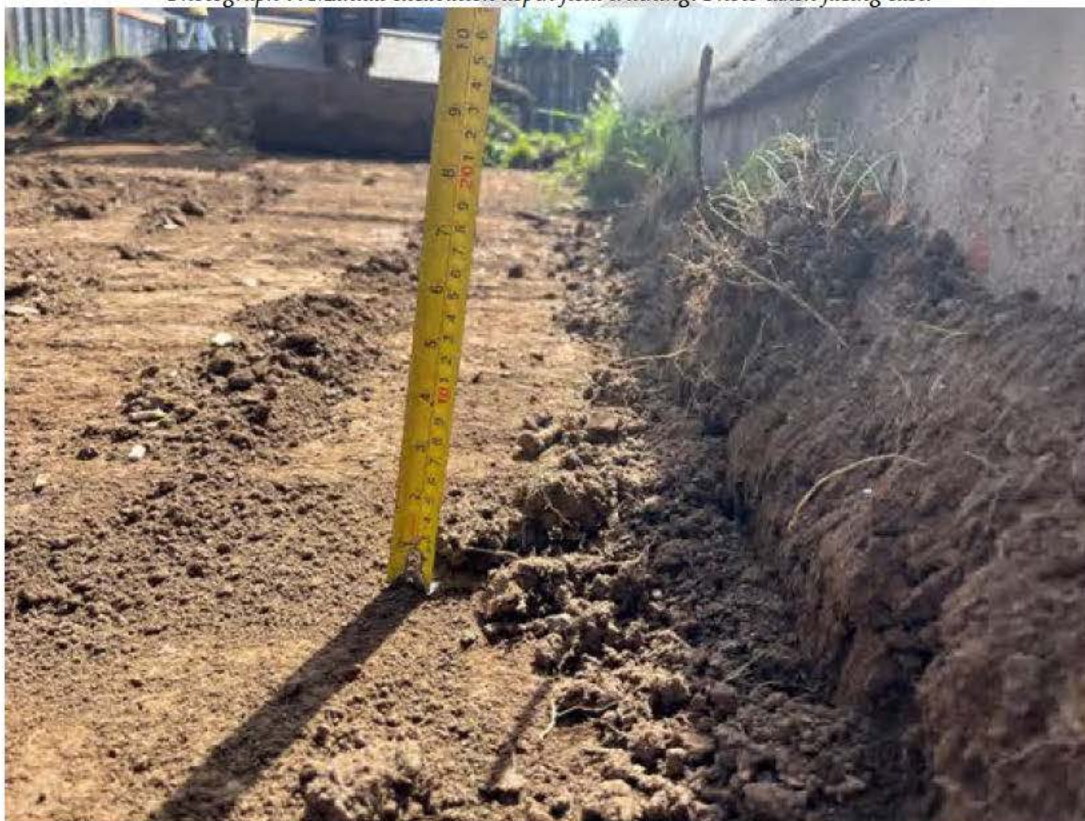
Photograph 7. Manual excavation depth field truthing. Photo taken facing east.

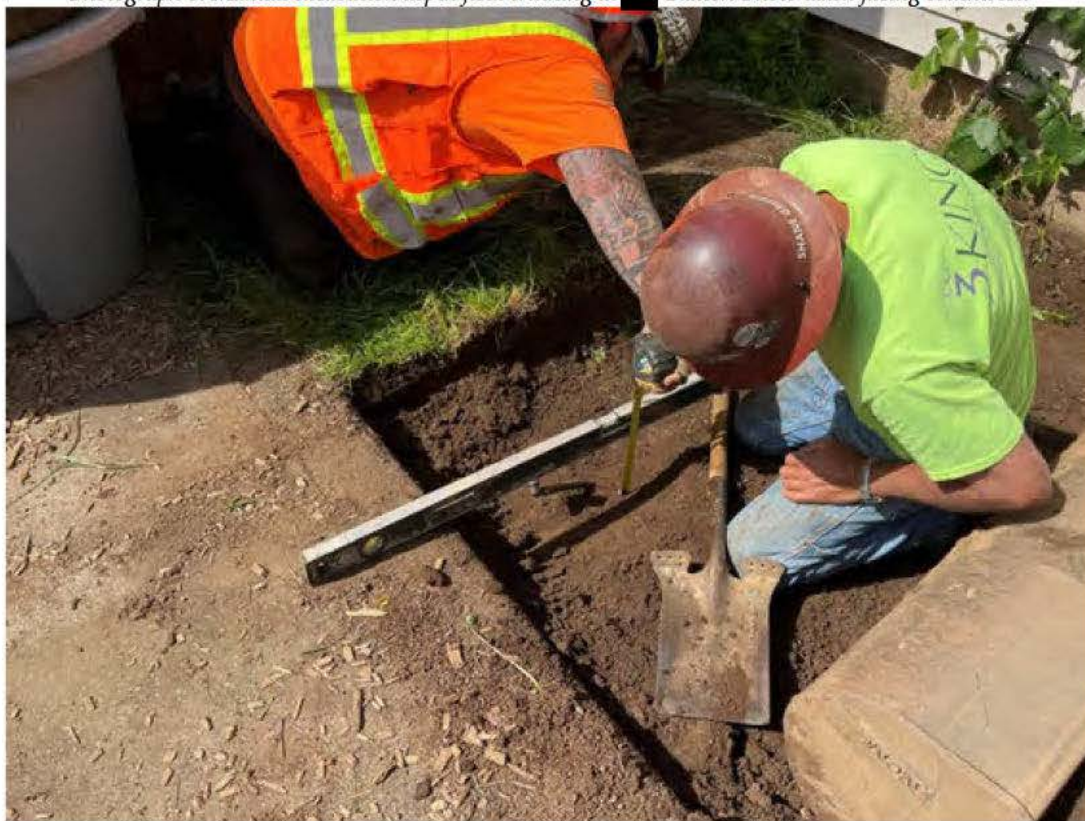
Photograph 8. Manual excavation depth field truthing at [REDACTED] Baxter. Photo taken facing southwest.

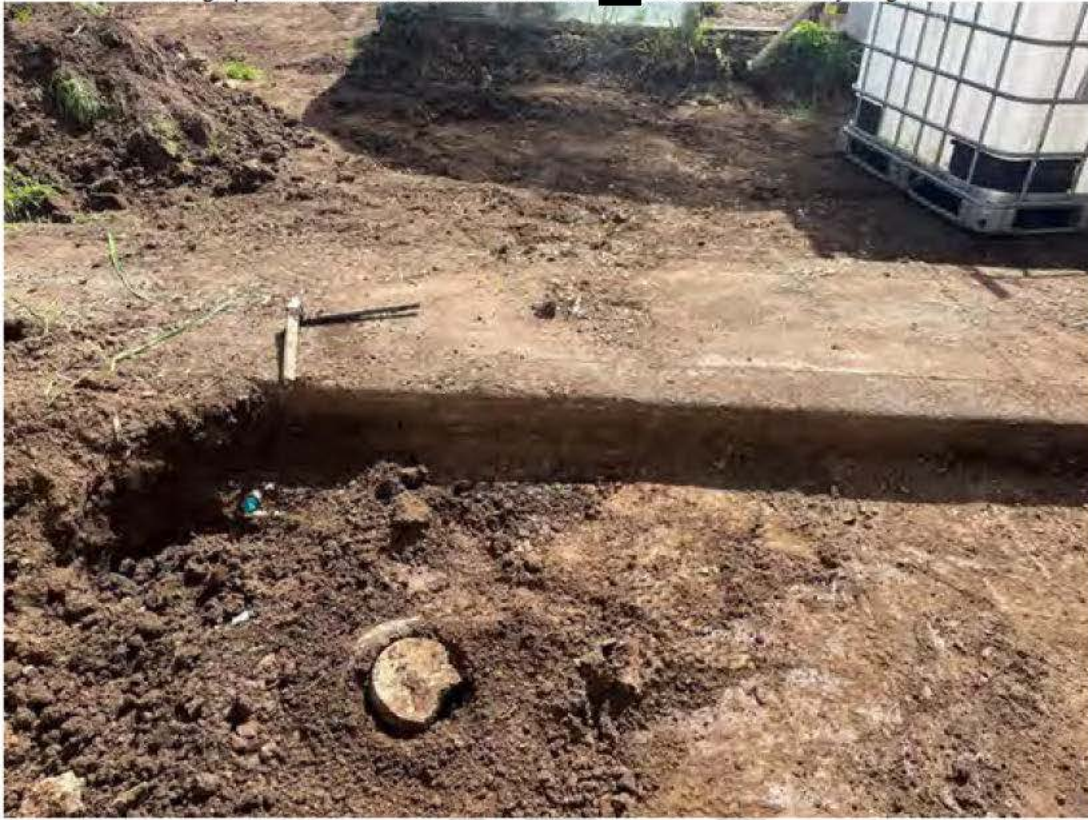
Photograph 10. Sewer cleanout encountered at [REDACTED] Baxter. Photo taken facing east.

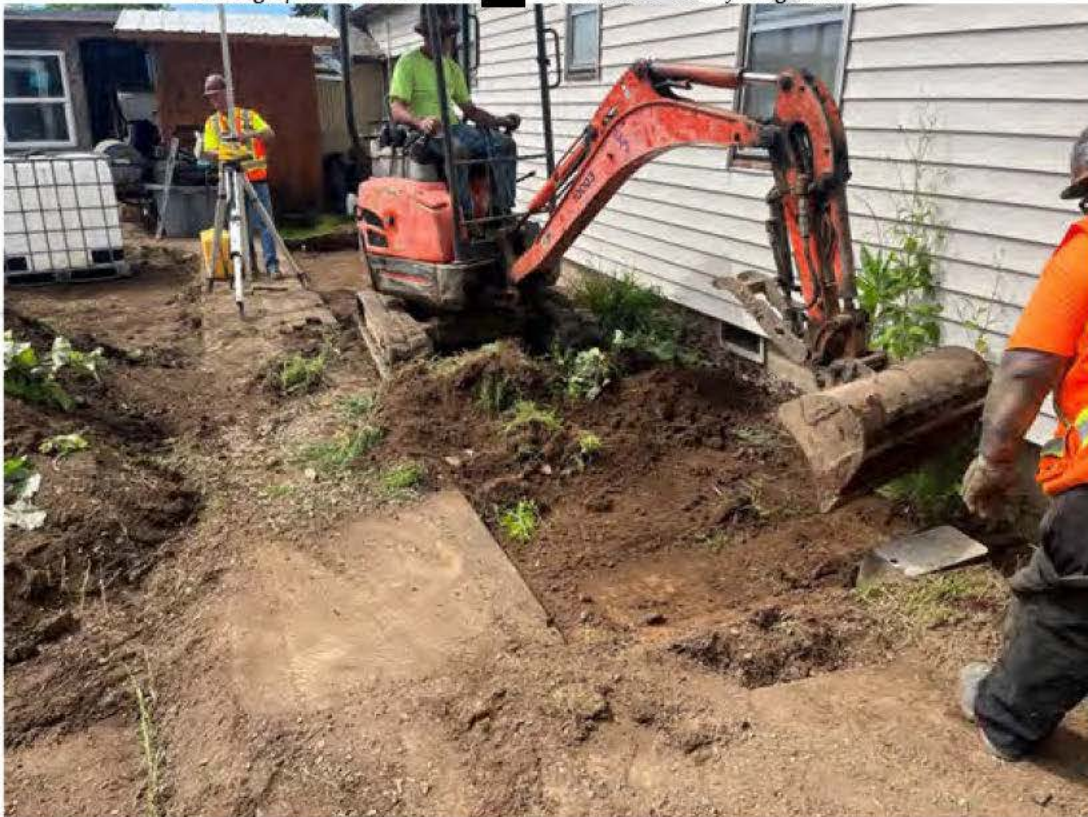
Photograph 11. Excavation at [REDACTED] Baxter. Photo taken facing southwest.
