APPENDIX B

Daily Field Reports Continued

Phase II RA

OFFSITE REMOVAL ACTION - DAILY FIELD REPORT
JH BAXTER OFFSITE REMEDIAL ACTION
EUGENE, OREGON

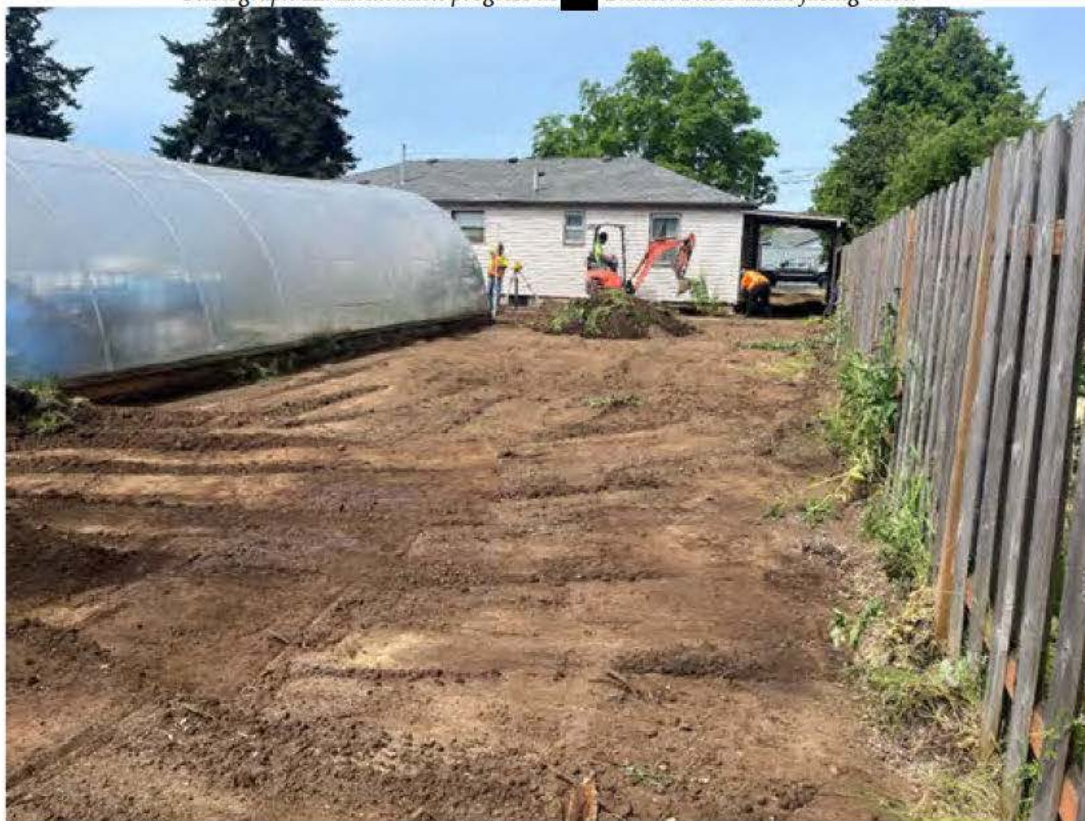
Photograph 12. Excavation progress at [REDACTED] Baxter. Photo taken facing west.

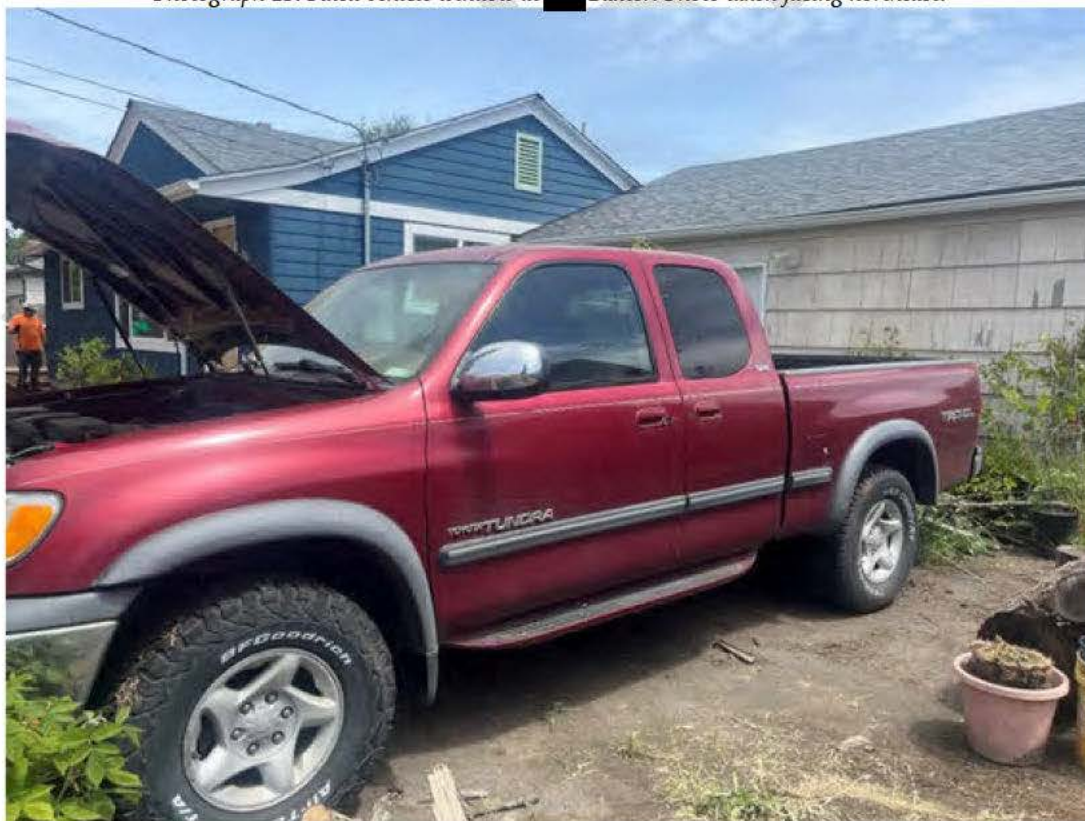
0950 – A-1 Auto Glass (1 crew) onsite to repair Toyota Tundra window damaged at [REDACTED] Baxter during earthwork. 3 Kings using hand tools to dig trench for drain line at [REDACTED] Baxter. GSI/3 Kings discussed footing excavations at [REDACTED] Baxter. 3 Kings indicated that the footing appeared to terminate around 6 inches below grade. GSI indicated that 3 Kings could remove the full six inches in accordance with project specifications as they were careful not to undermine the footing.

Photograph 13. Fixed vehicle window at [REDACTED] Baxter. Photo taken facing northeast.

1235 – A-1 Auto Glass completed replacement of vehicle window at [REDACTED] Baxter. 3 Kings continuing restoration work with mini excavator in front yards [REDACTED] and [REDACTED] Baxter.

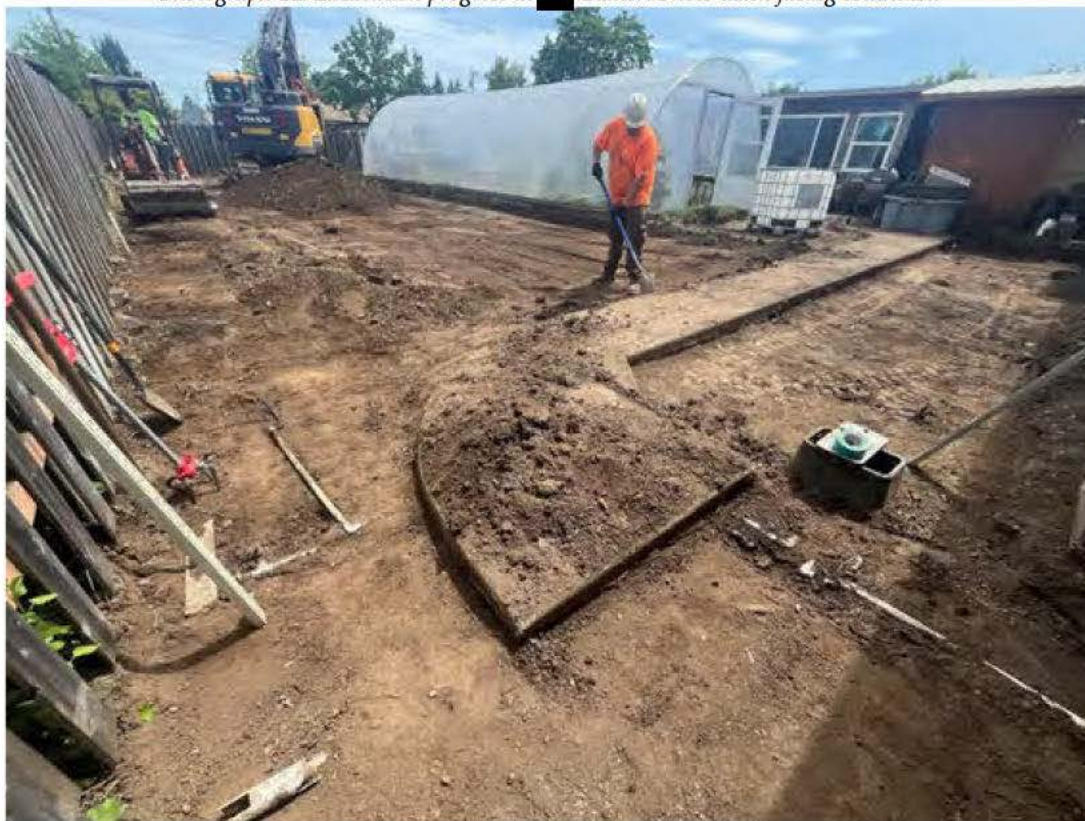
Photograph 14. Excavation progress at [REDACTED] Baxter. Photo taken facing southeast.

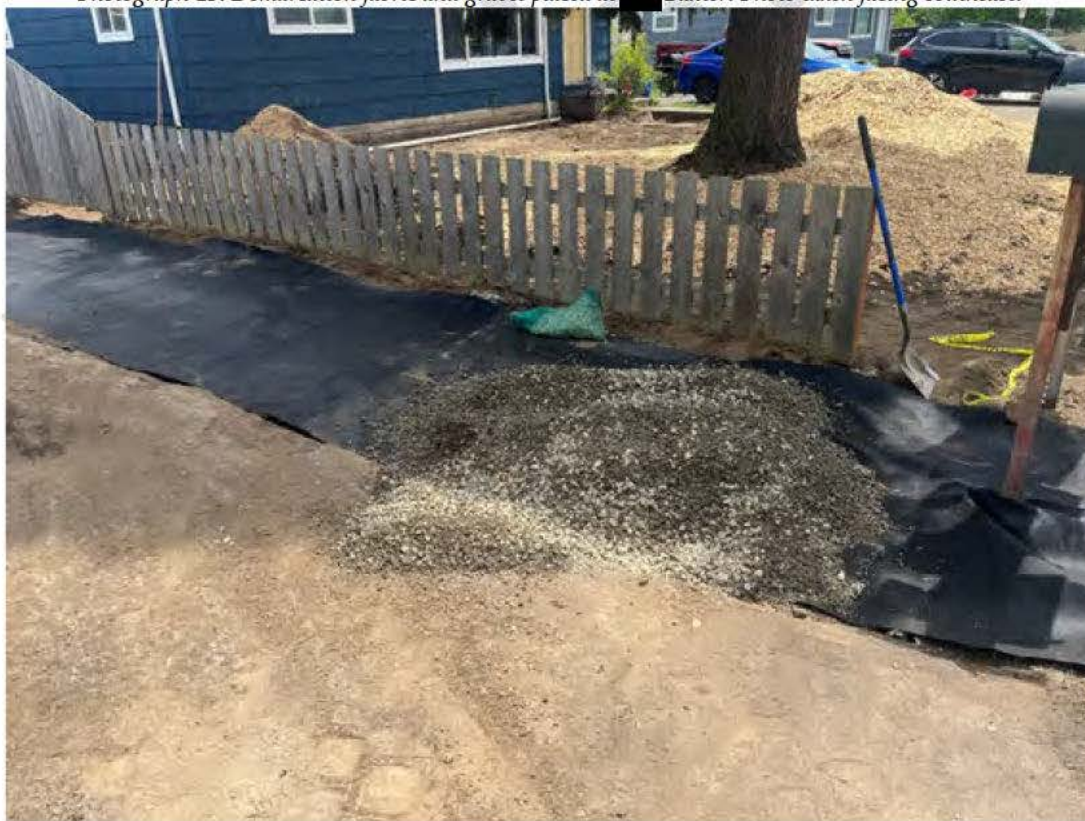
Photograph 15. Demarcation fabric and gravel placed at [REDACTED] Baxter. Photo taken facing southeast.

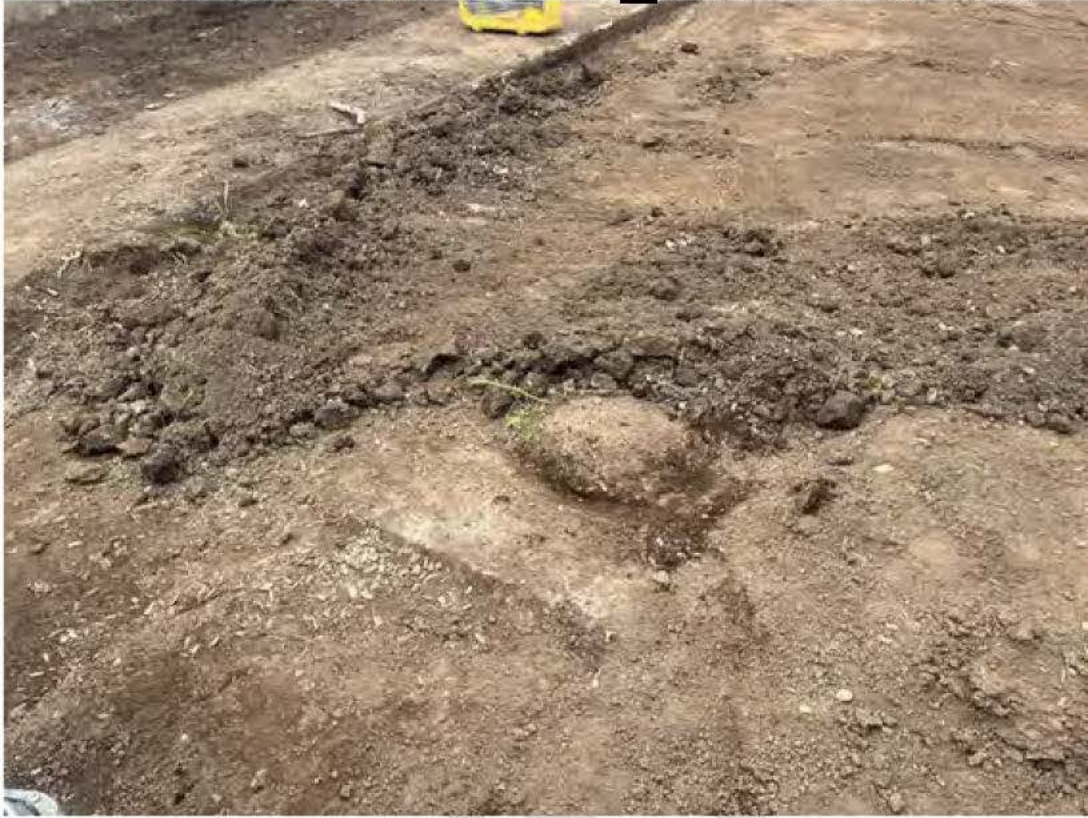
3 Kings operator indicated that he had felt what was likely a septic system while excavating between the greenhouse and the residence at [REDACTED] Baxter. GSI indicated to carefully continue removing material in this area to required excavation grade (6 inches) and that any potential system handling would be discussed when the condition of the septic system is observed.

Photograph 16. Septic tank with apparent concrete cap at [REDACTED] Baxter. Photo taken facing northwest.

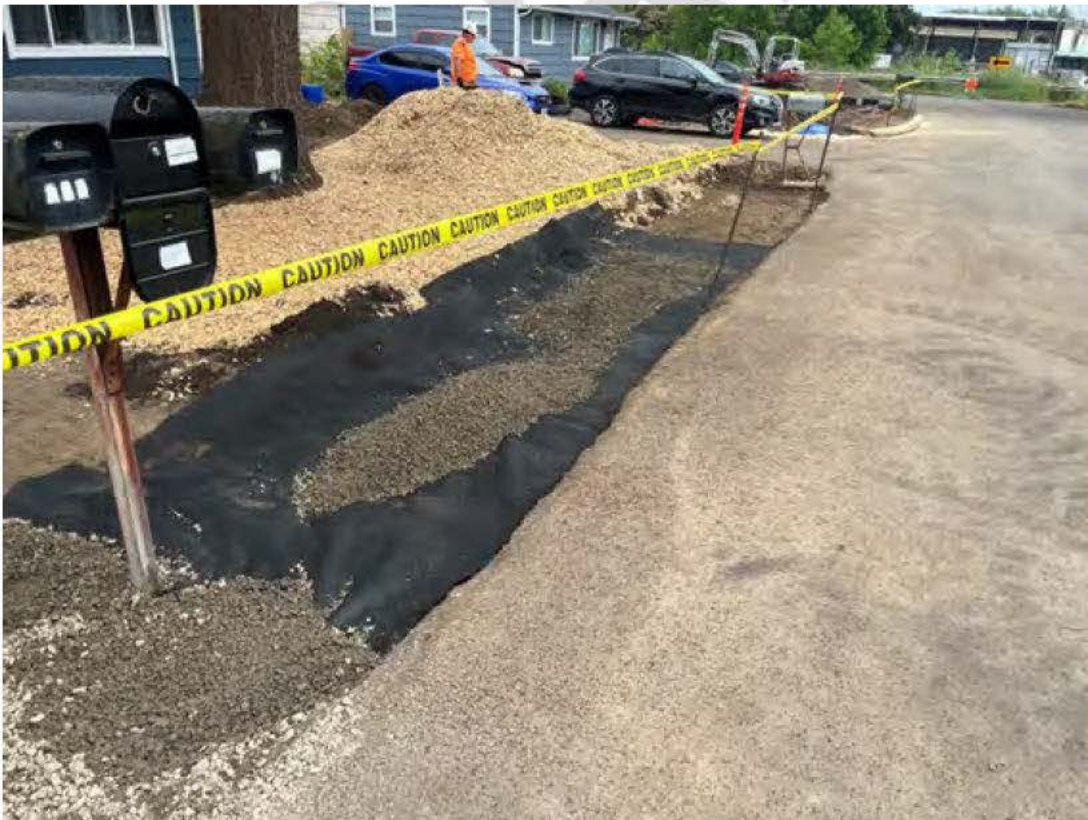
Photograph 17. Fabric and gravel mistakenly placed in ROW along [REDACTED] Baxter. Photo taken facing south.

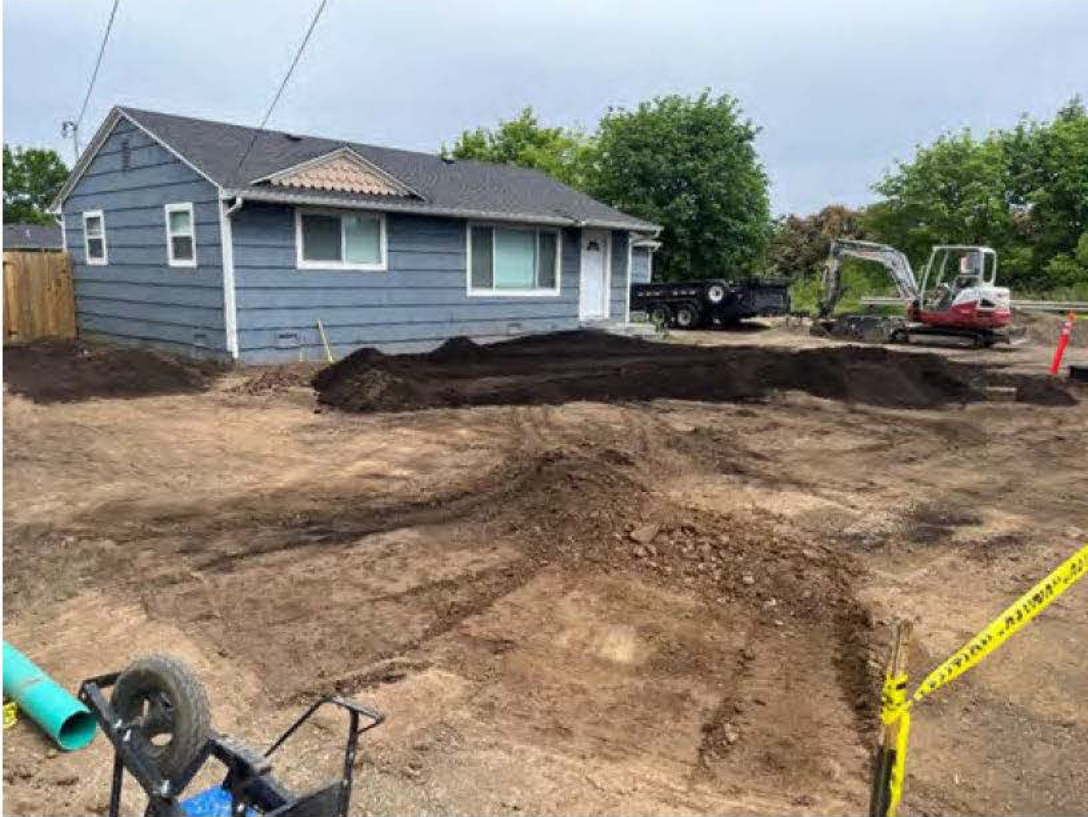
Photograph 18. Start of topsoil placing at [REDACTED] Baxter. Photo taken facing southeast.

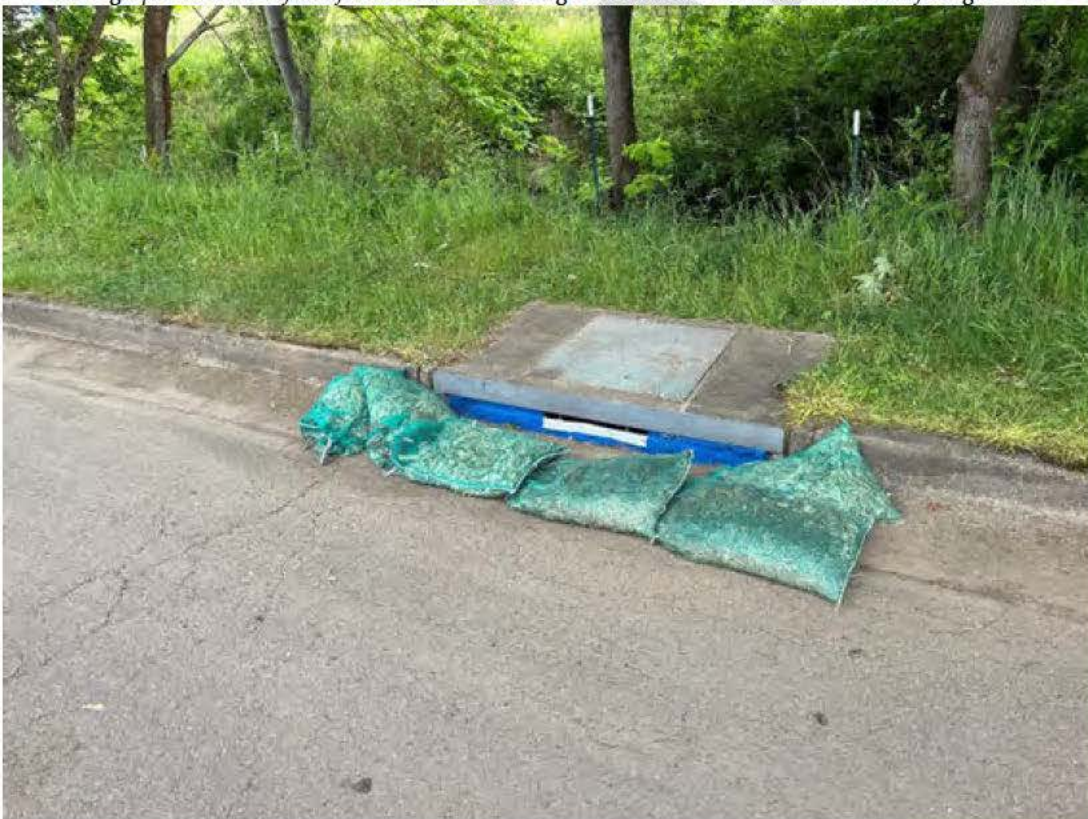
Photograph 19. BMP refresh for side road connecting Baxter and Alva Park. Photo taken facing south.

curb inlets could use a refresh, particularly with some evening rain forecast. 3 Kings indicated they had some additional biobags and/or fabric they could replace at inlets in addition to the installed dedicated inserts.

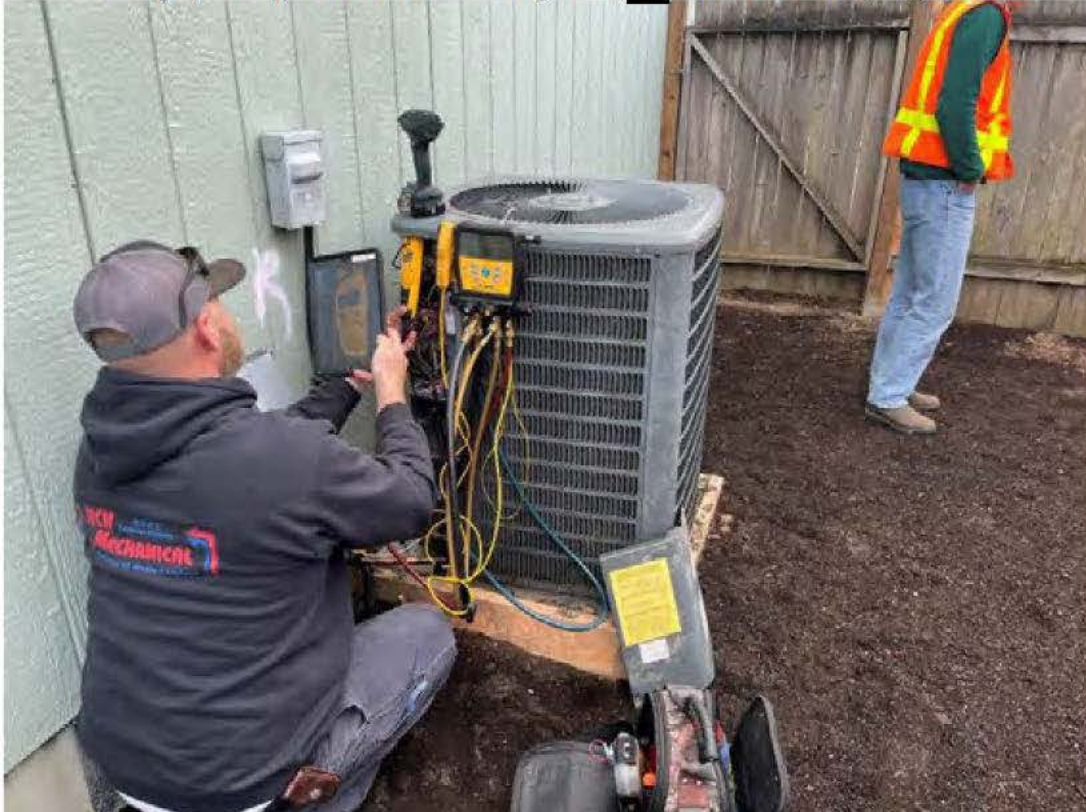
Photograph 1. Supplemental HVAC unit diagnosis at [REDACTED] Baxter. Photo taken facing south.

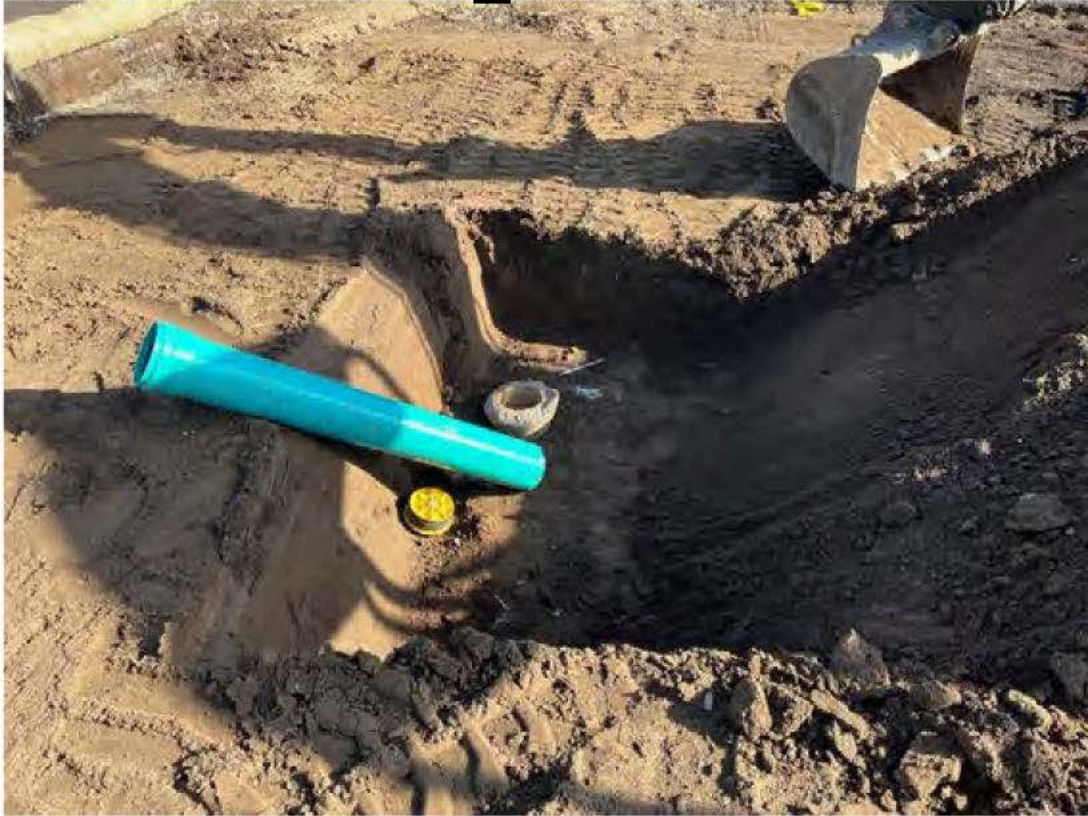
Photograph 2. 3 Kings uncovered cleanout at [REDACTED] Baxter for new stickup install. Photo taken facing north.

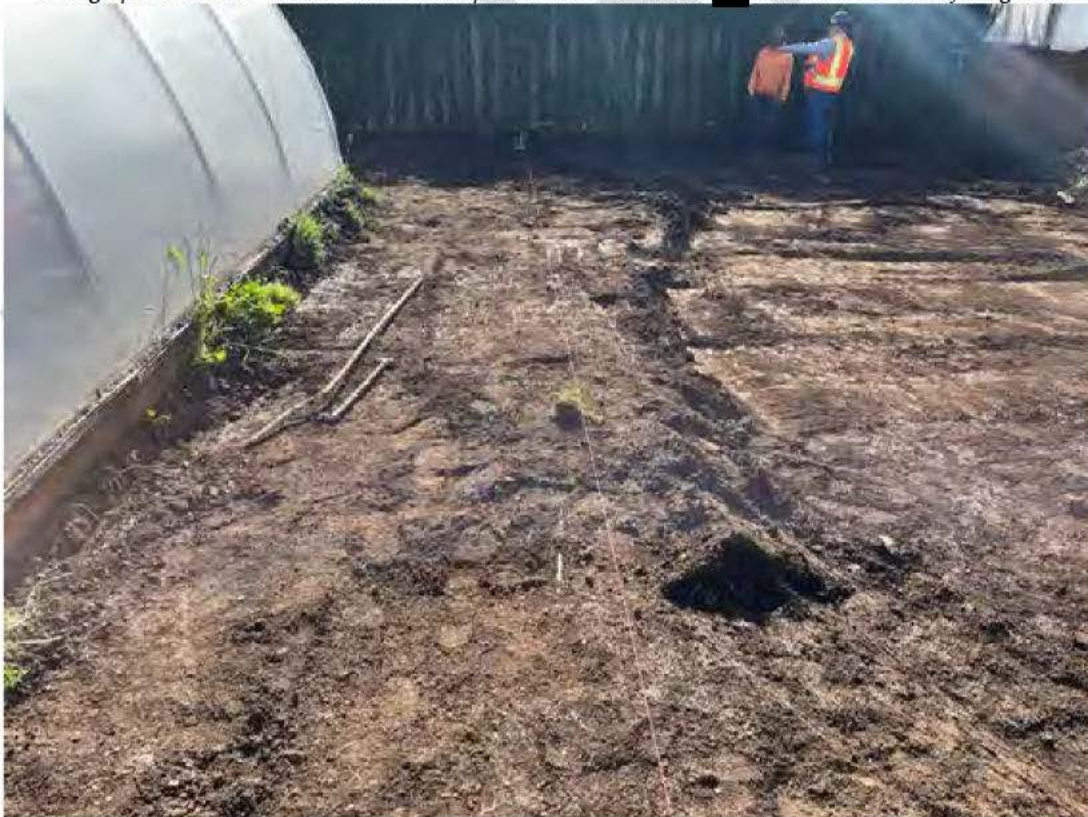
Photograph 3. 6 inch to 12 inch excavation depth transition marked at [REDACTED] Baxter. Photo taken facing east.

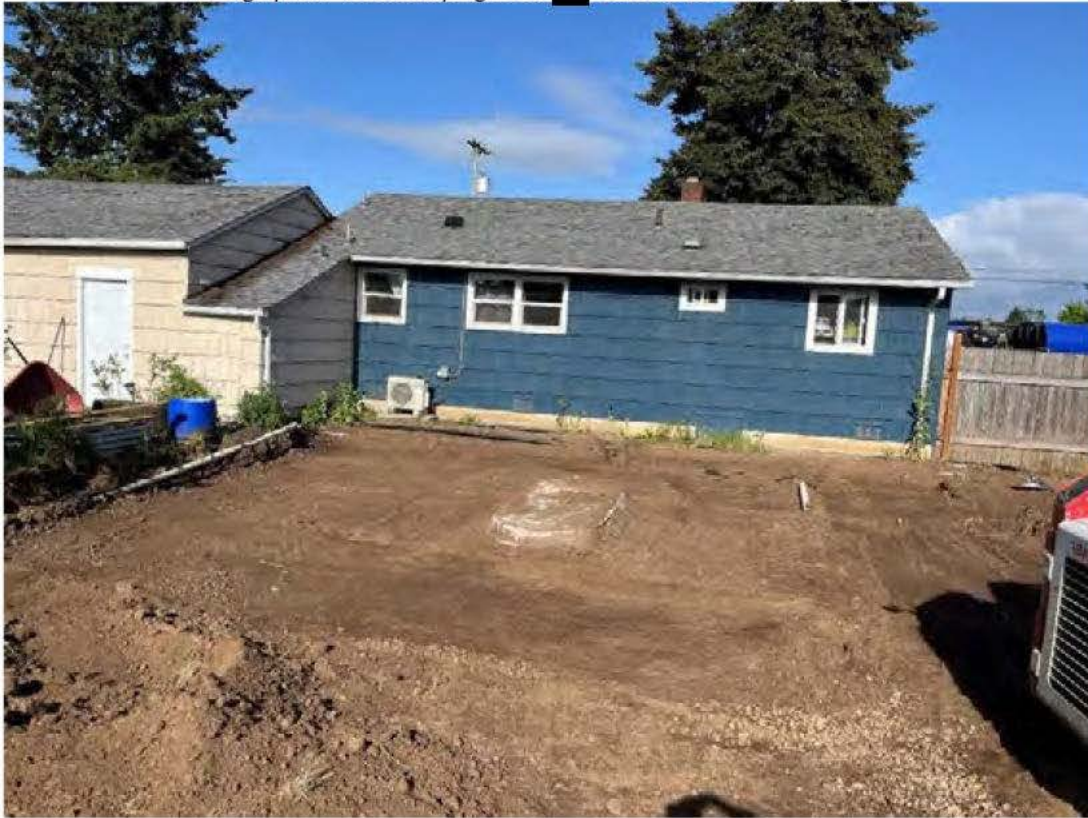
Photograph 4. Excavation progress at [REDACTED] Baxter. Photo taken facing west.

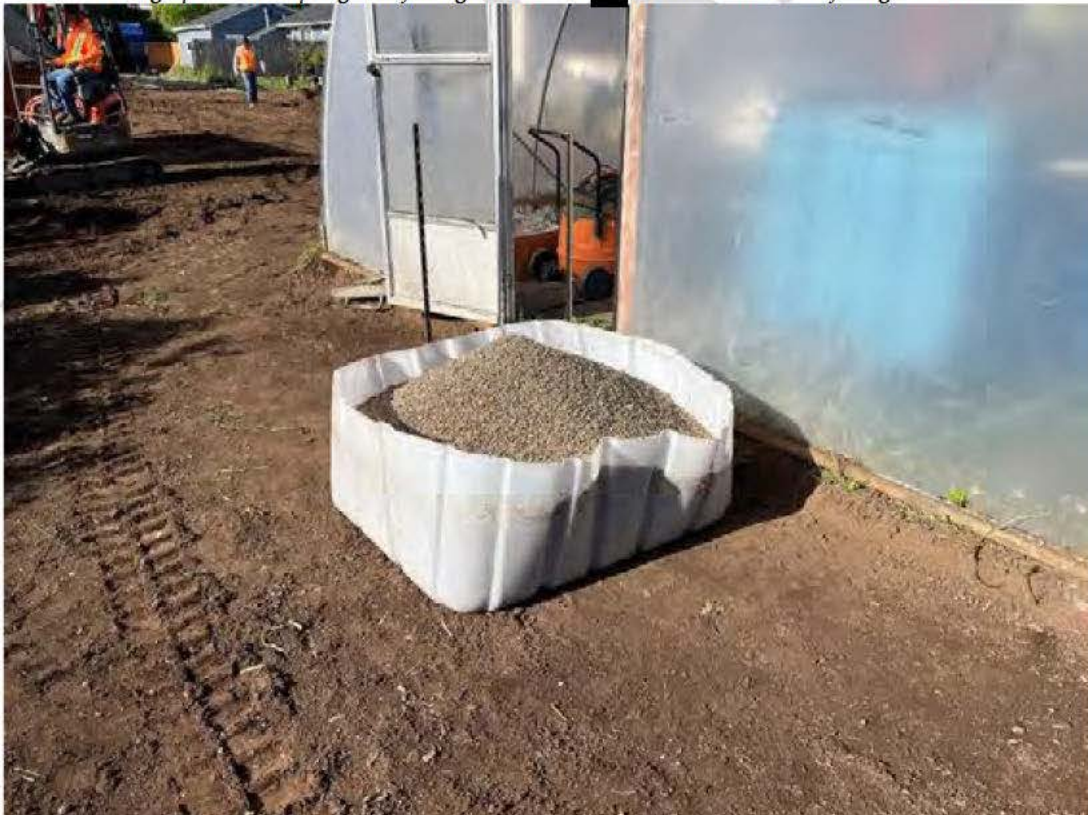
Photograph 5. Saved pea gravel from greenhouse at [REDACTED] Baxter. Photo taken facing southwest.

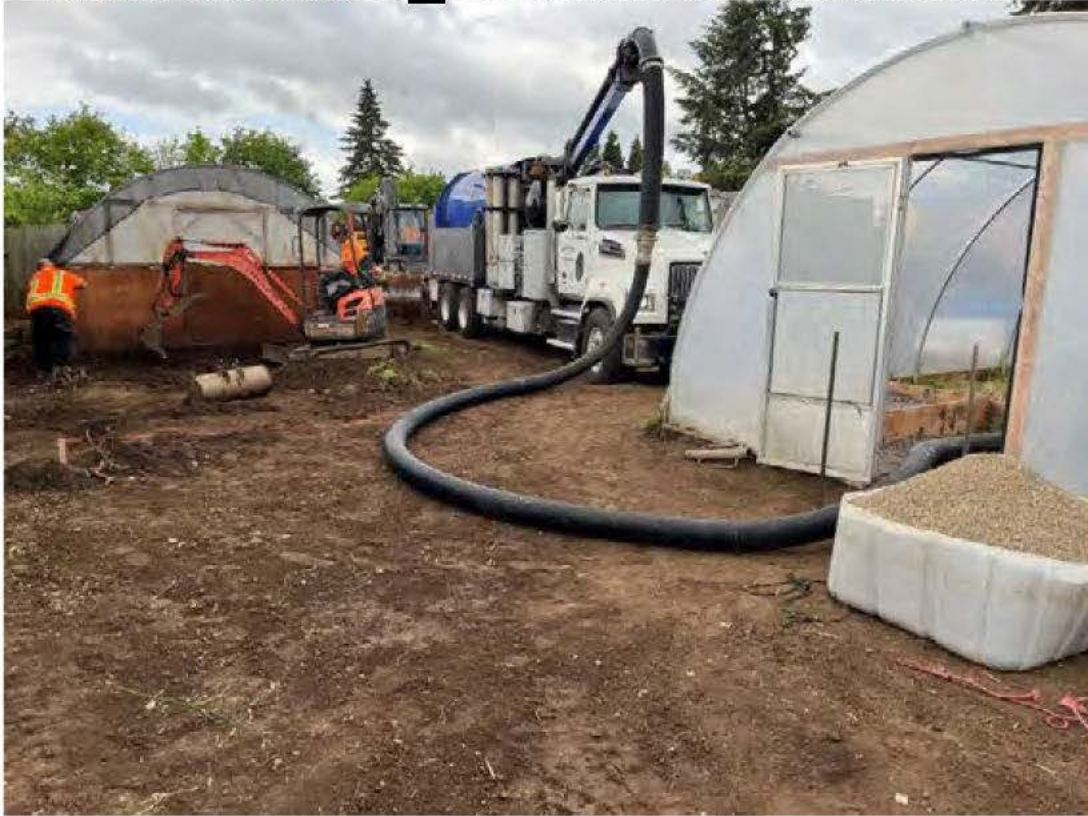
Photograph 7. Septic lid opened at [REDACTED] Baxter. Photo taken facing northeast.

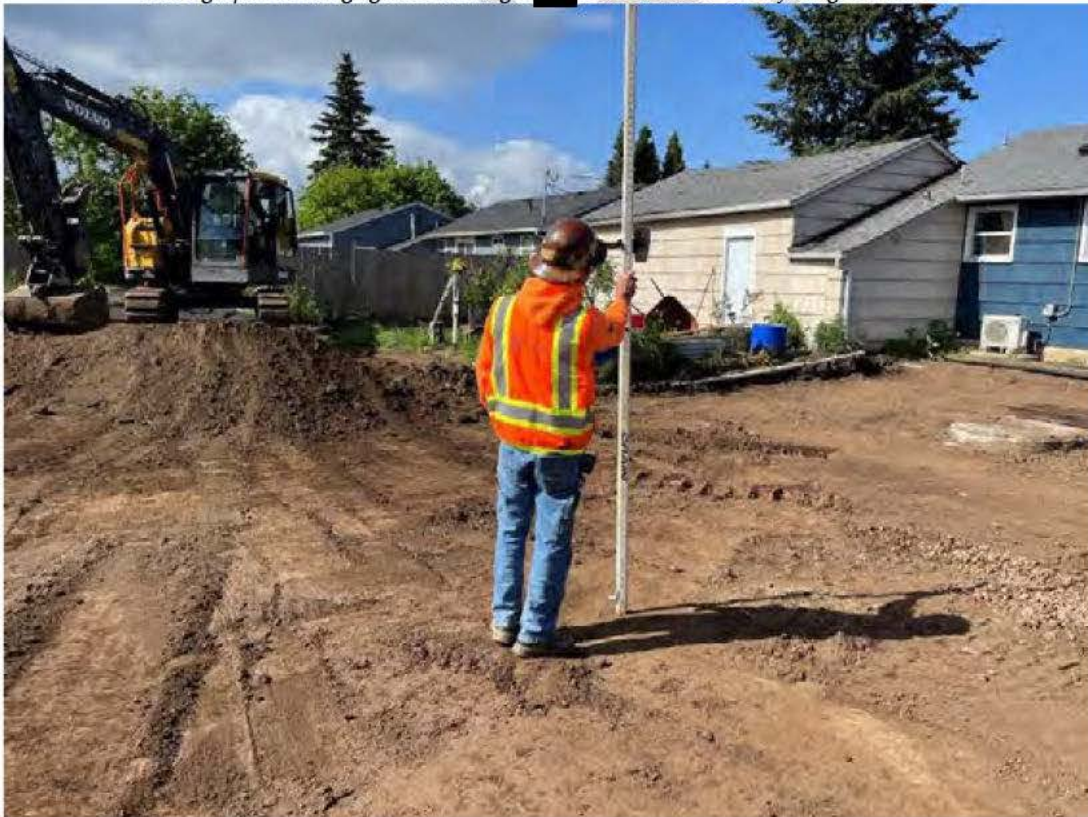
Photograph 10. Cleanout stickup installed at [REDACTED] Baxter. Photo taken facing south.

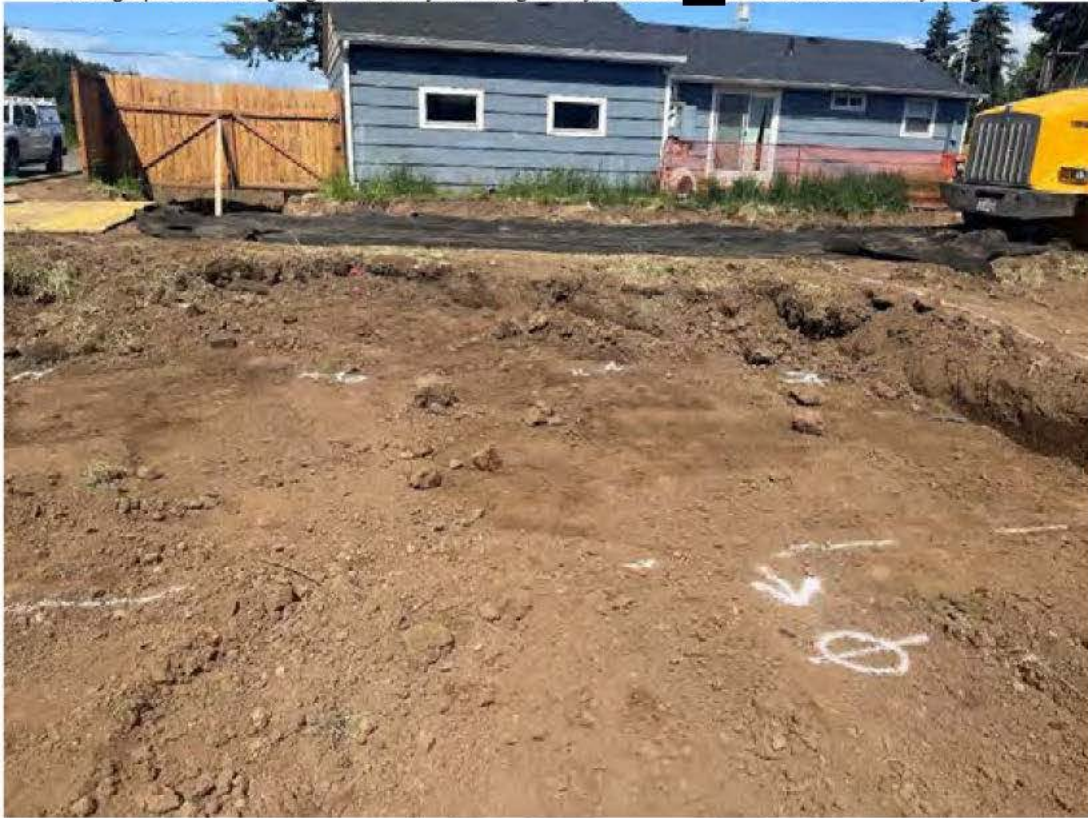
Photograph 13. Manual excavation depth field truthing at [REDACTED] Baxter. Photo taken facing west.

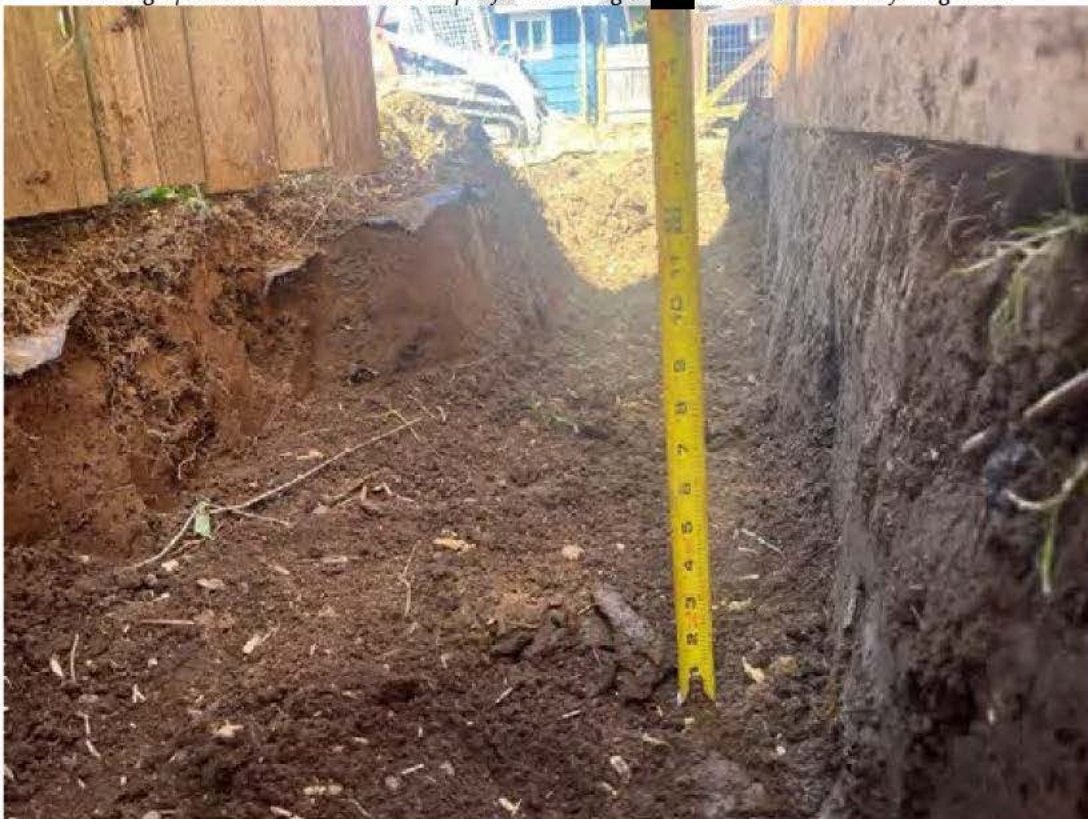
Photograph 14. Manual excavaiton depth field truthing at [REDACTED] Baxter. Photo taken facing north.

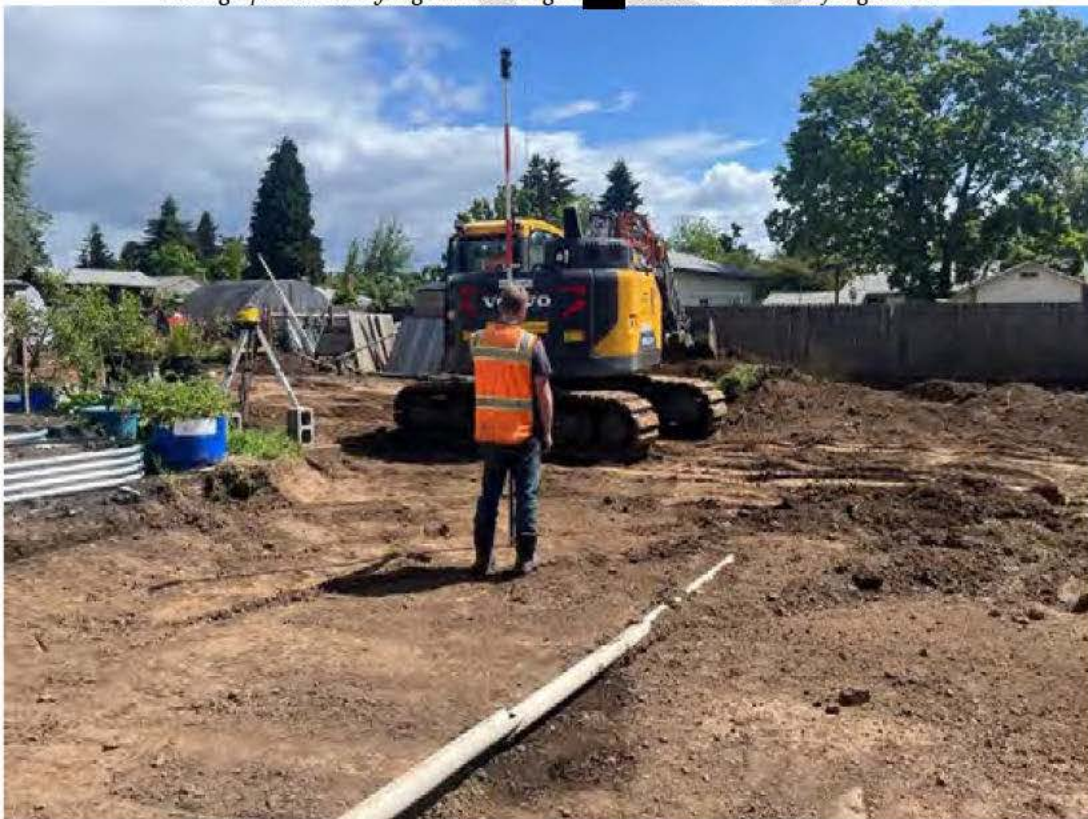
Photograph 16. Surveyor grade marks for 3 Kings to reference at [REDACTED] Baxter. Photo taken facing southwest.

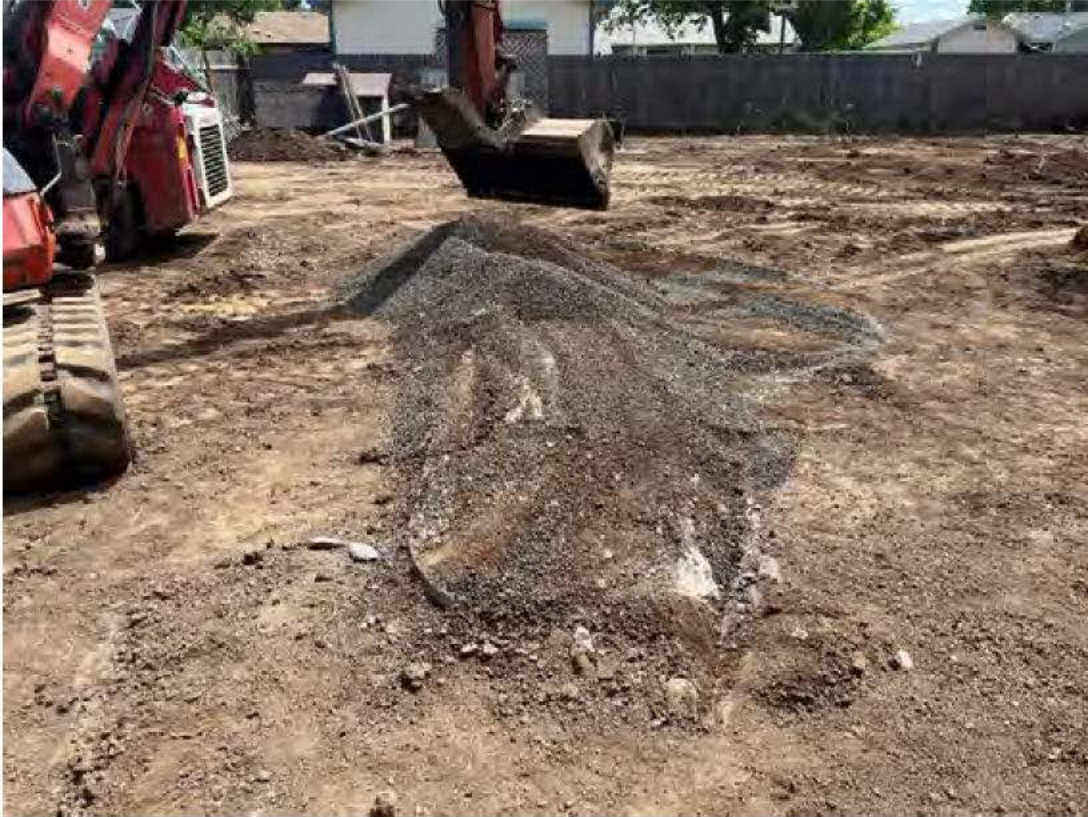
Photograph 19. Gravel and fabric placing at [REDACTED] Baxter. Photo taken facing west.

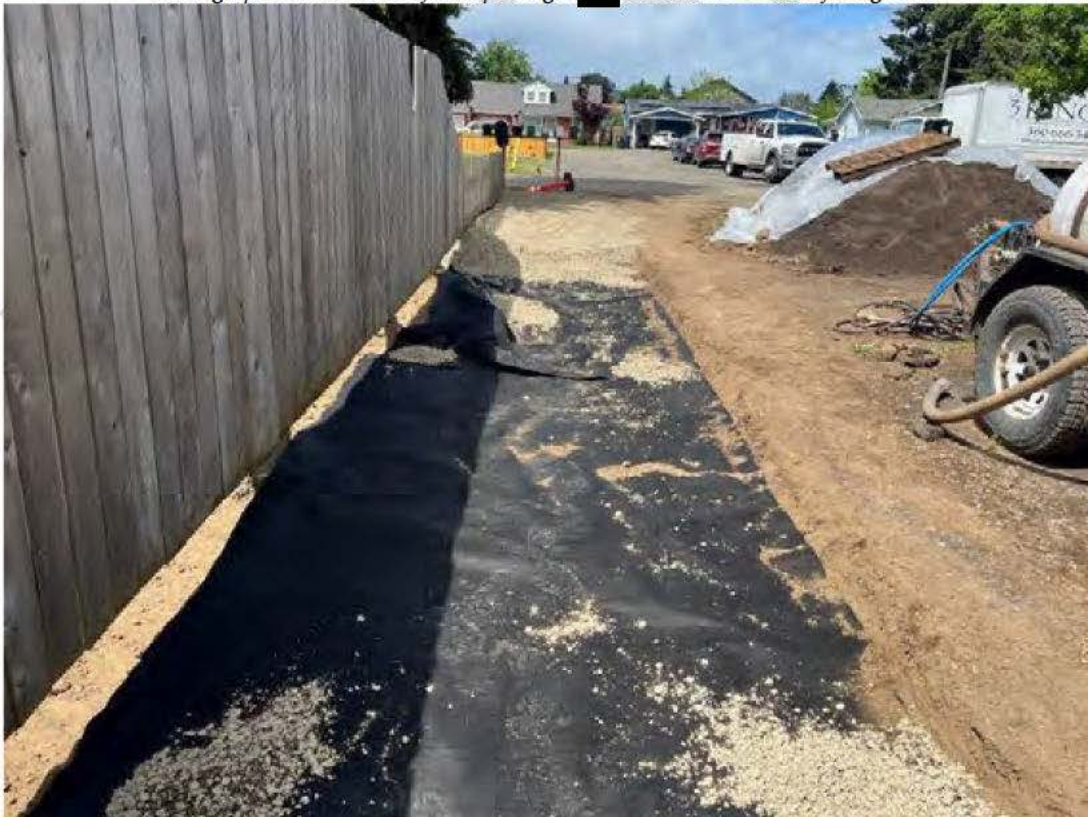
Photograph 20. Manual excavation depth field truthing in greenhouse. Photo taken facing east.

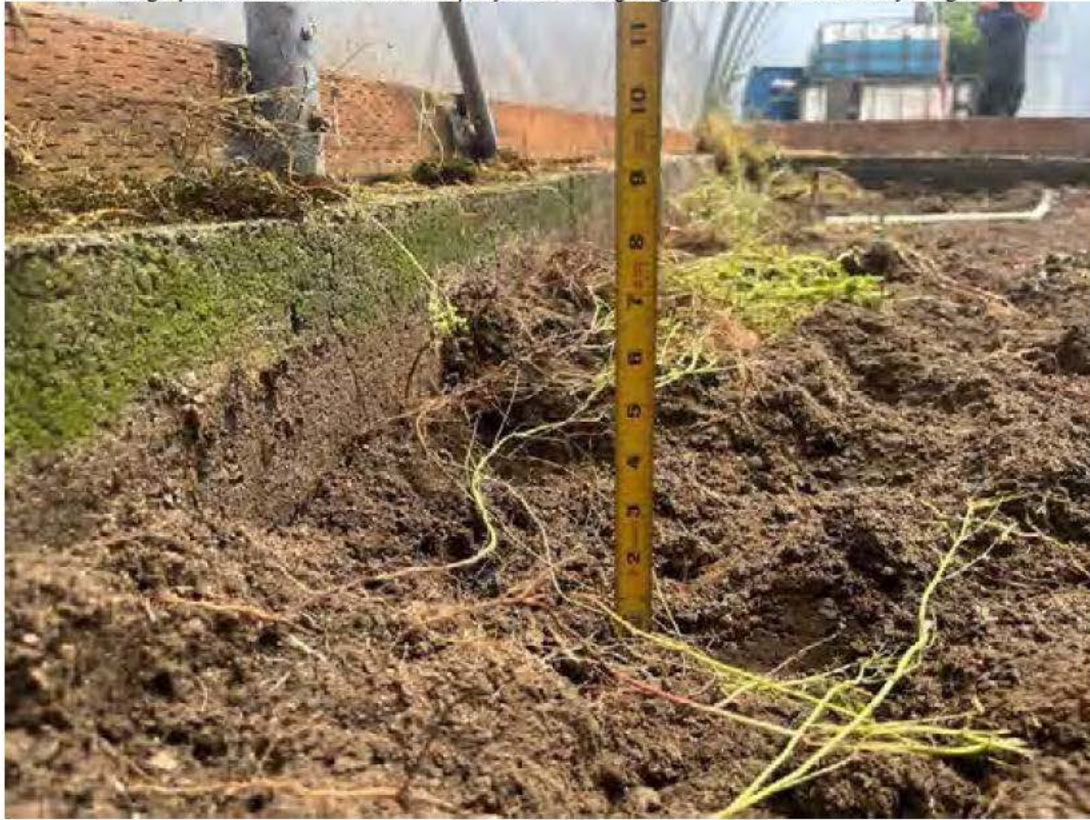
Photograph 21. Vacuum truck excavations in greenhouse at [REDACTED] Baxter. Photo taken facing east.

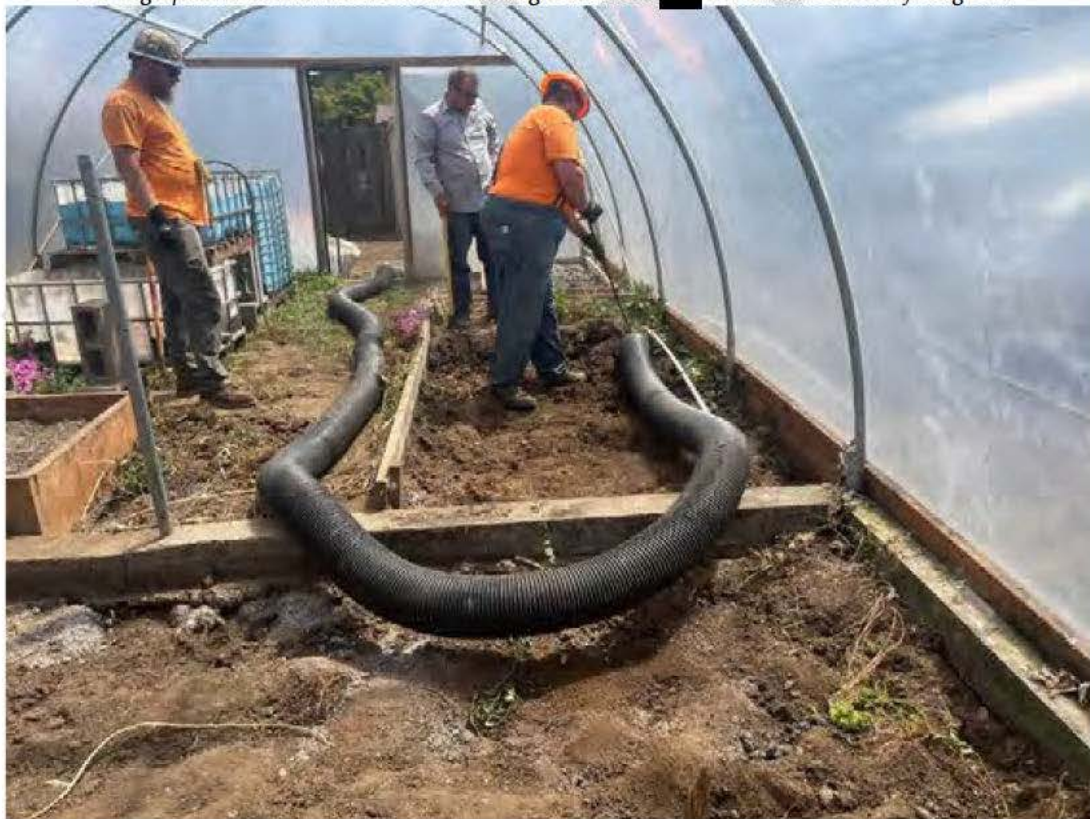
Photograph 22. Excavation progress in greenhouse at [REDACTED] Baxter. Photo taken facing east.

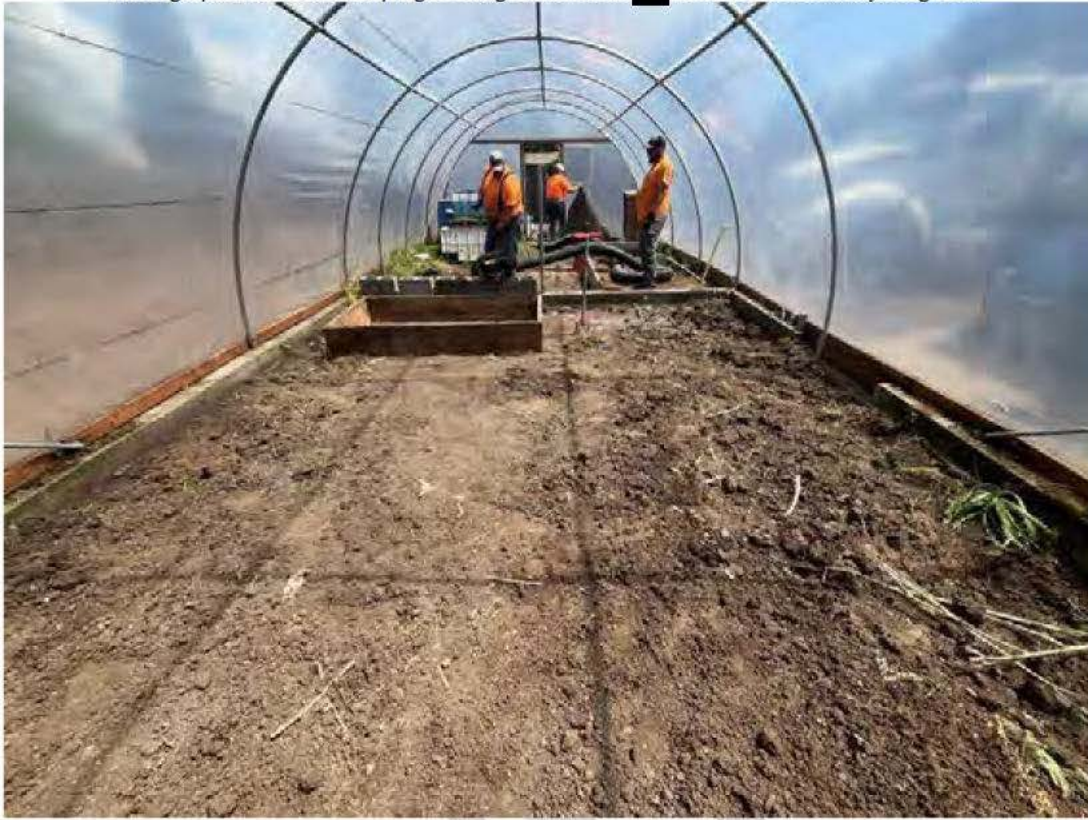
Photograph 23. Follow up grading based on surveyor marks. Photo taken facing south.

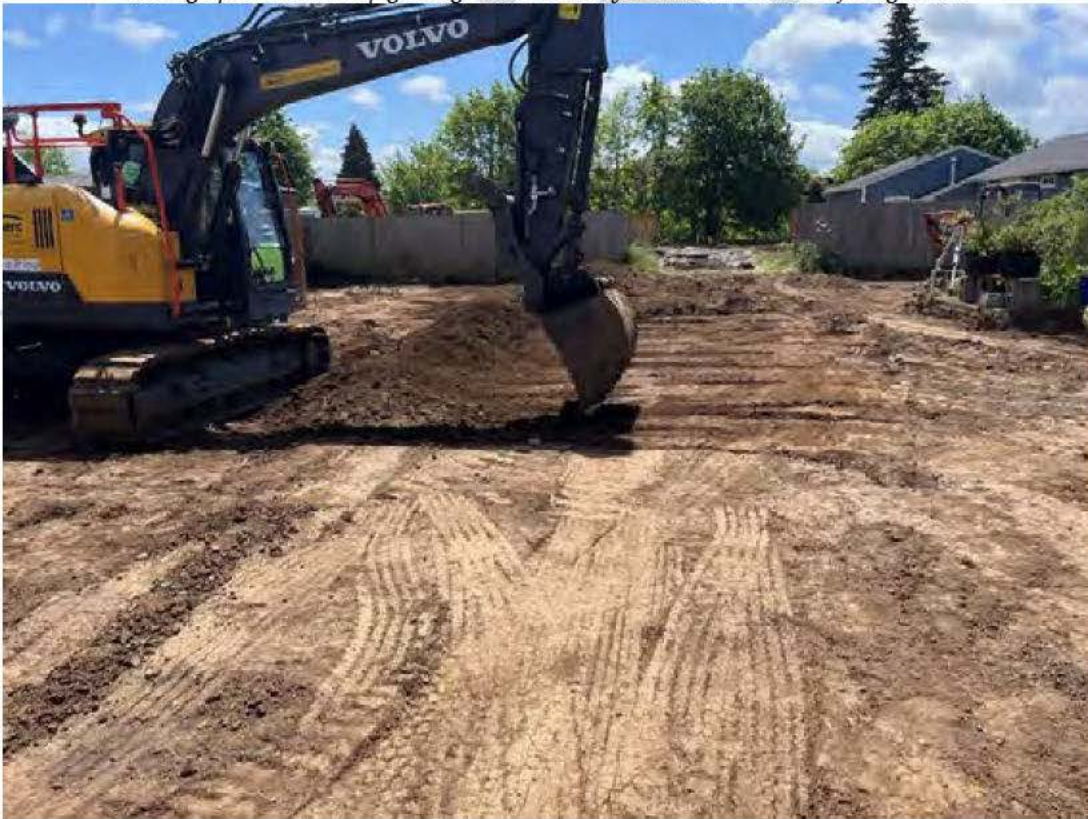
Photograph 24. Reference grade marks by surveyor at [REDACTED] Baxter. Photo taken facing south.

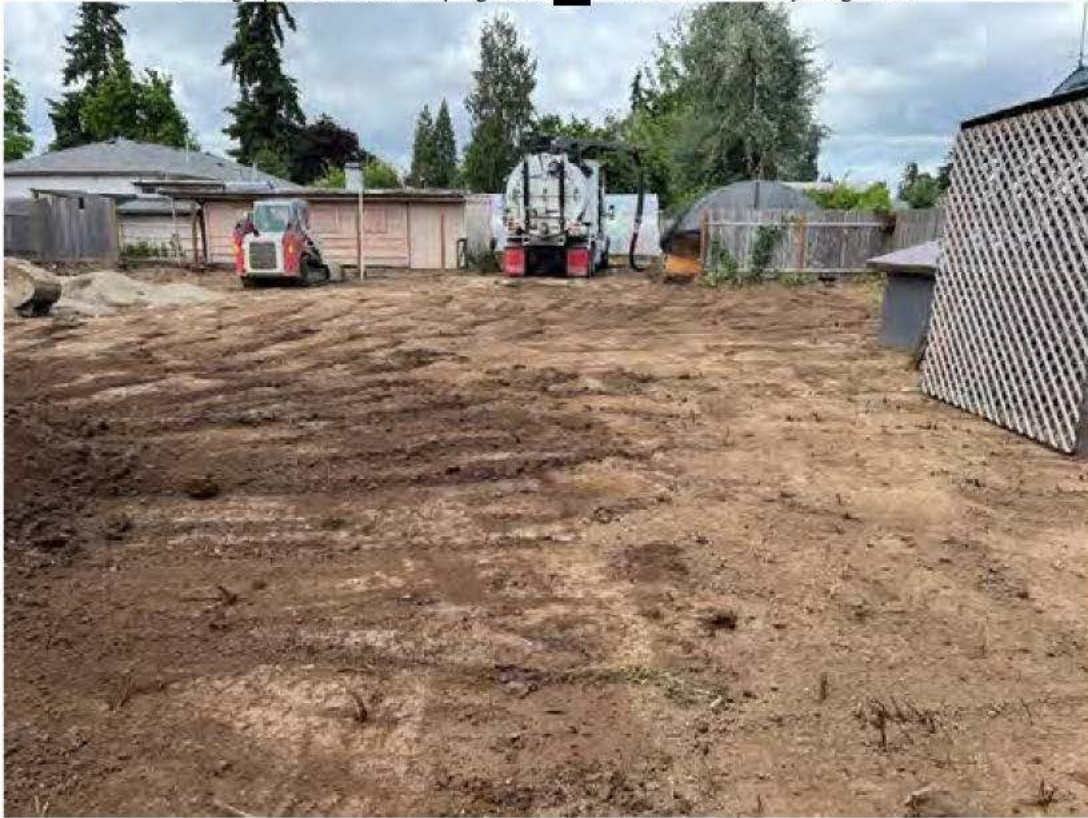
Photograph 29. 3 Kings assisting with soil removal for within greenhouse. Photo taken facing northeast.
