APPENDIX B

Daily Field Reports Continued

Phase II RA

OFFSITE REMOVAL ACTION - DAILY FIELD REPORT
JH BAXTER OFFSITE REMEDIAL ACTION
EUGENE, OREGON

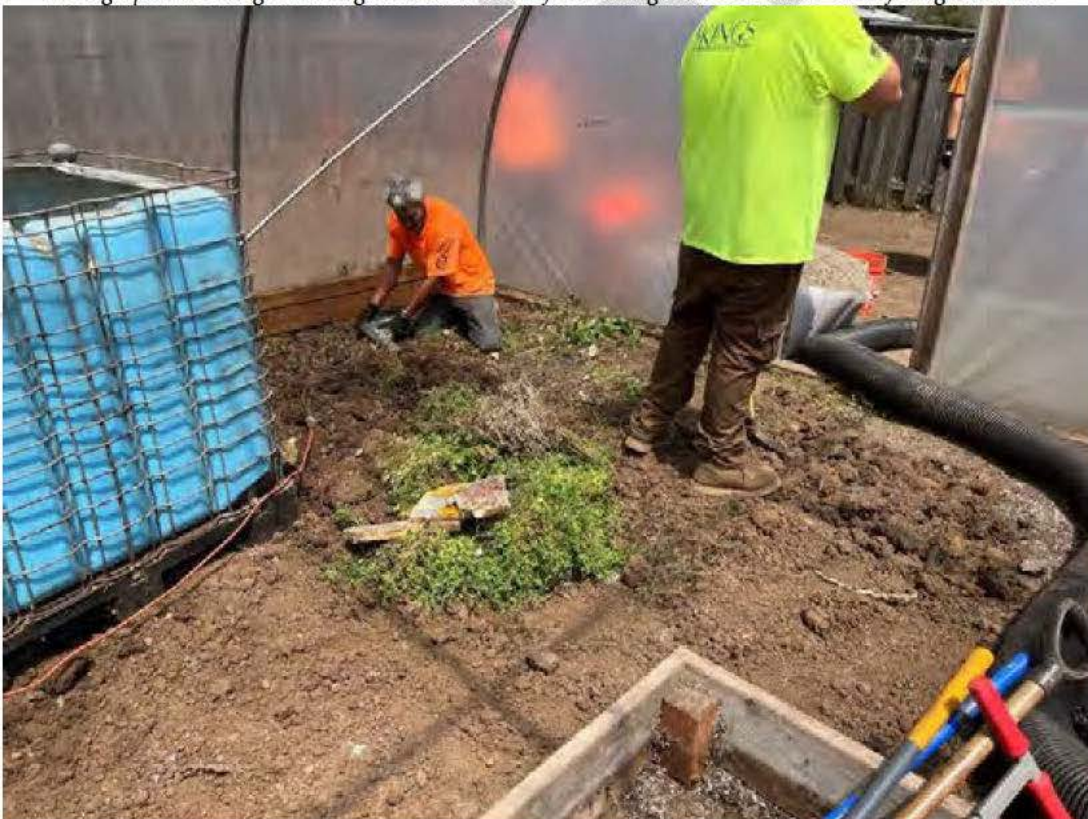
Photograph 30. Manual excavation depth field truthing in greenhouse. Photo taken facing east.

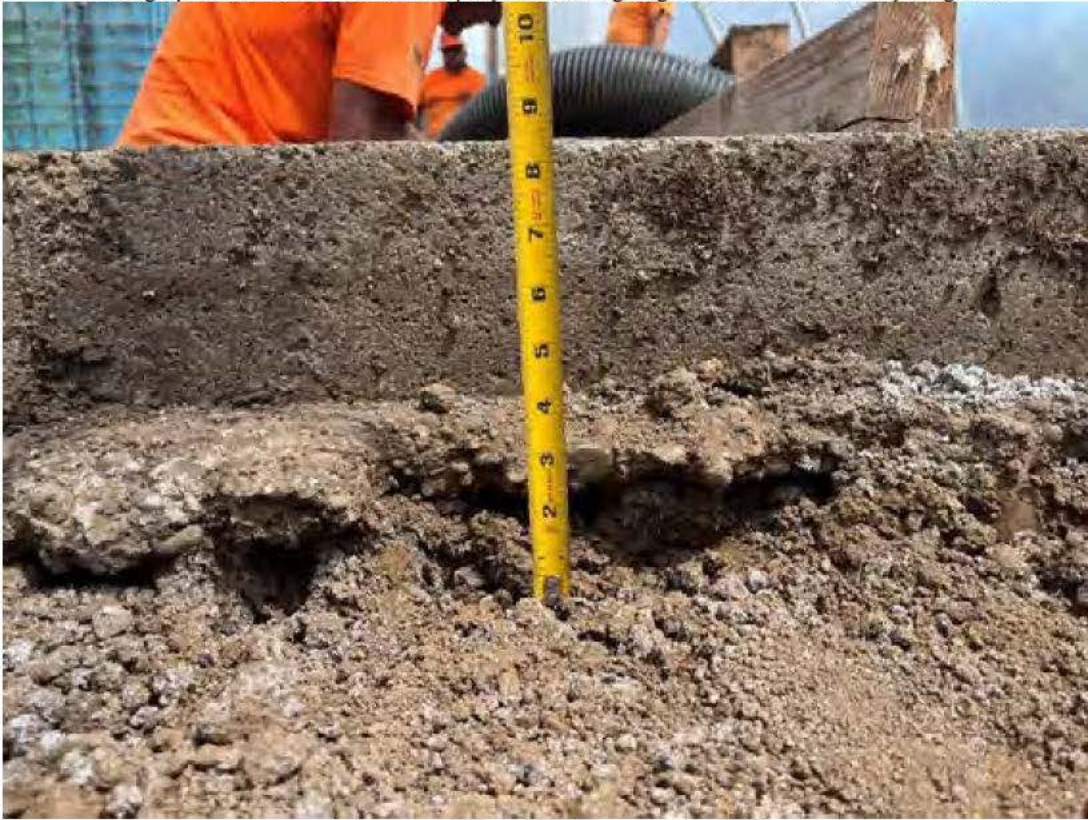
Photograph 31. Manual excavation depth field truthing in greenhouse. Photo taken facing south.

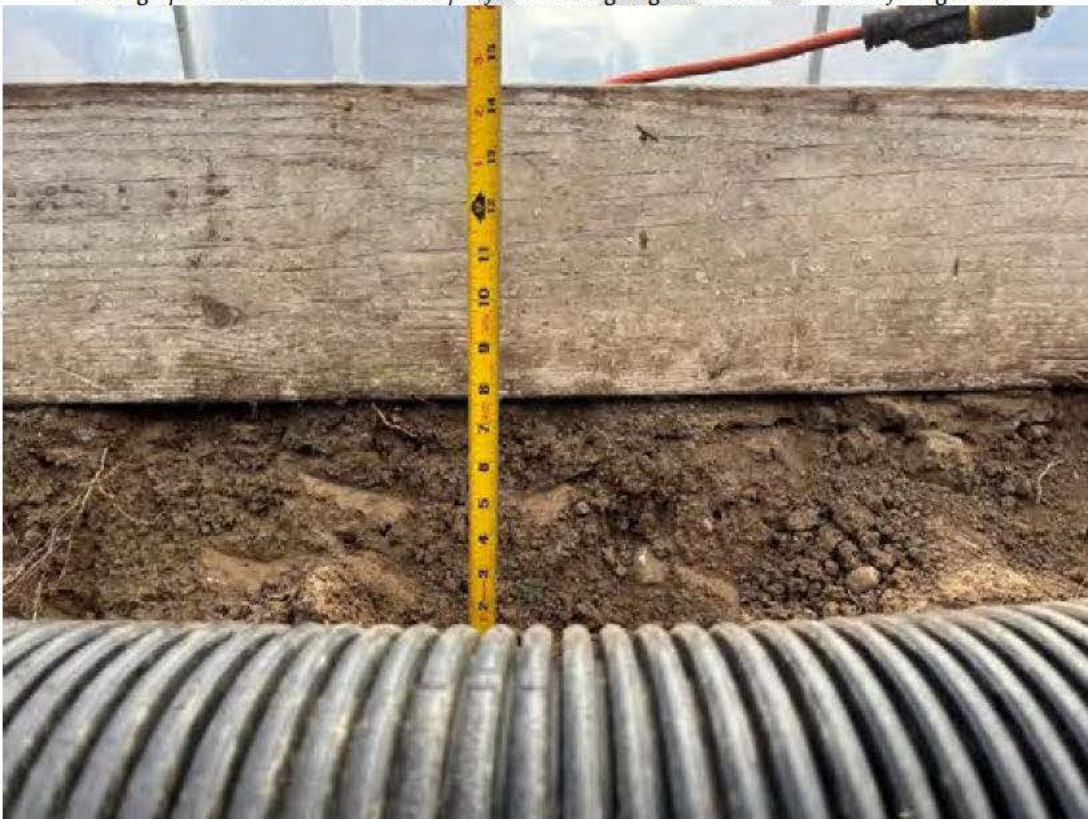
Photograph 32. Manual excavation depth field truthing in greenhouse. Photo taken facing west.

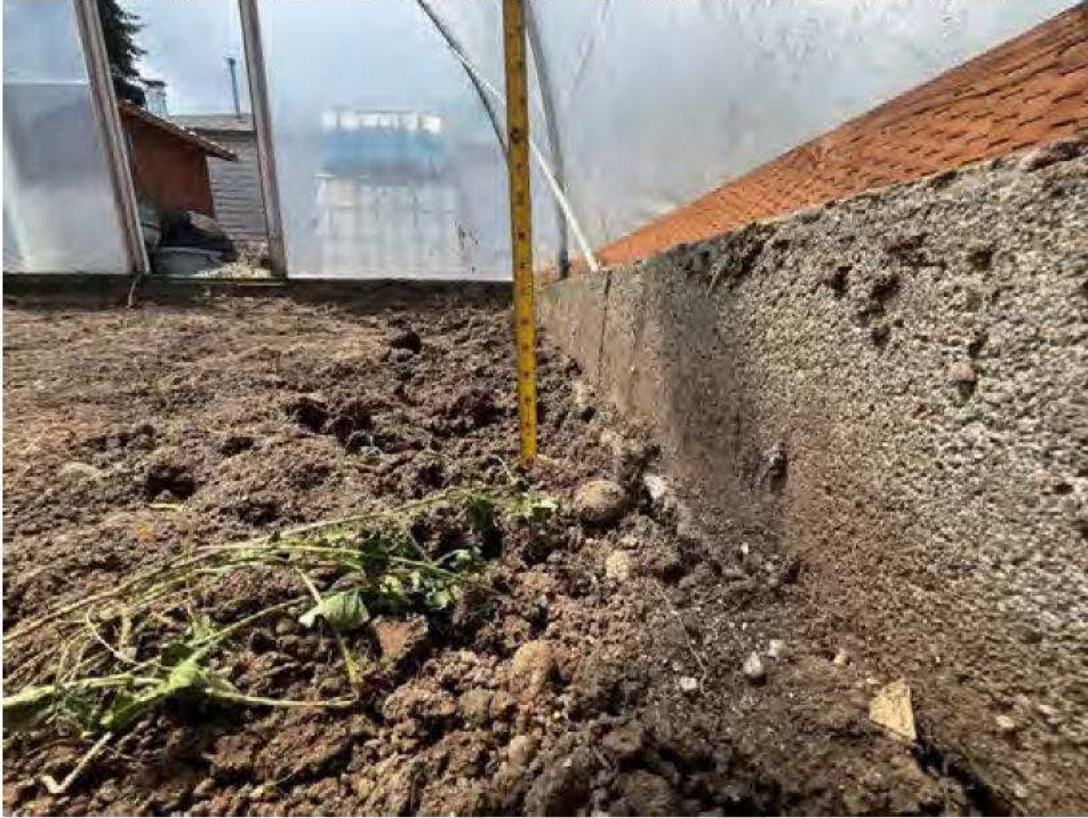
Photograph 33. Greenhouse excavation extents at [REDACTED] Baxter. Photo taken facing west.

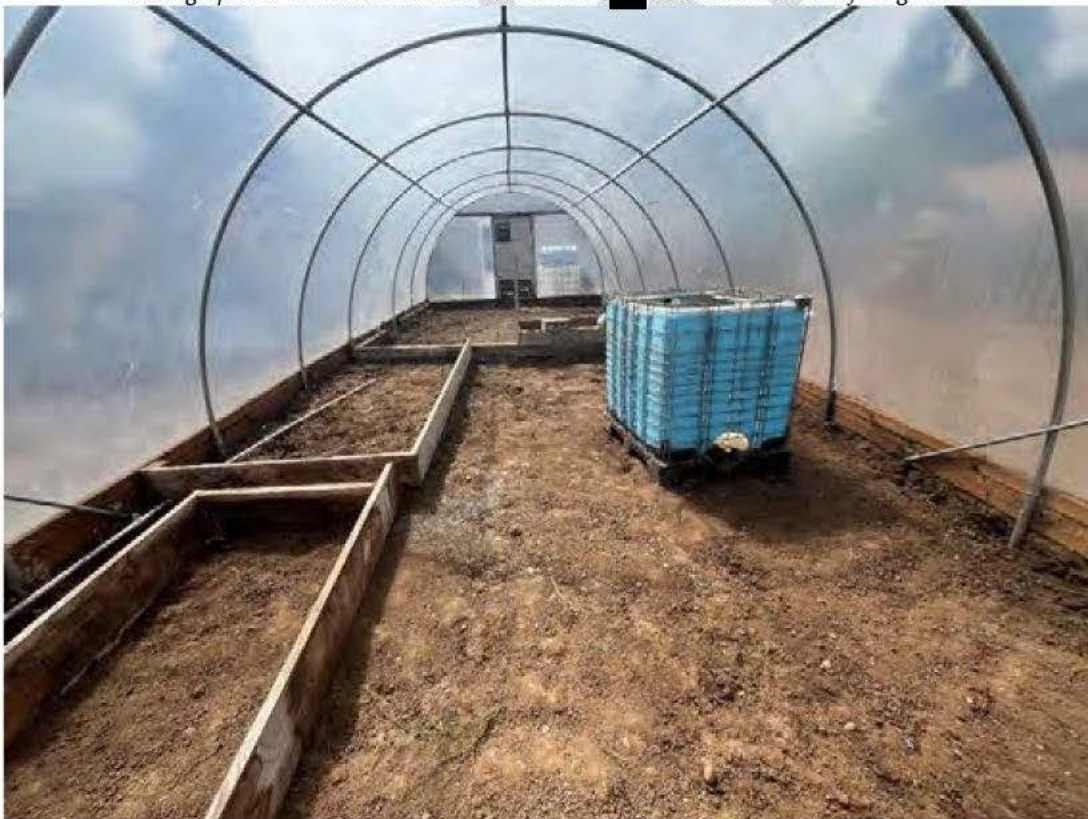
Photograph 34. Manual excavation depth field truthing in greenhouse. Photo taken facing west.

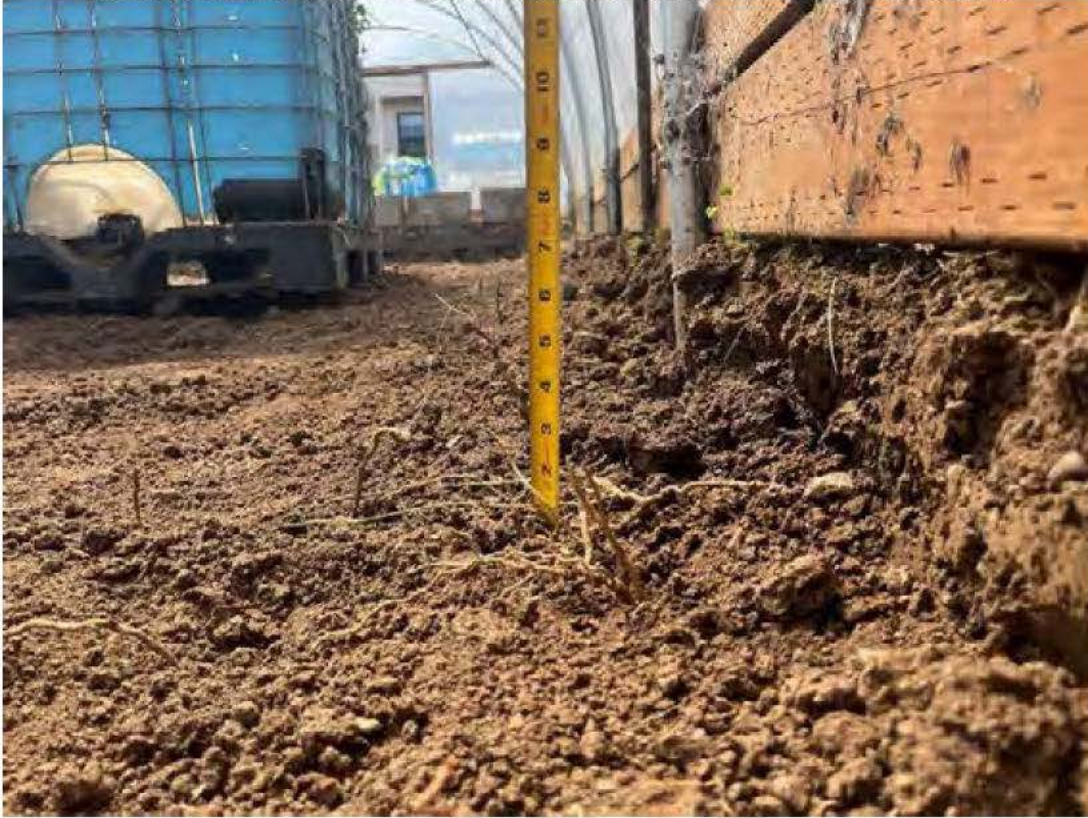
Photograph 35. Excavation extents in greenhouse at Baxter. Photo taken facing east.

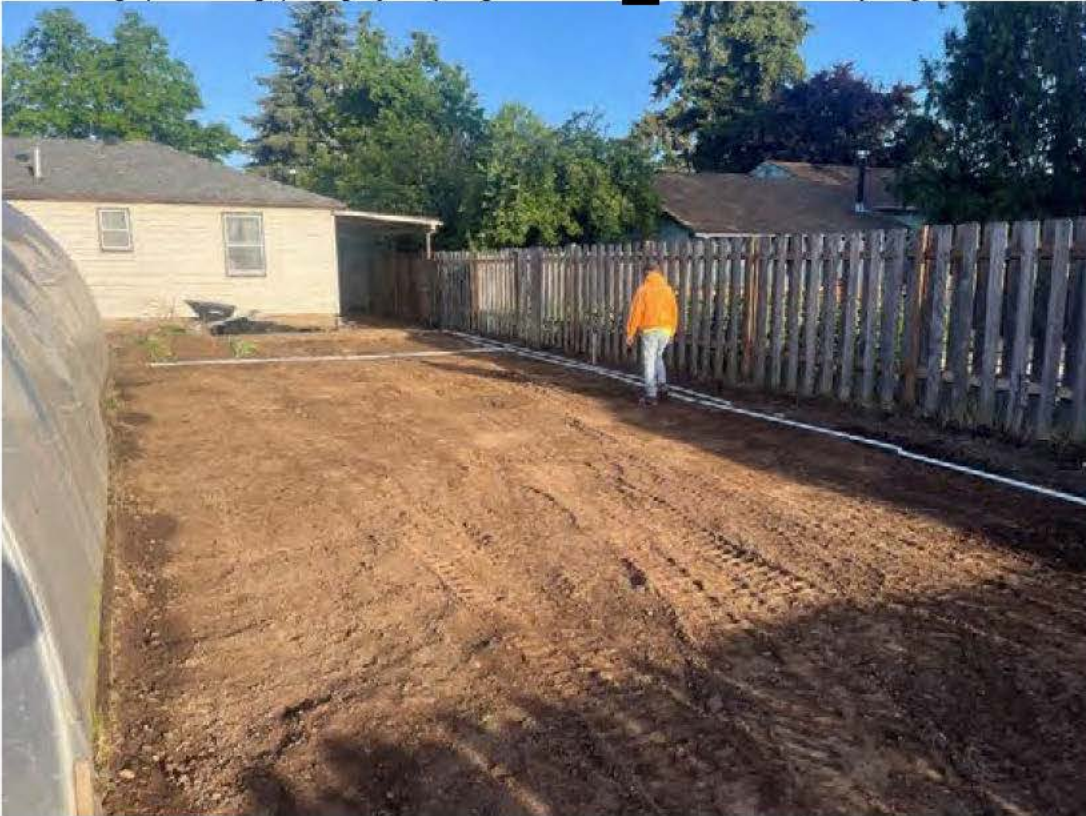
Photograph 2. Excavation in backyard of [REDACTED] Baxter. Photo taken facing west.

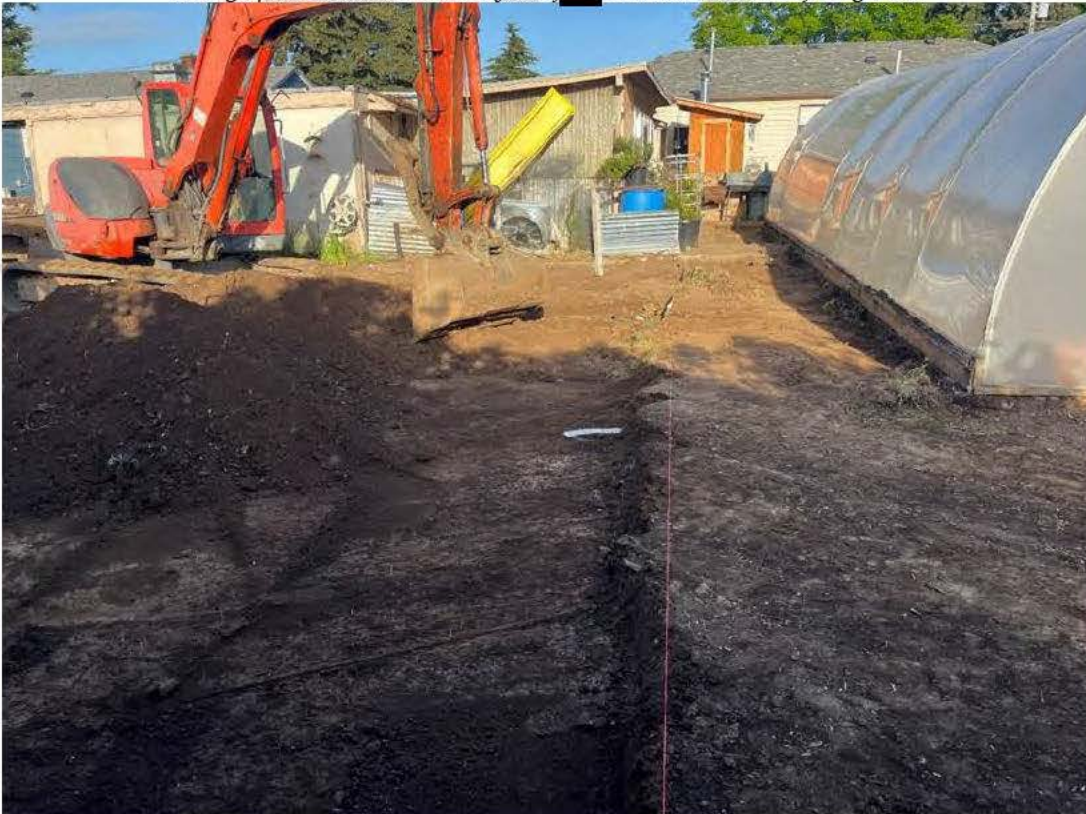
Photograph 3. 3 Kings excavating to north of back porch at [REDACTED] Baxter. Photo taken facing southeast.

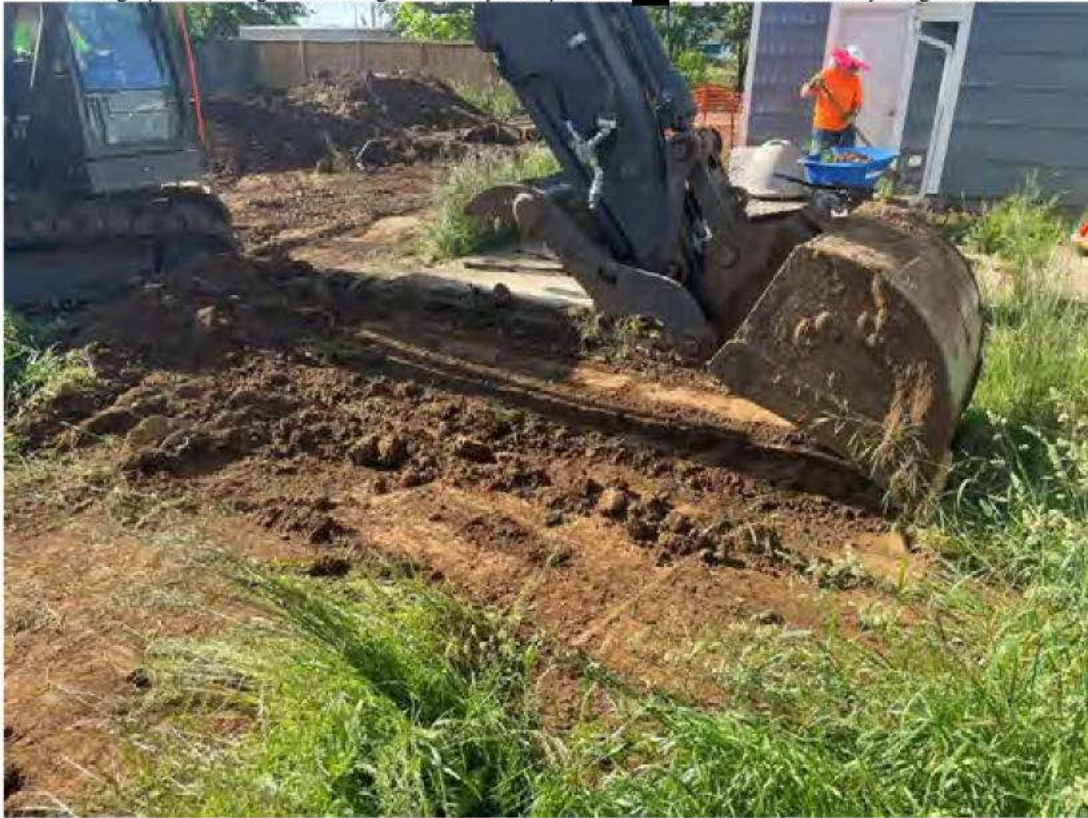
Photograph 4. Compacting additional gravel placed at [REDACTED] Baxter. Photo taken facing northeast.

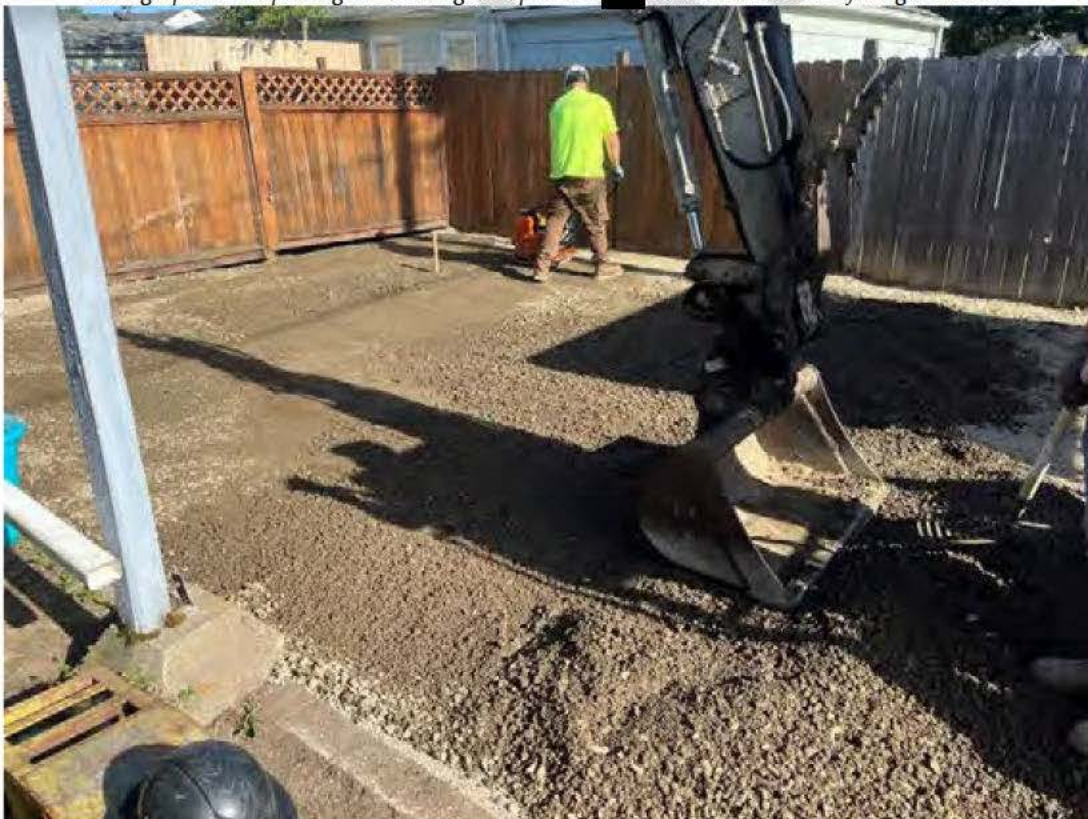
Photograph 5. Manual excavation depth field truthing at [REDACTED] Baxter. Photo taken facing south.

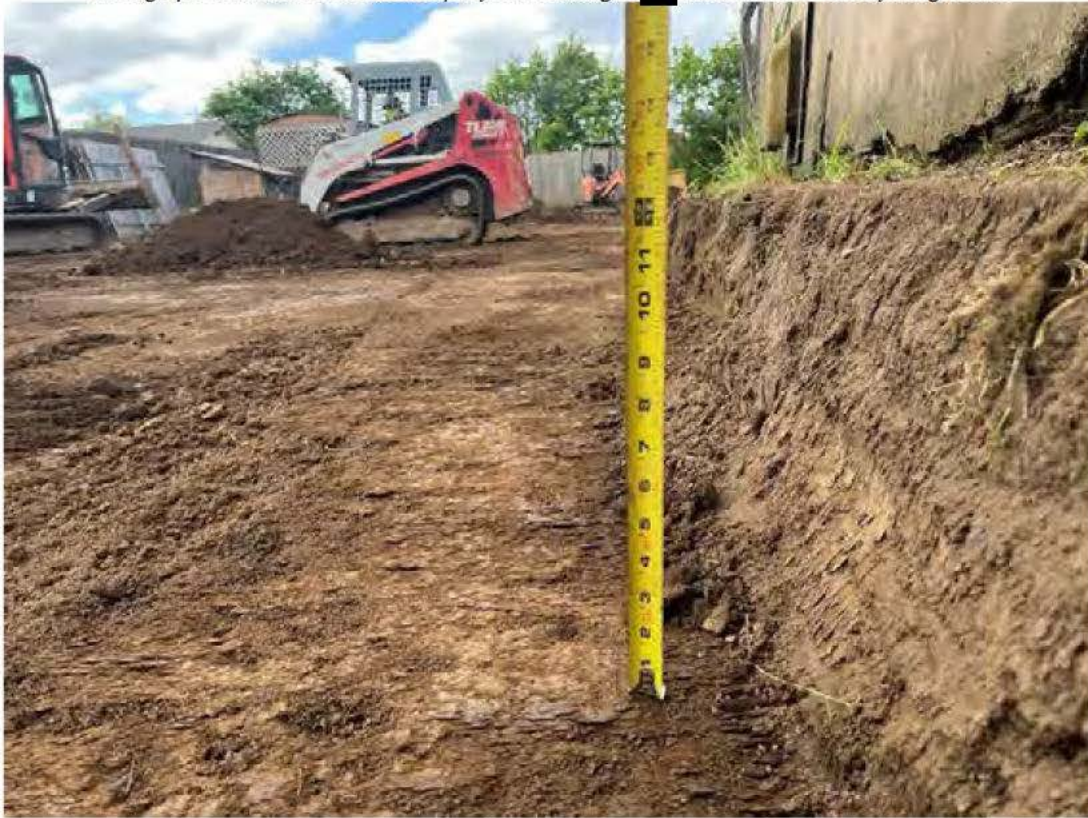
Photograph 6. Excavation along fence line and rabbitry at [REDACTED] Baxter. Photo taken facing west.

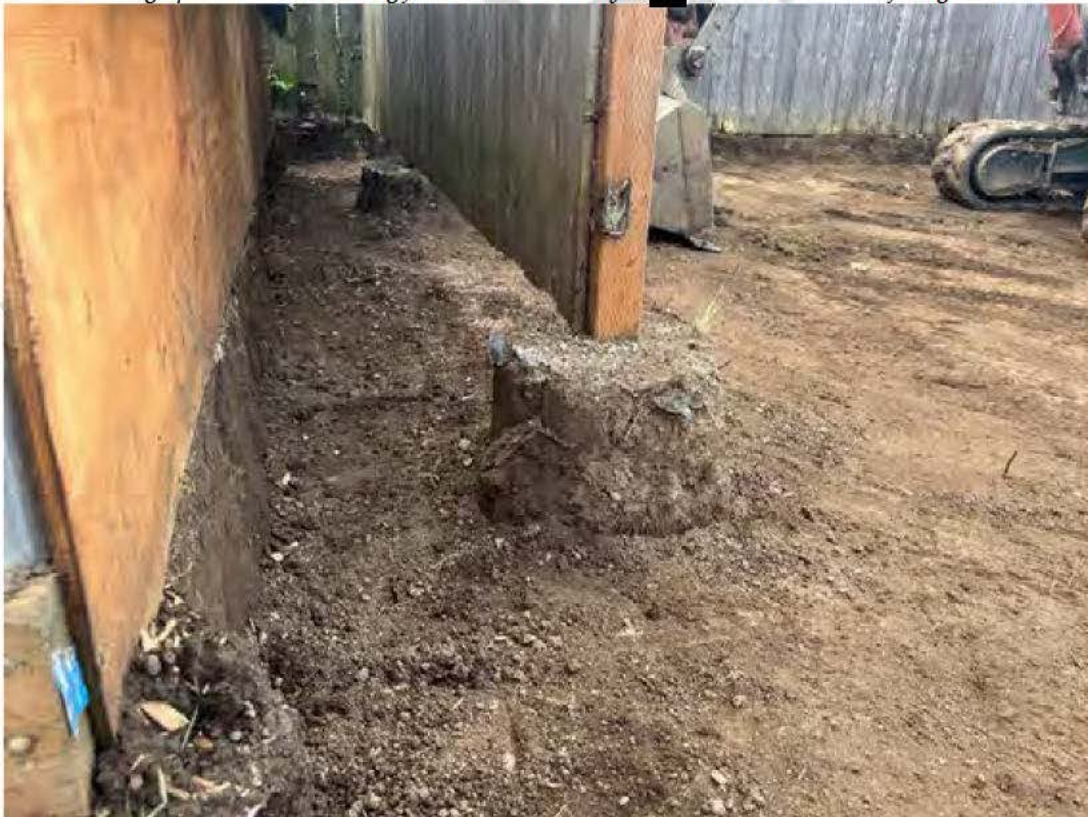
Photograph 7. Manual excavation depth field truthing at [REDACTED] Baxter. Photo taken facing south.

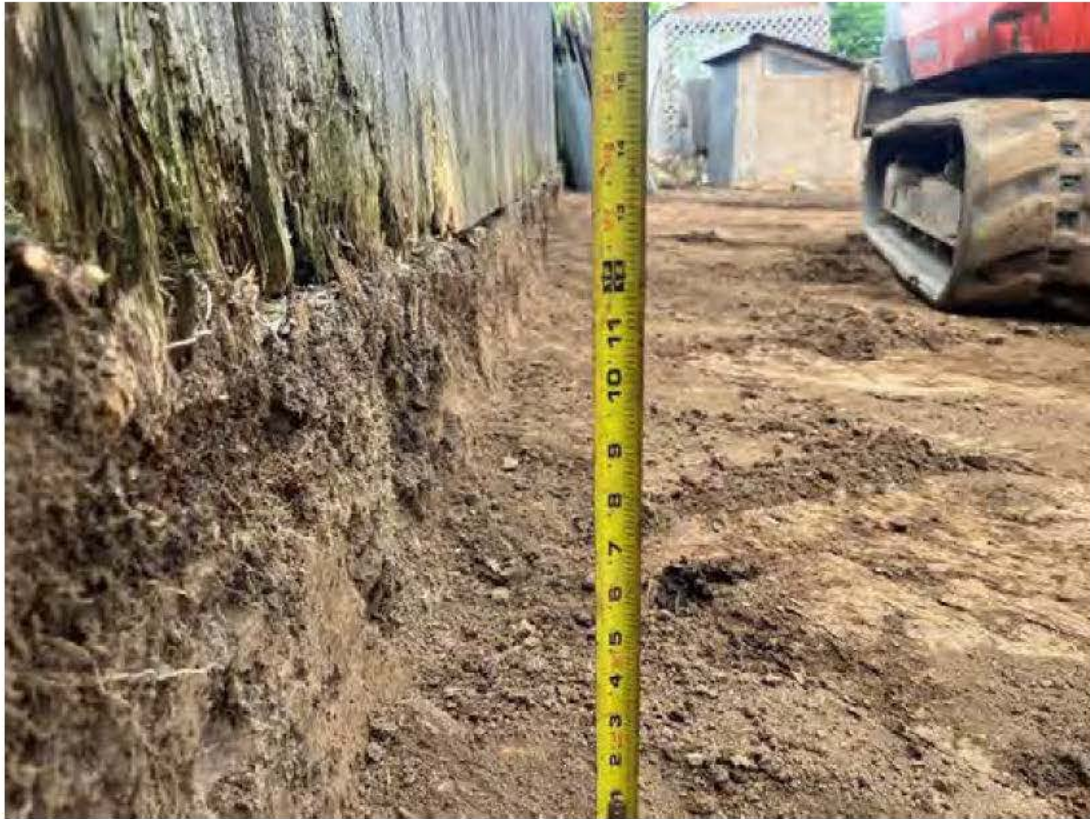
Photograph 8. Excavation north of porch at [REDACTED] Baxter. Photo taken facing northeast.

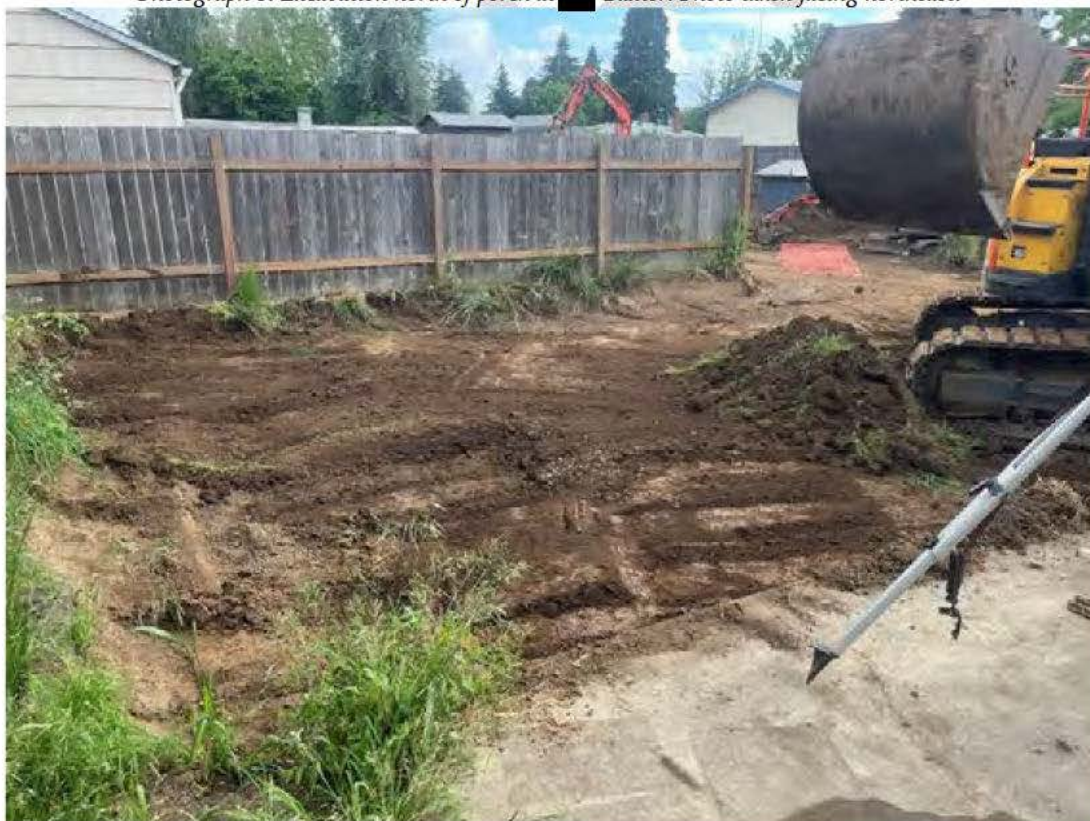
Photograph 9. Topsoil placing in front yard of [REDACTED] Baxter. Photo taken facing southwest.

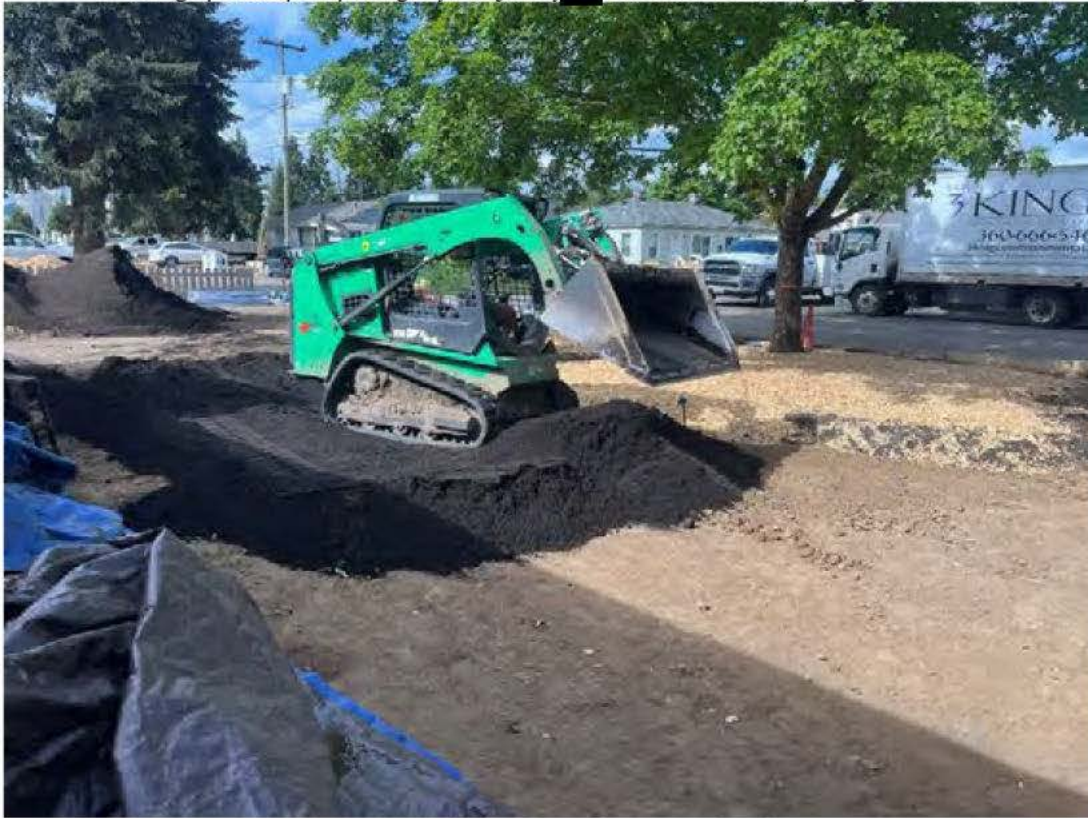
Photograph 10. 3 Kings marking anticipated locations of sprinkler heads at [REDACTED] Baxter. Photo taken facing northwest.

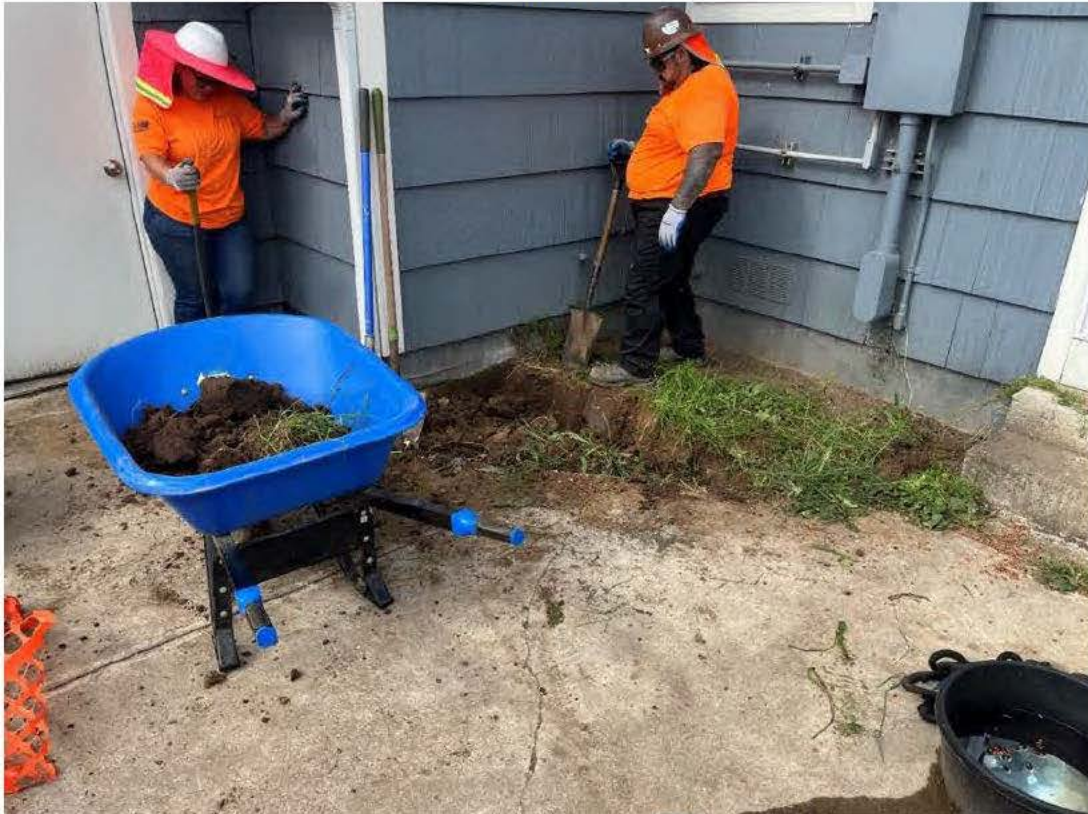
Photograph 12. Replaced section of washing machine drain line at [REDACTED] Baxter. Photo taken facing southwest.

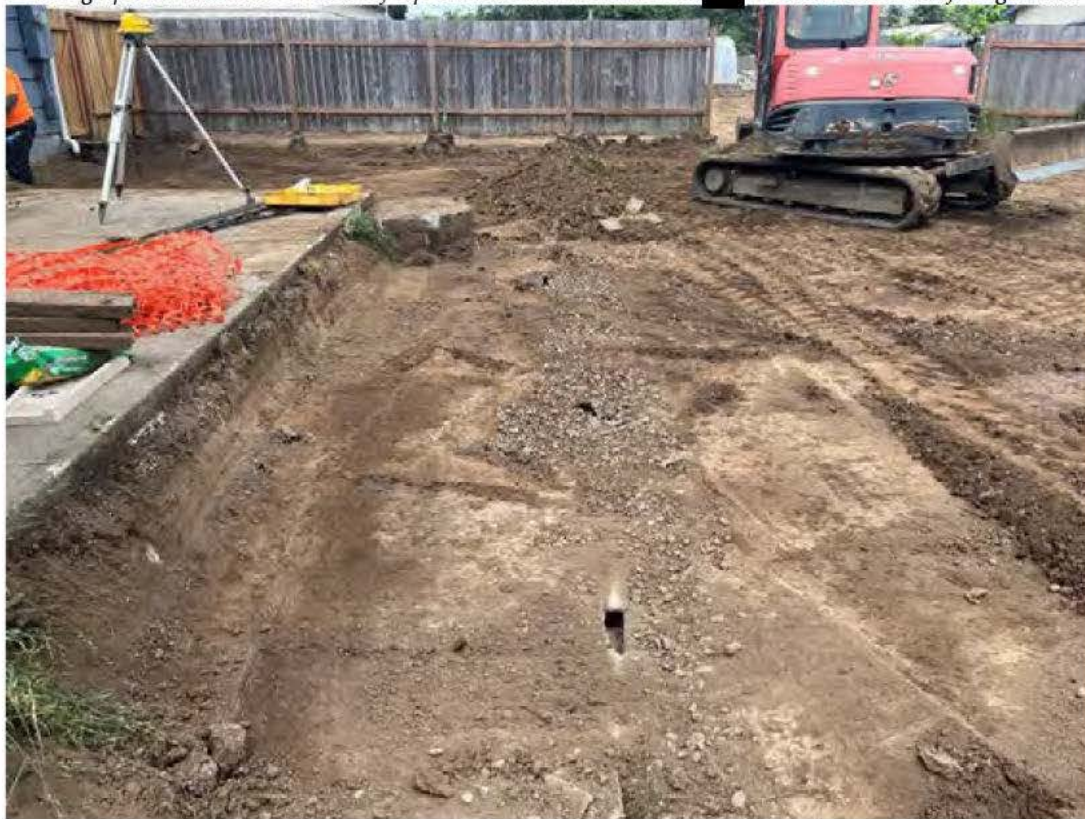
Photograph 23. Additional sections of septic leach lines encountered at [REDACTED] Baxter. Photo taken facing north.

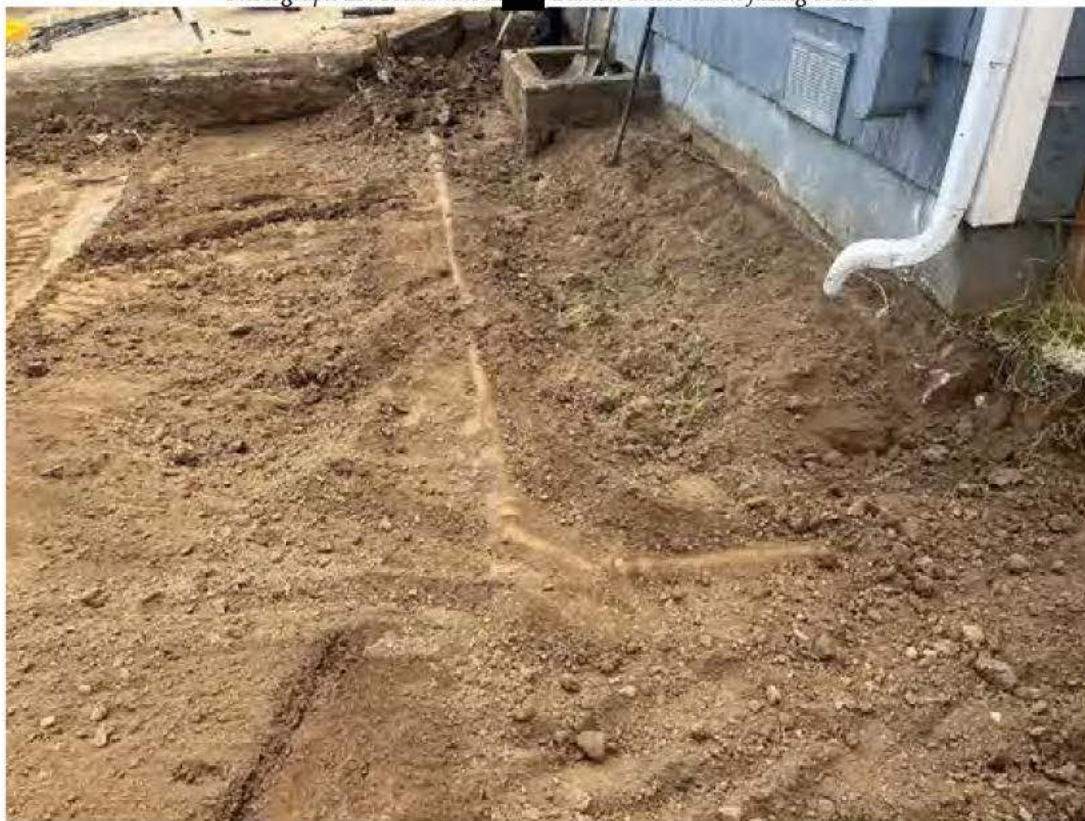
Photograph 25. Sewer line at [REDACTED] Baxter. Photo taken facing south.

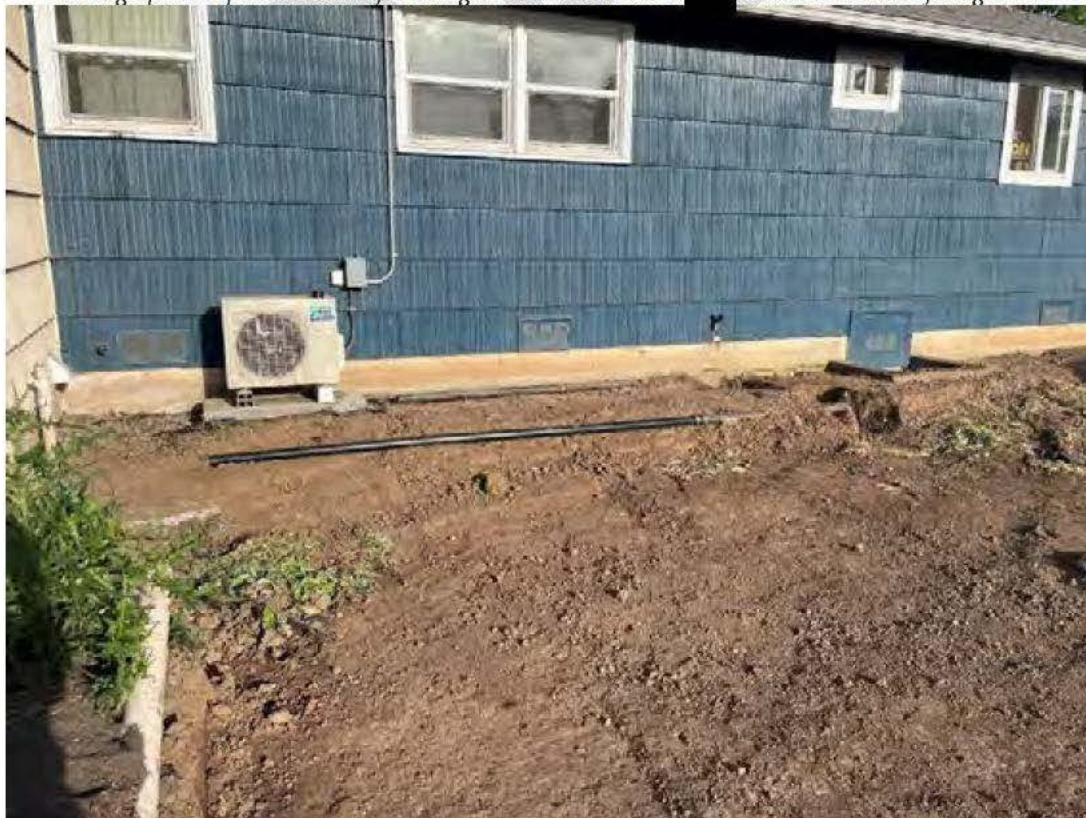
Photograph 2. Repaired section of washing machine drain line at [REDACTED] Baxter. Photo taken facing west.

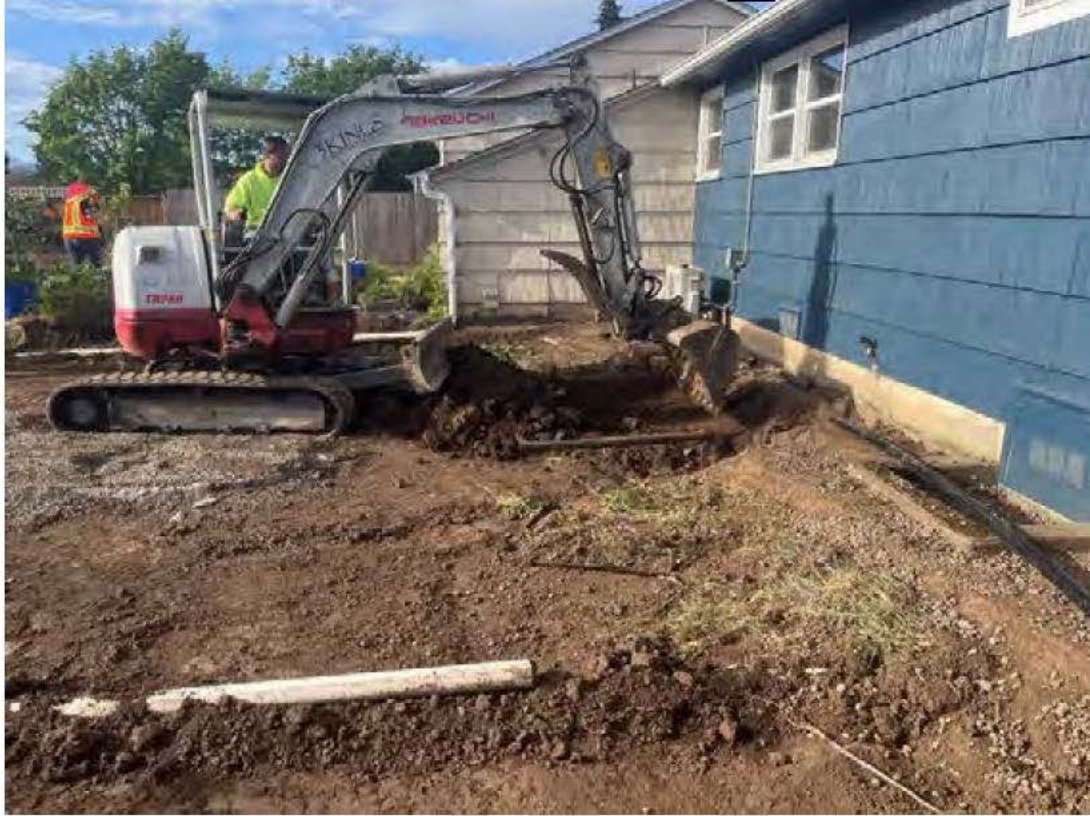
Photograph 3. 3 Kings performing additional excavation along residence at [REDACTED] Baxter. Photo taken facing south.

1250 - Rexius onsite delivering topsoil. 3 Kings using skid steer with sweeper attachment to clean out some track out observed in roadways along work zones. GSI pointed out some additional areas along the backside of the residence at [REDACTED] Baxter that needed follow up excavation to meet project requirements.

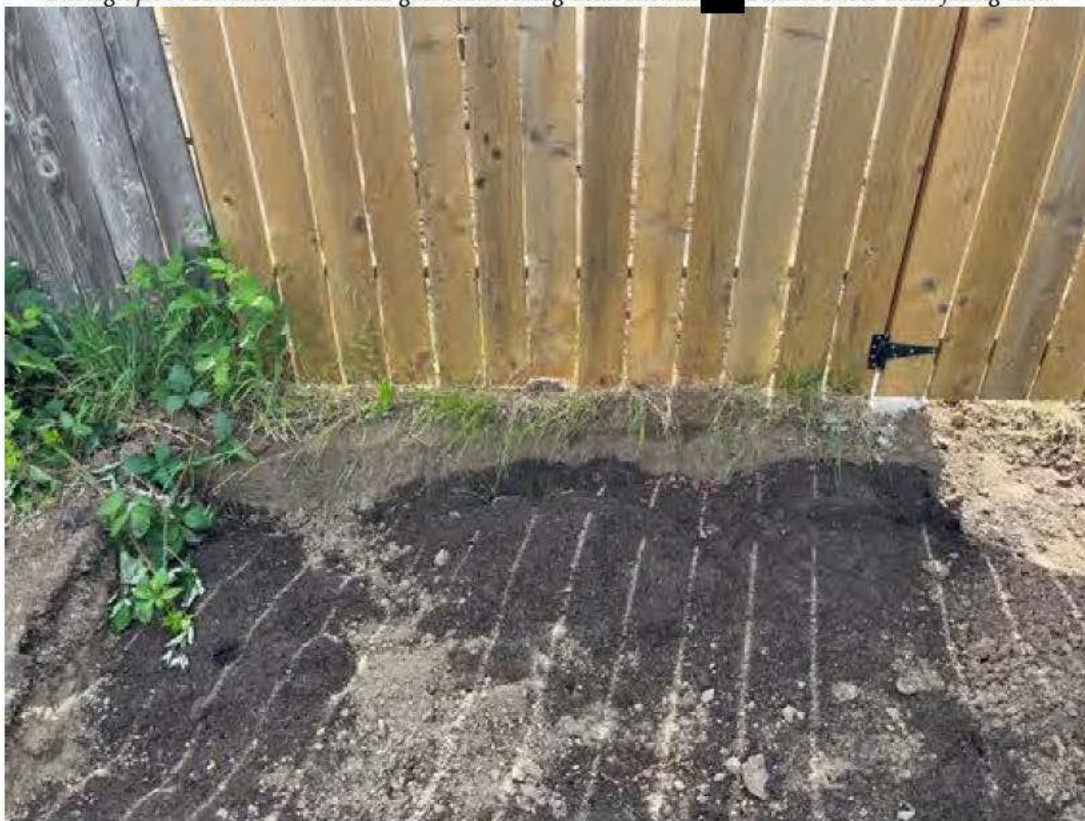
Photograph 7. Soil under north side gate still needing excavation at [REDACTED] Baxter. Photo taken facing east.

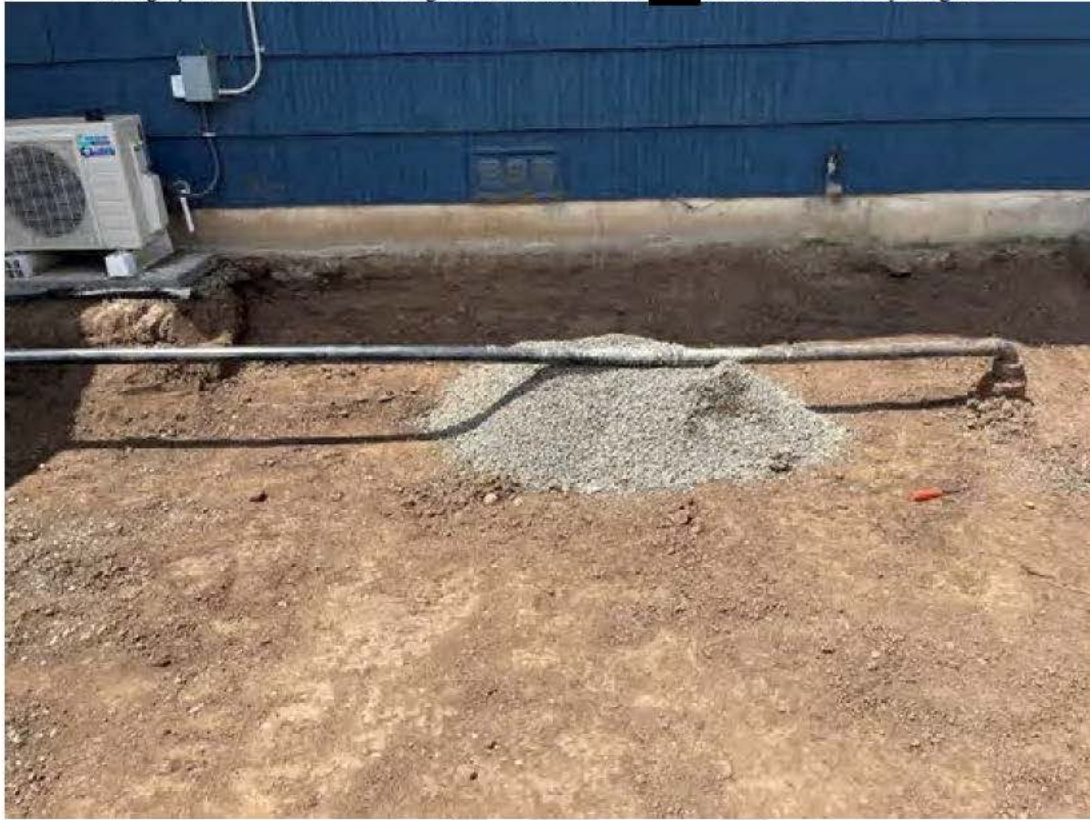
Photograph 19. Reattached washing machine drain line at [REDACTED] Baxter. Photo taken facing west.

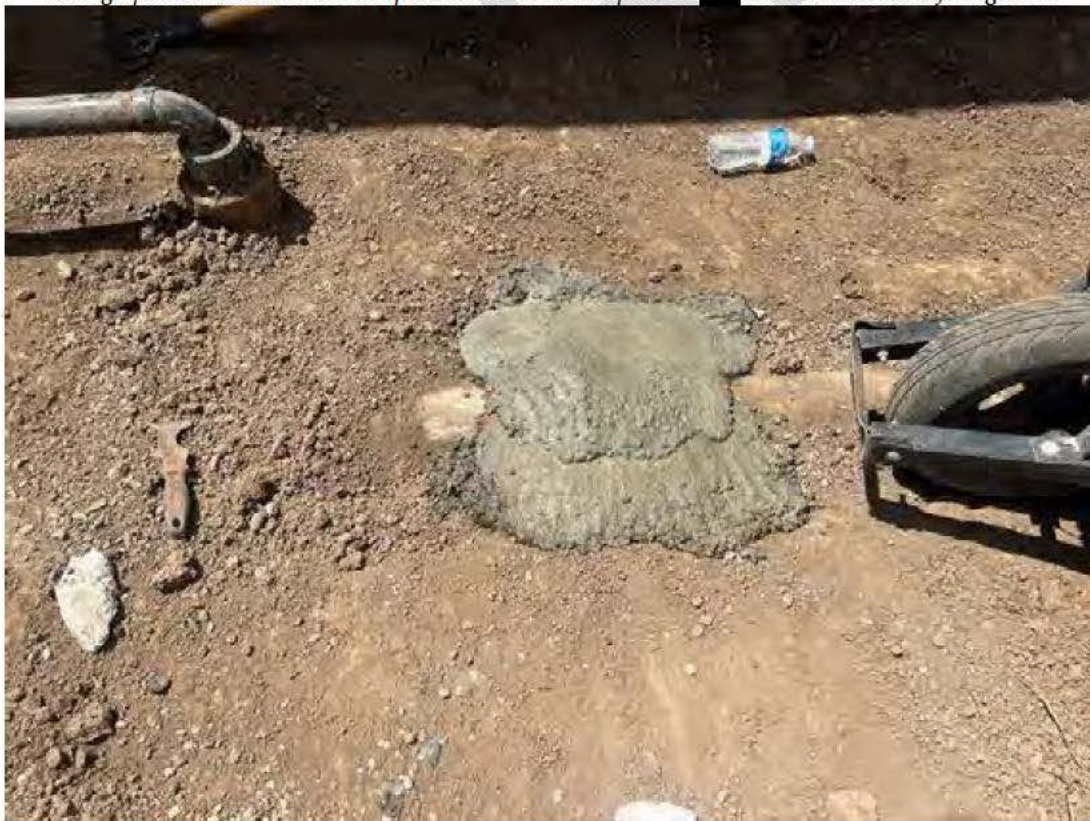
Photograph 20. Additional concrete poured over sewer line patch at [REDACTED] Baxter. Photo taken facing west.

0935 - GSI observed that 3 Kings had encountered and damaged the concrete sewer line at [REDACTED] Baxter while performing additional excavation along the backside of the building. 3 Kings indicated they would properly repair the damaged section of pipe in similar fashion to the anticipated repair at [REDACTED] Baxter.

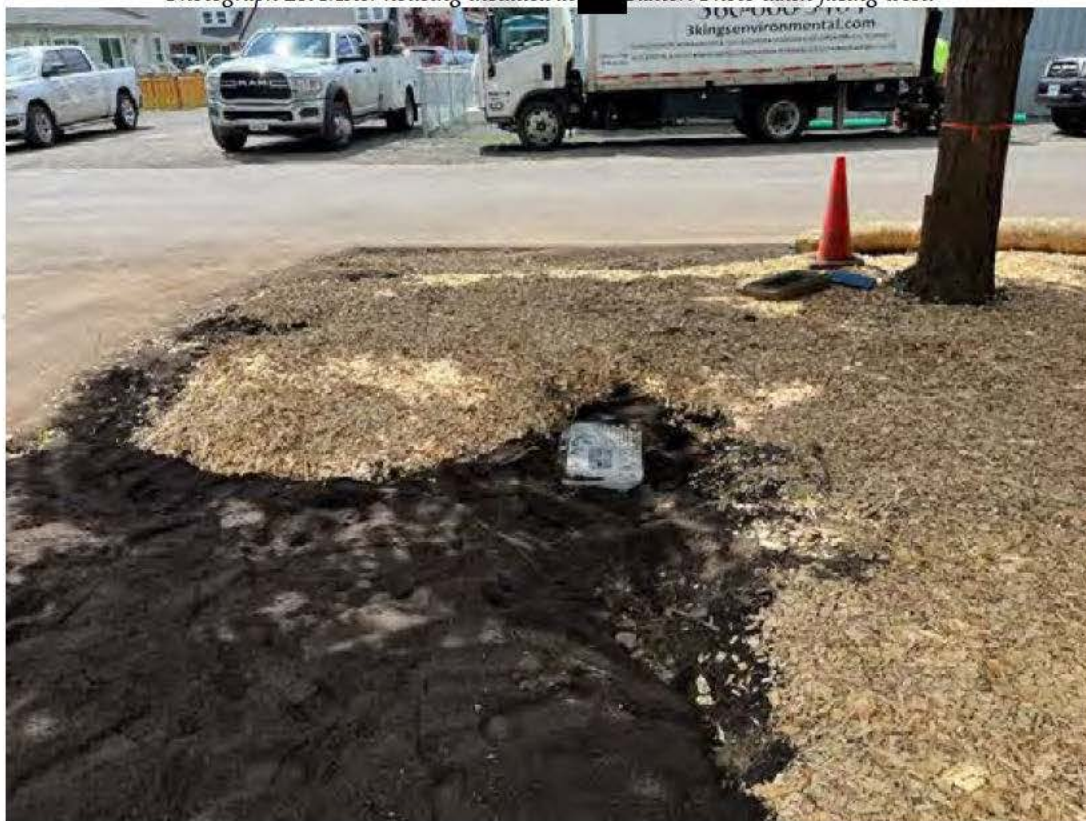
Photograph 28. Meter housing installed at [REDACTED] Baxter. Photo taken facing west.

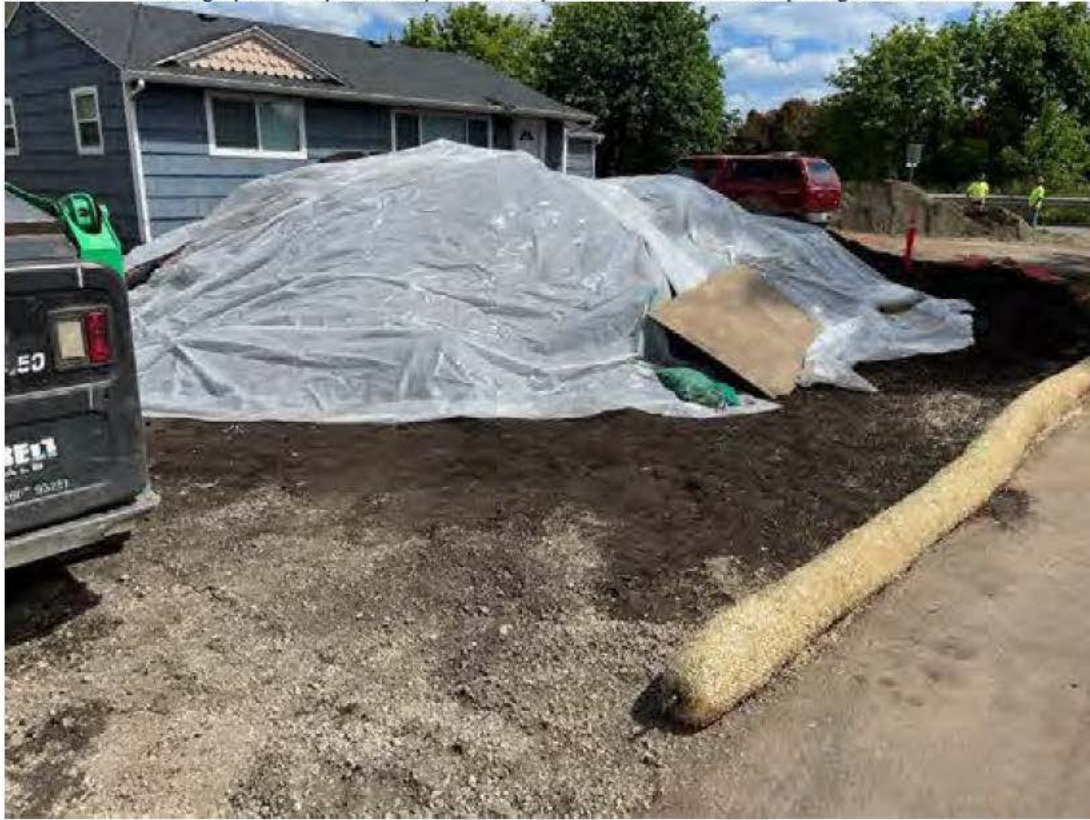
Photograph 29. Topsoil stockpile covered for weekend. Photo taken facing southeast,
