APPENDIX B

Daily Field Reports Continued

Phase II RA

OFFSITE REMOVAL ACTION - DAILY FIELD REPORT
JH BAXTER OFFSITE REMEDIAL ACTION
EUGENE, OREGON

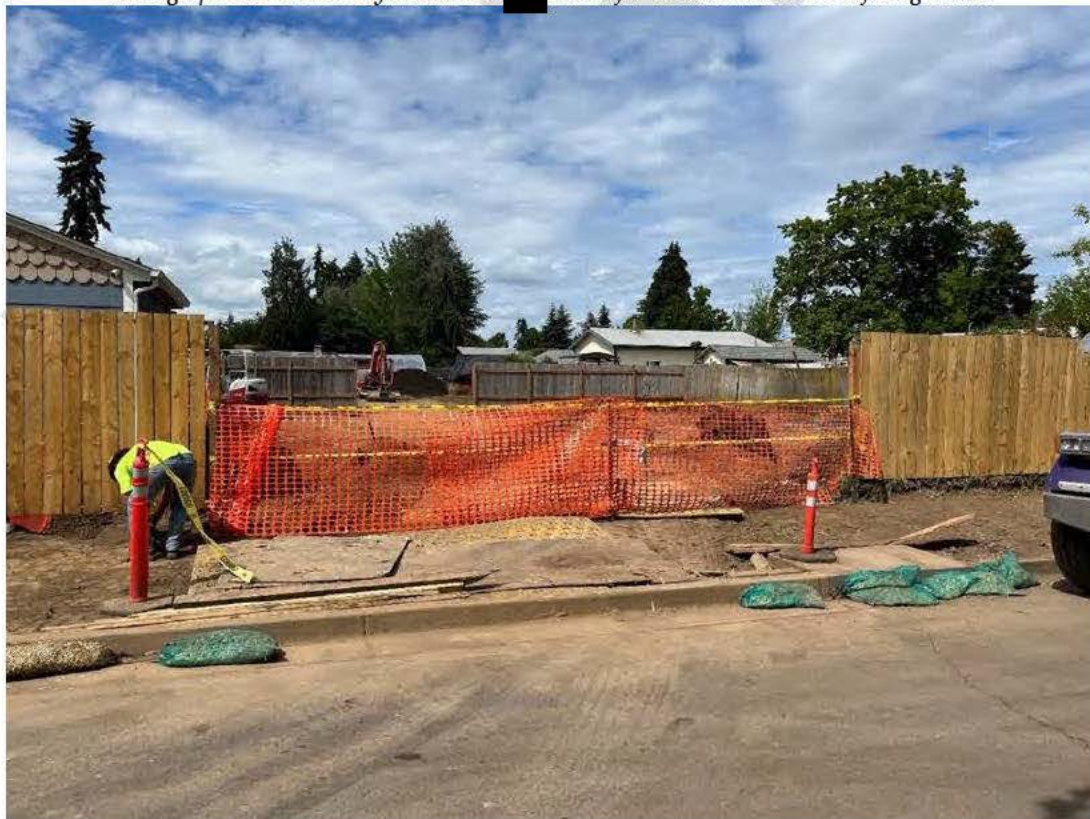
Photograph 30. Site security installed at [REDACTED] Baxter for weekend. Photo taken facing north.

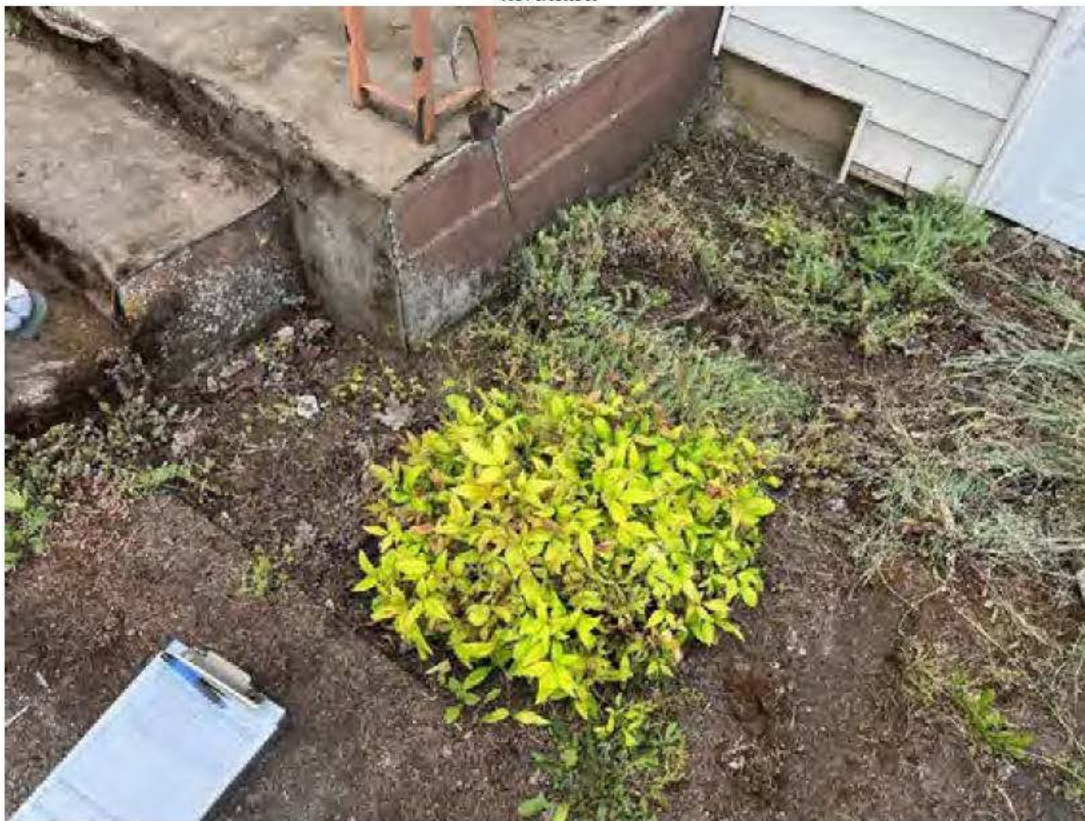
Photograph 1. Area of soil in front yard of [REDACTED] Baxter to be excavated and shrub to be saved. Photo taken facing northeast.

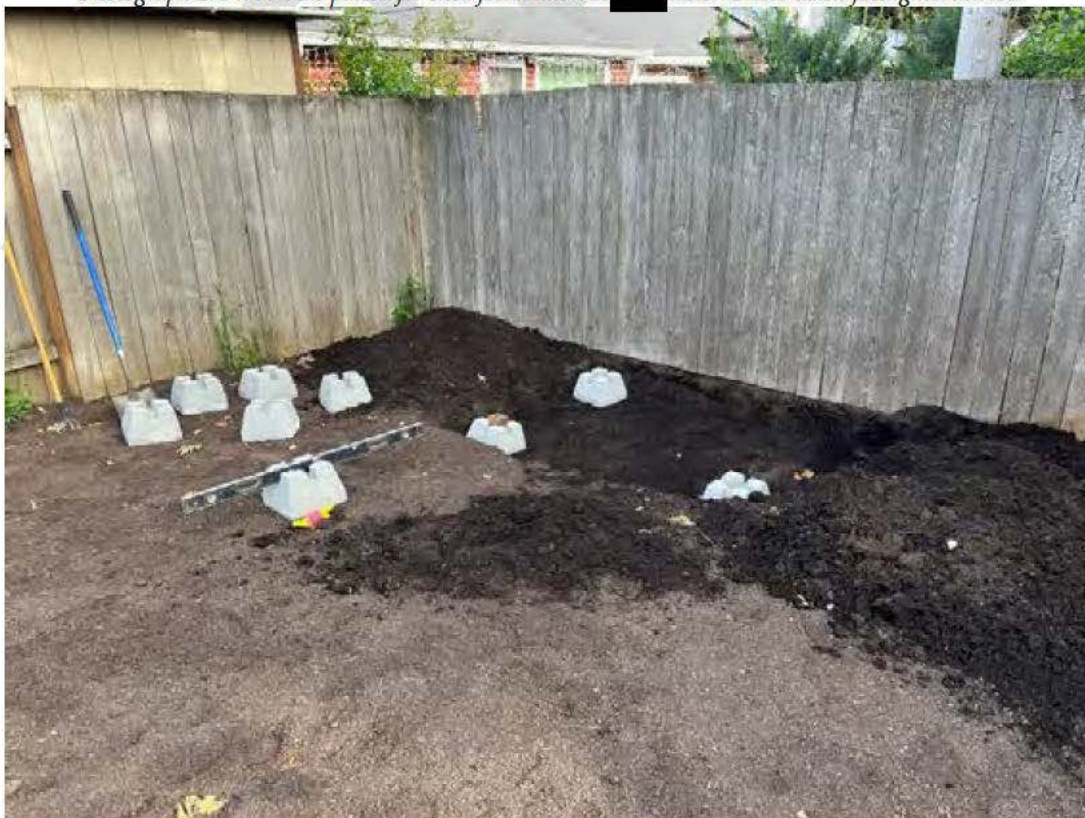
Photograph 2. Pier blocks placed for shed foundation at [REDACTED] Baxter. Photo taken facing northwest.

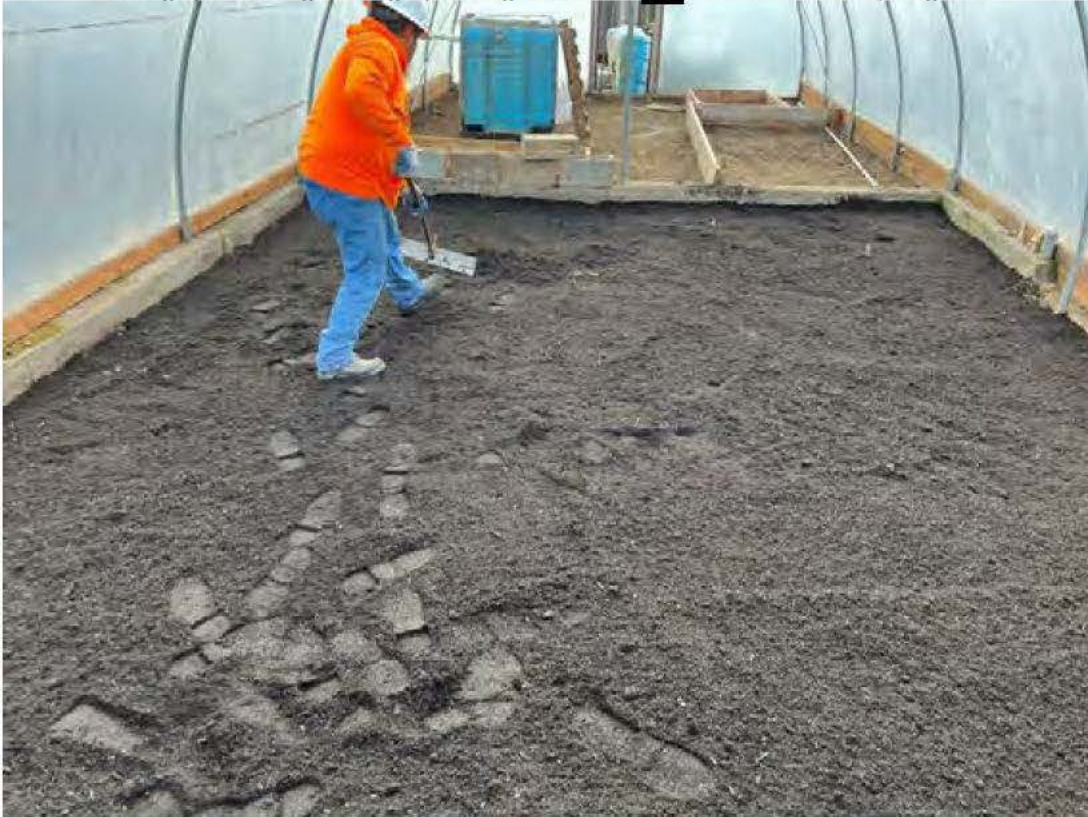
Photograph 3. 3 Kings placing topsoil in greenhouse at [REDACTED] Baxter. Photo taken facing east.

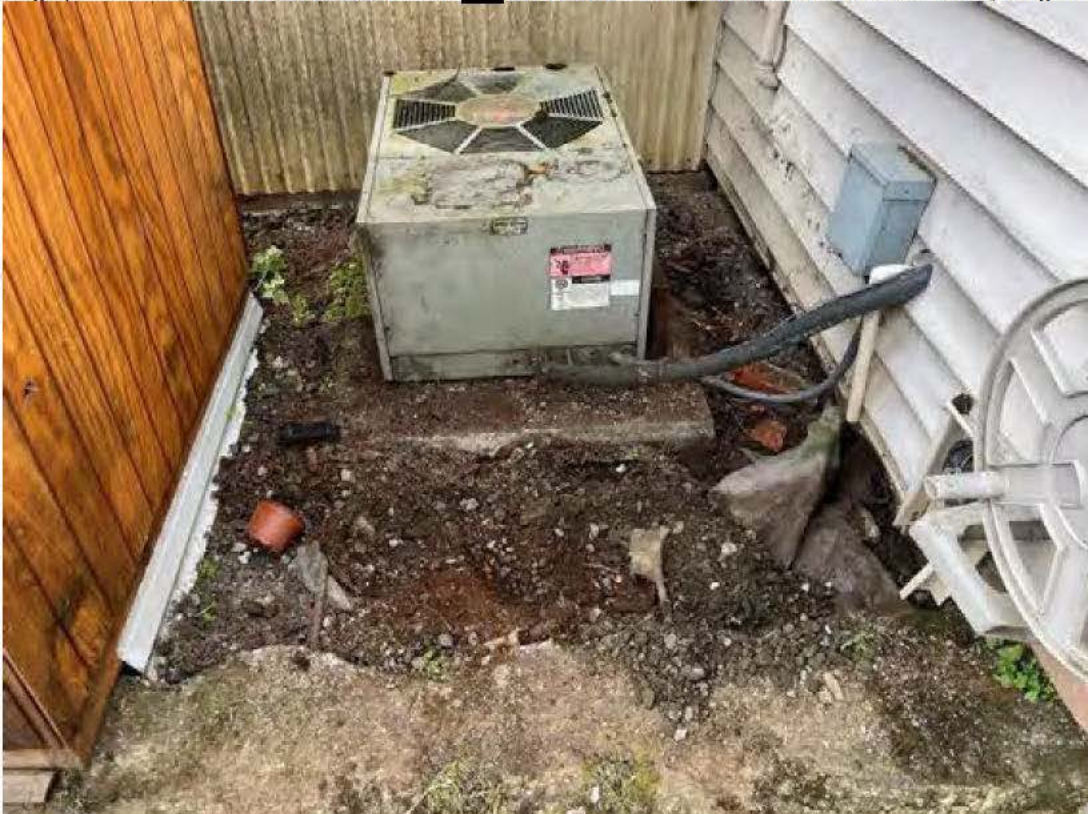
Photograph 4. Area of soil around AC unit and at [REDACTED] Baxter to be excavated via hand tools. Photo taken facing south.

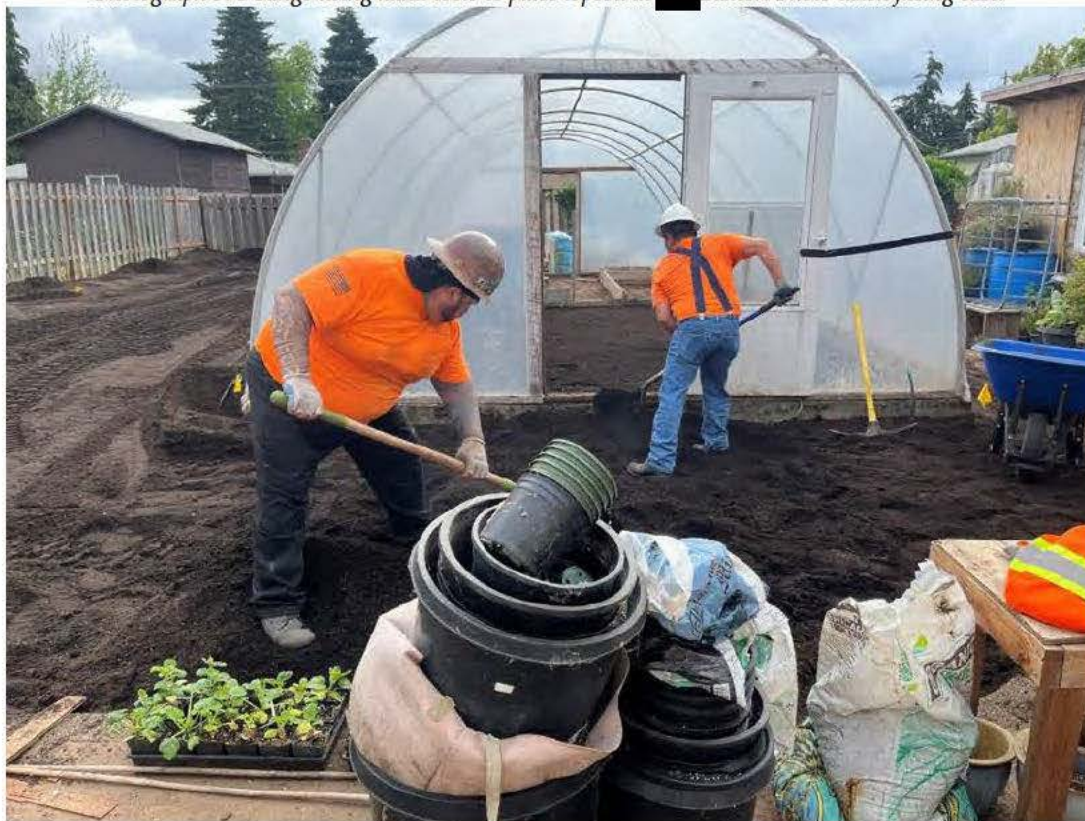
Photograph 5. 3 Kings using hand tools to place topsoil at Baxter. Photo taken facing east.

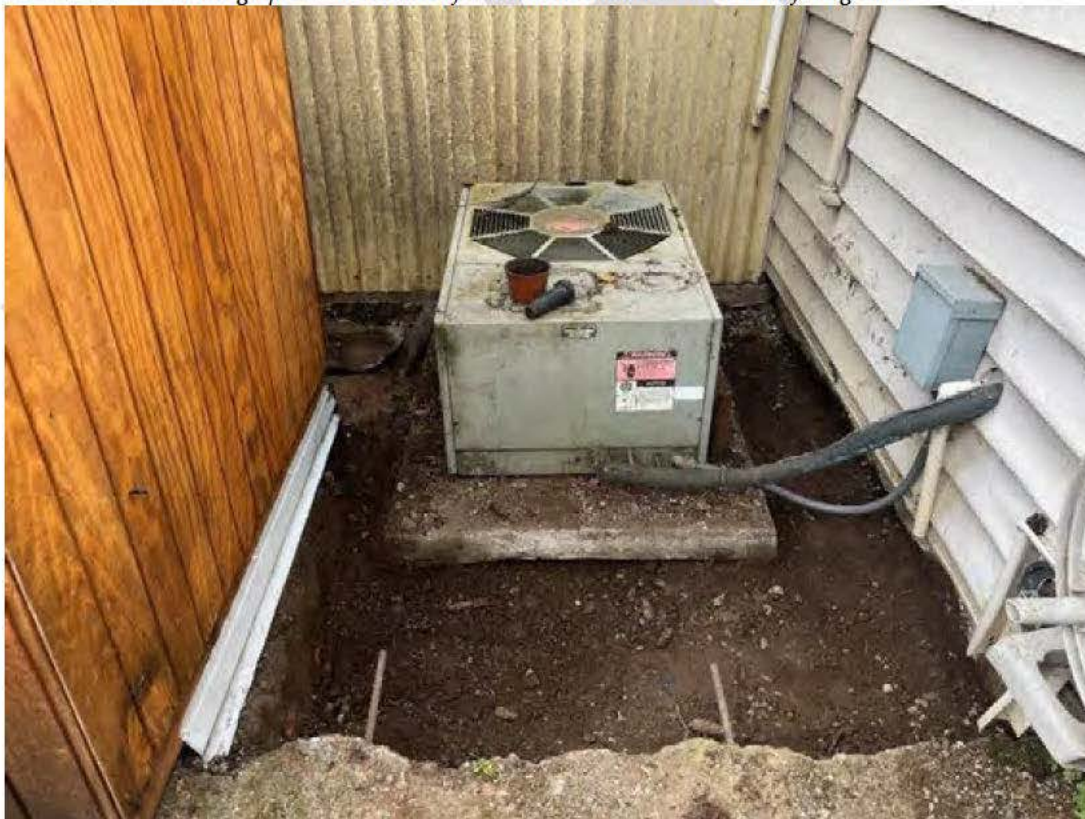
Photograph 6. Soil removed from around AC unit. Photo taken facing south.

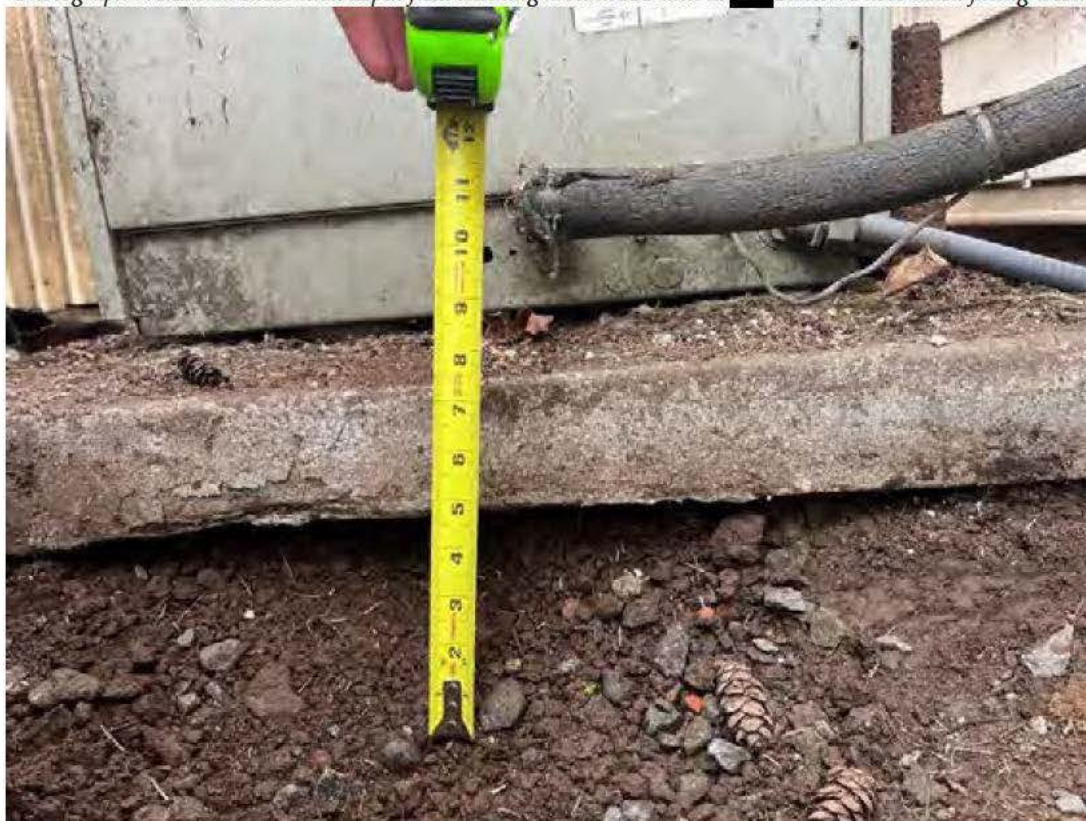
Photograph 7. Manual excavation depth field truthing around AC unit at Baxter. Photo taken facing west.

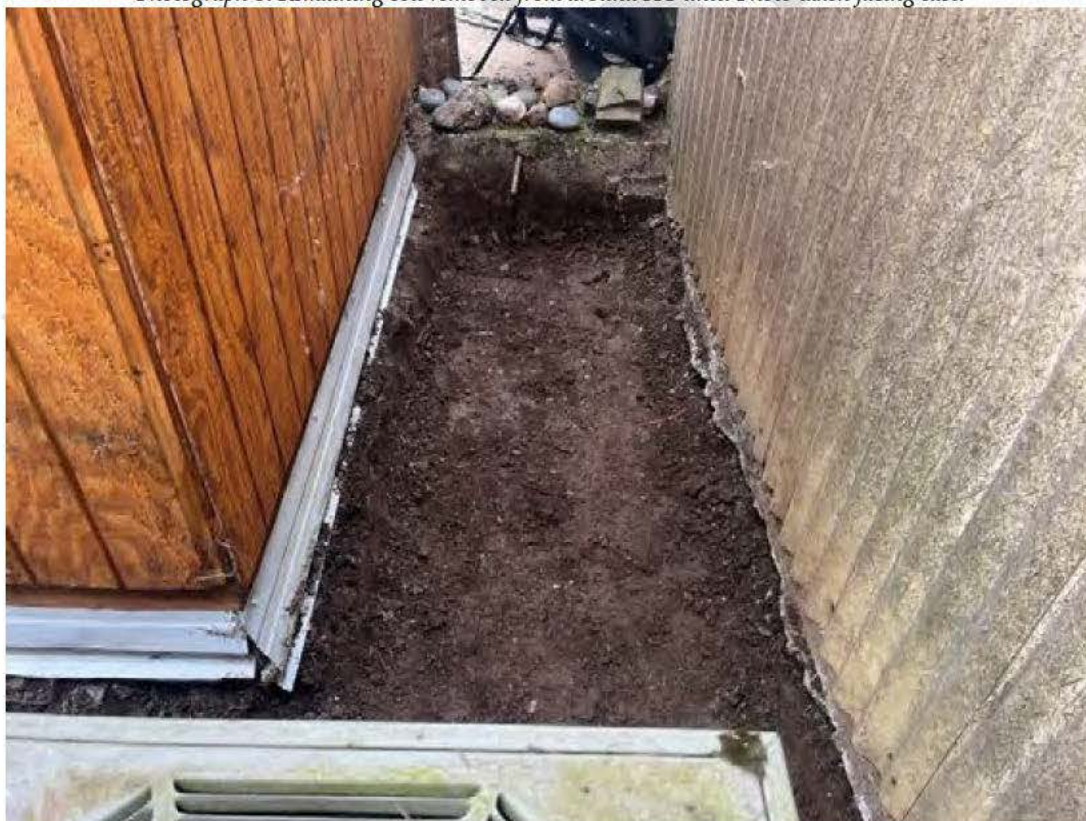
Photograph 8. Remaining soil removed from around AC unit. Photo taken facing east.

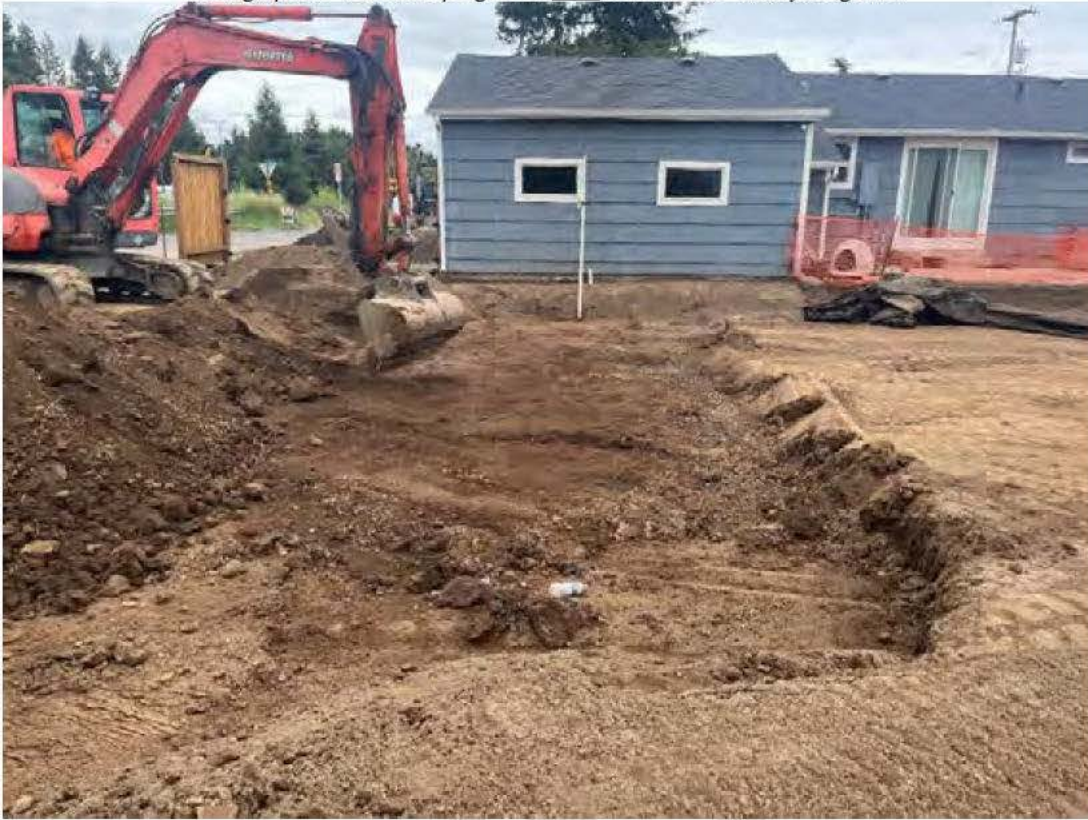
Photograph 9. Excavation progress at [REDACTED] Baxter. Photo taken facing west.

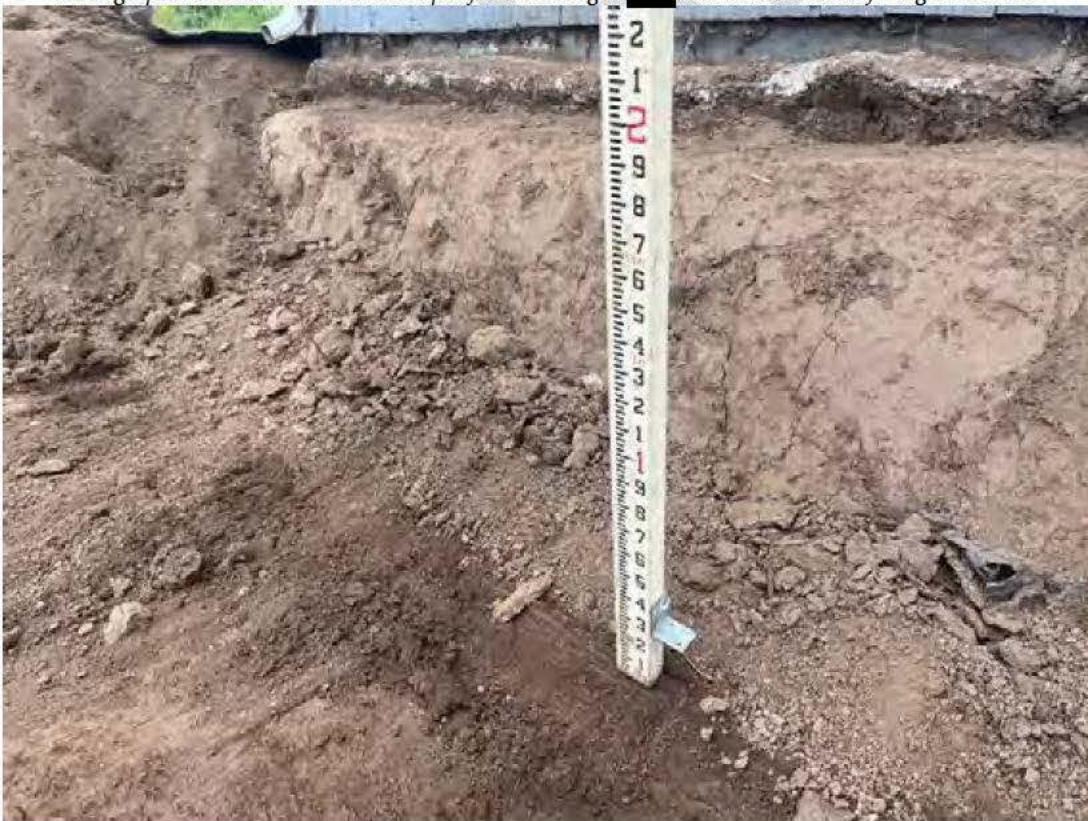
Photograph 10. Manual excavation depth field truthing at [REDACTED] Baxter. Photo taken facing southwest.

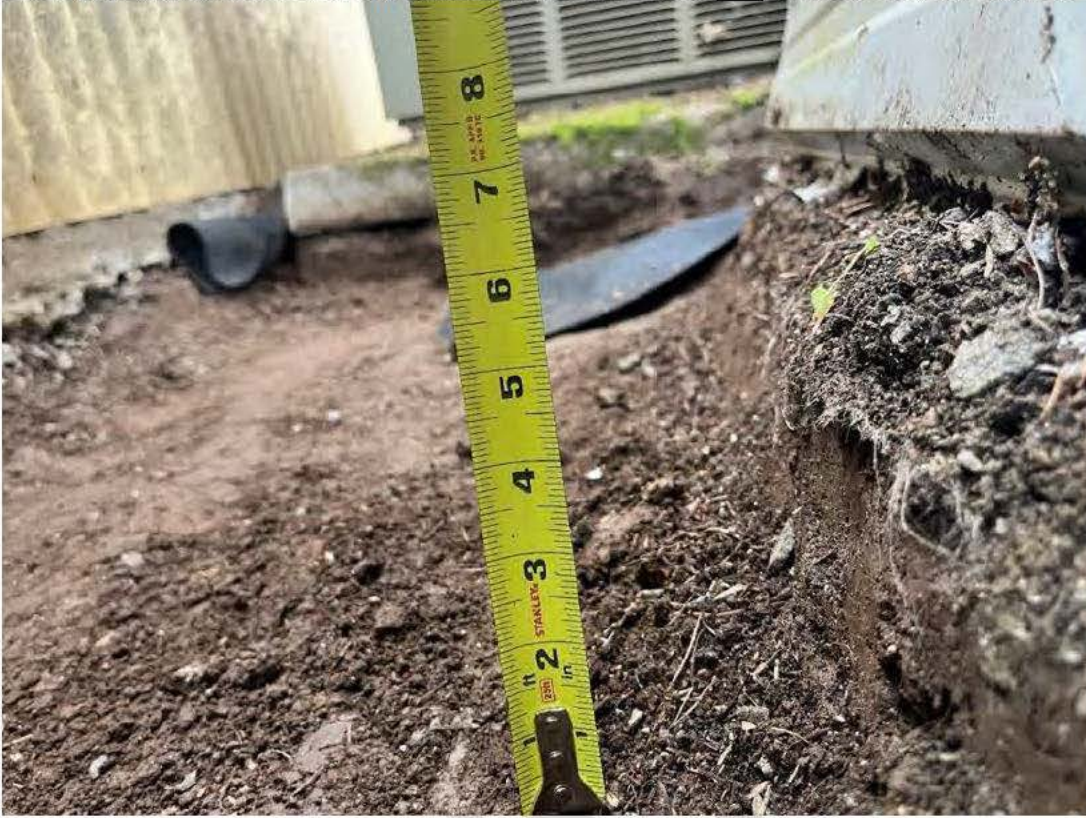
Photograph 11. Manual excavation depth field truthing near AC unit at Baxter. Photo taken facing west.

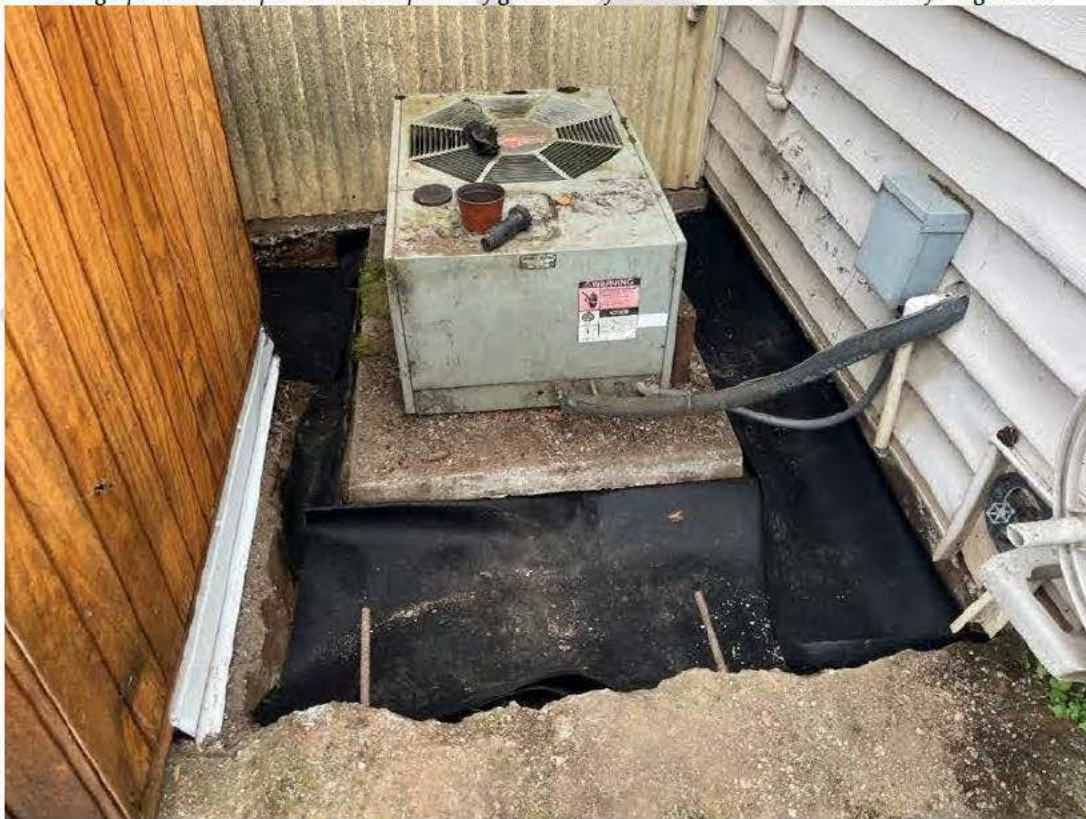
Photograph 12. Fabric placed in anticipation of gravel backfill around AC unit. Photo taken facing south.

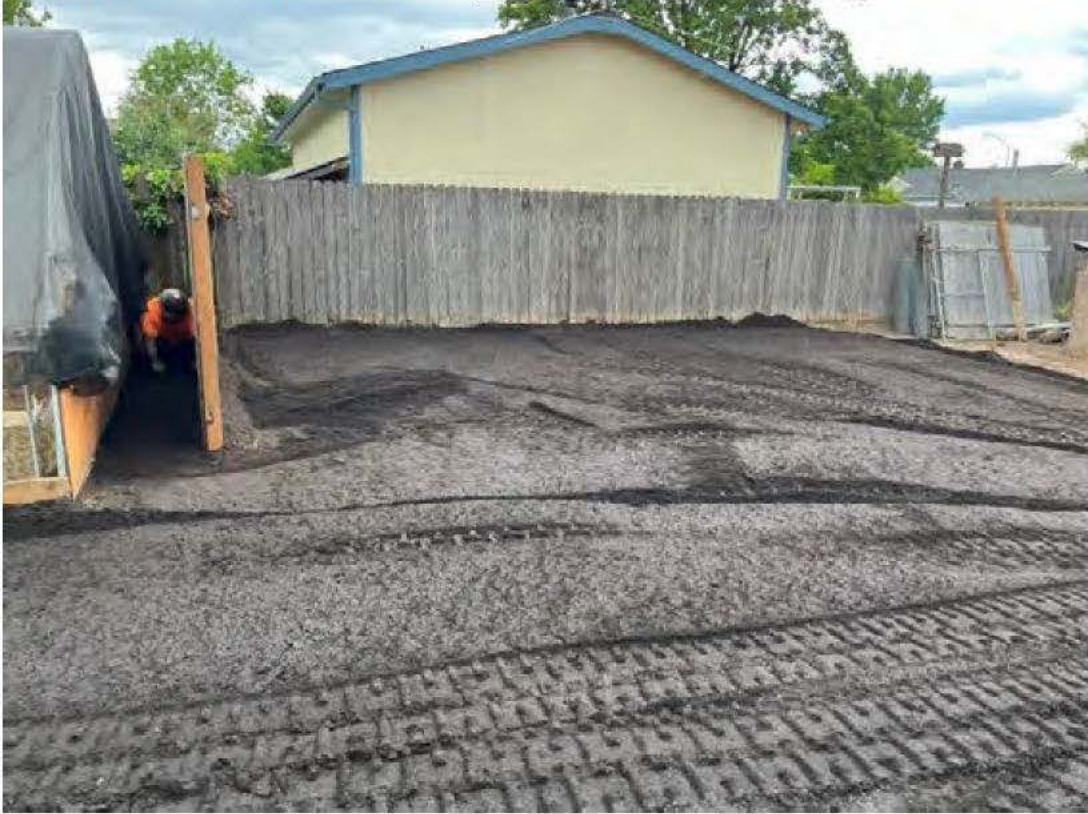
Photograph 13. Topsoil being placed and graded at [REDACTED] Baxter and south side of [REDACTED] Baxter. Photo taken facing east.

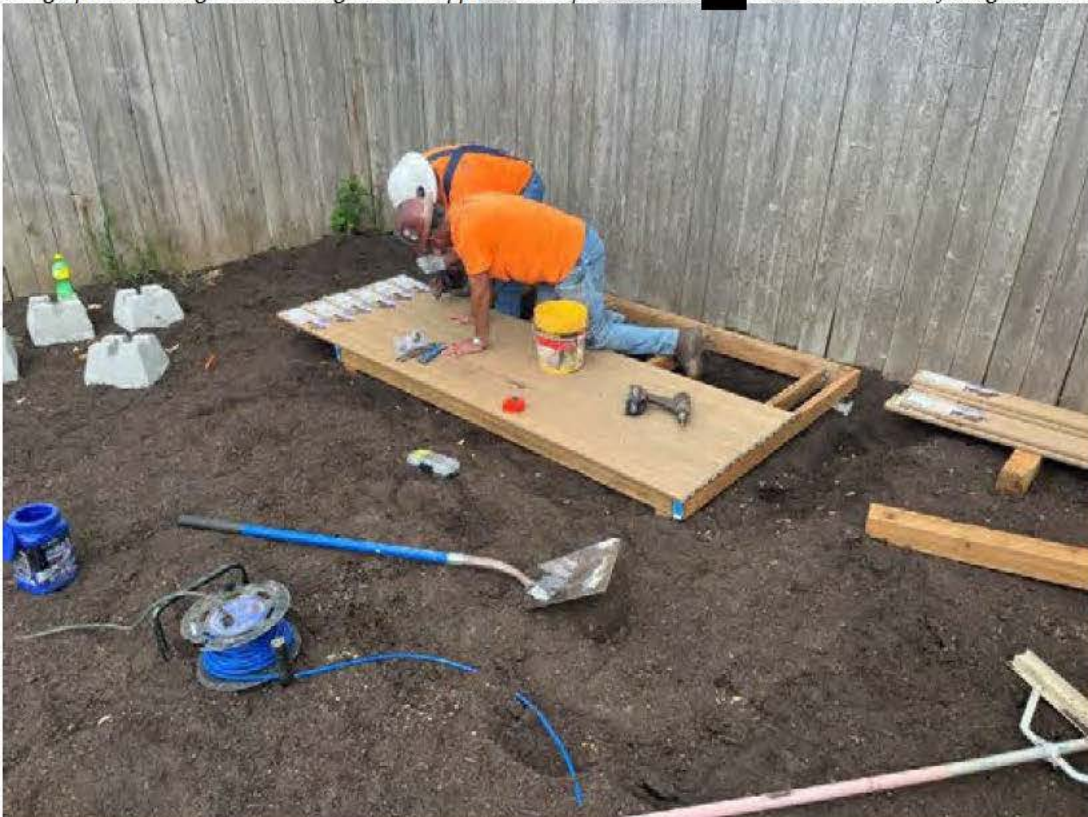
Photograph 14. 3 Kings constructing deck to support shed replacement at [REDACTED] Baxter. Photo taken facing northwest.

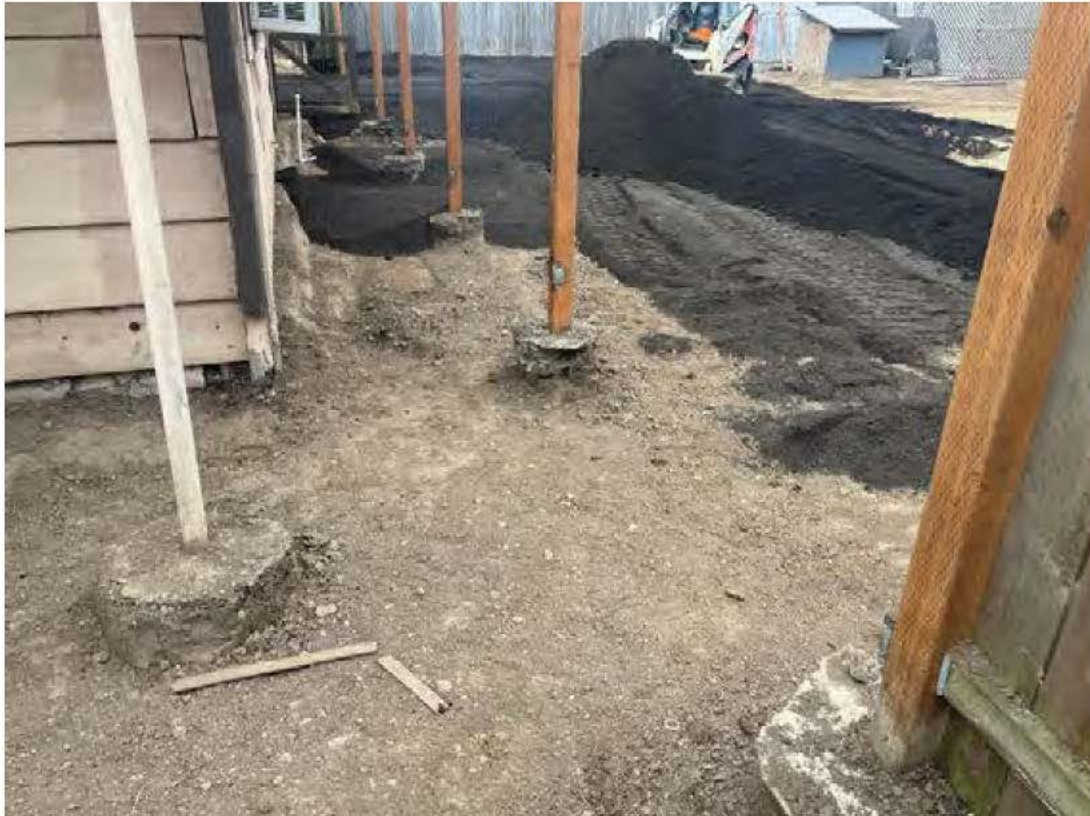
Photograph 15. Excavation extents and backfill placing along property line of [REDACTED] and [REDACTED] Baxter. Photo taken facing southeast.

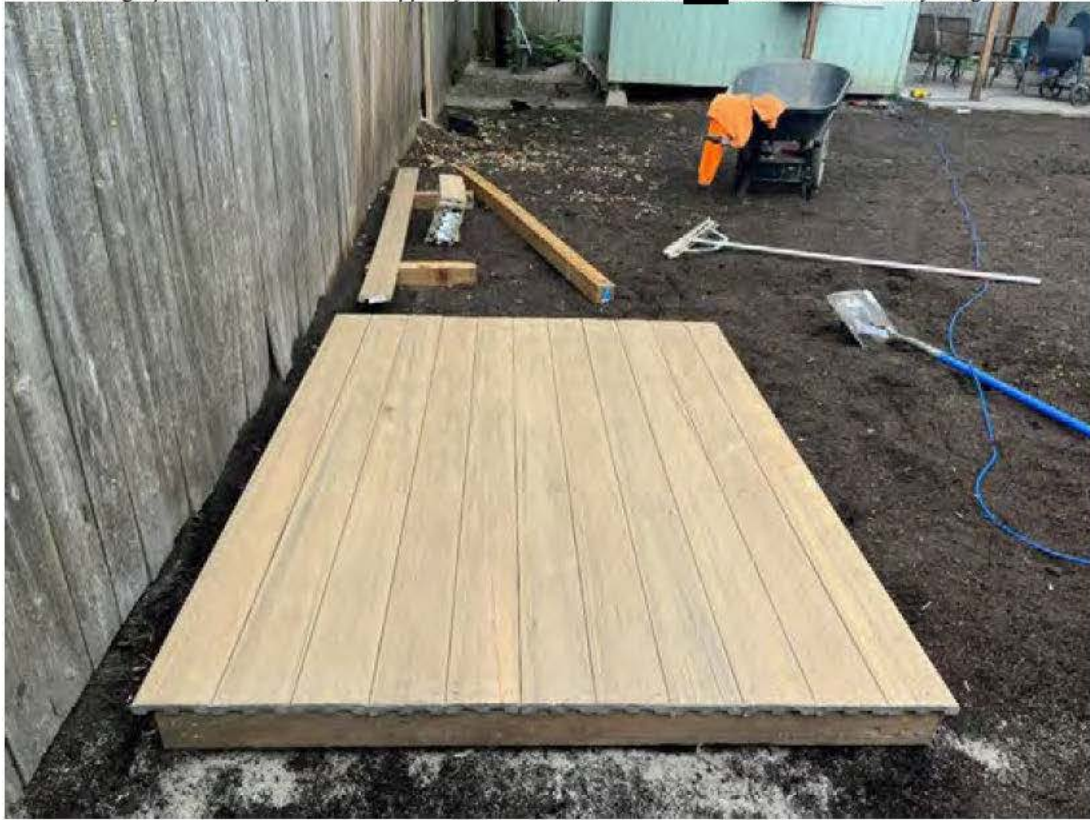
Photograph 17. Completed deck support for shed replacement at [REDACTED] Baxter. Photo taken facing east.

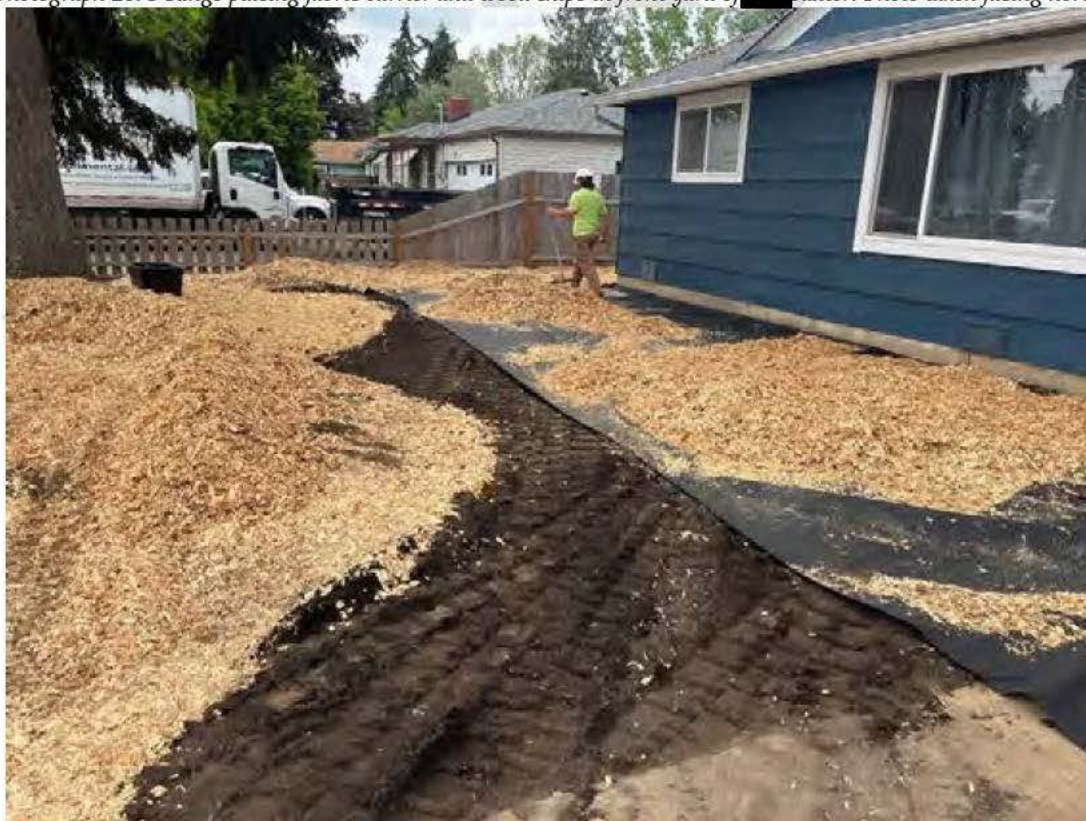
Photograph 20. 3 Kings placing fabric barrier and wood chips in front yard of [REDACTED] Baxter. Photo taken facing north.

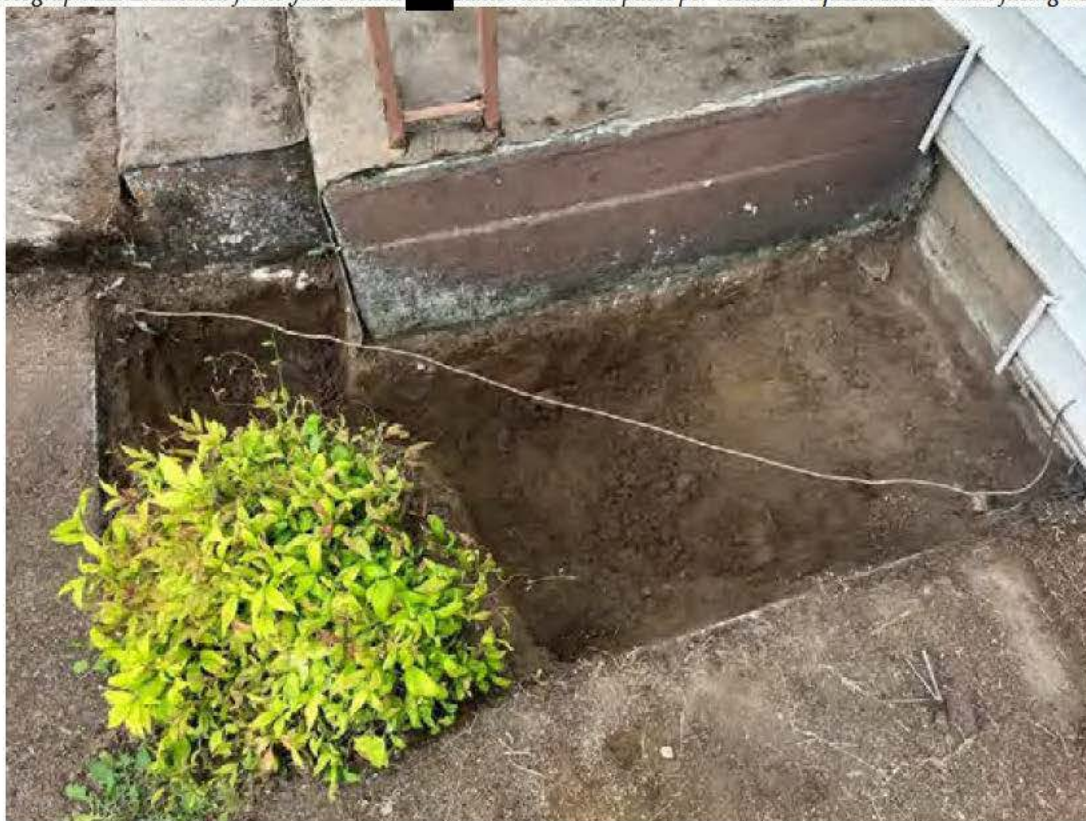
Photograph 21. Excavated front yard area at [REDACTED] Baxter and saved plant per resident request. Photo taken facing north.

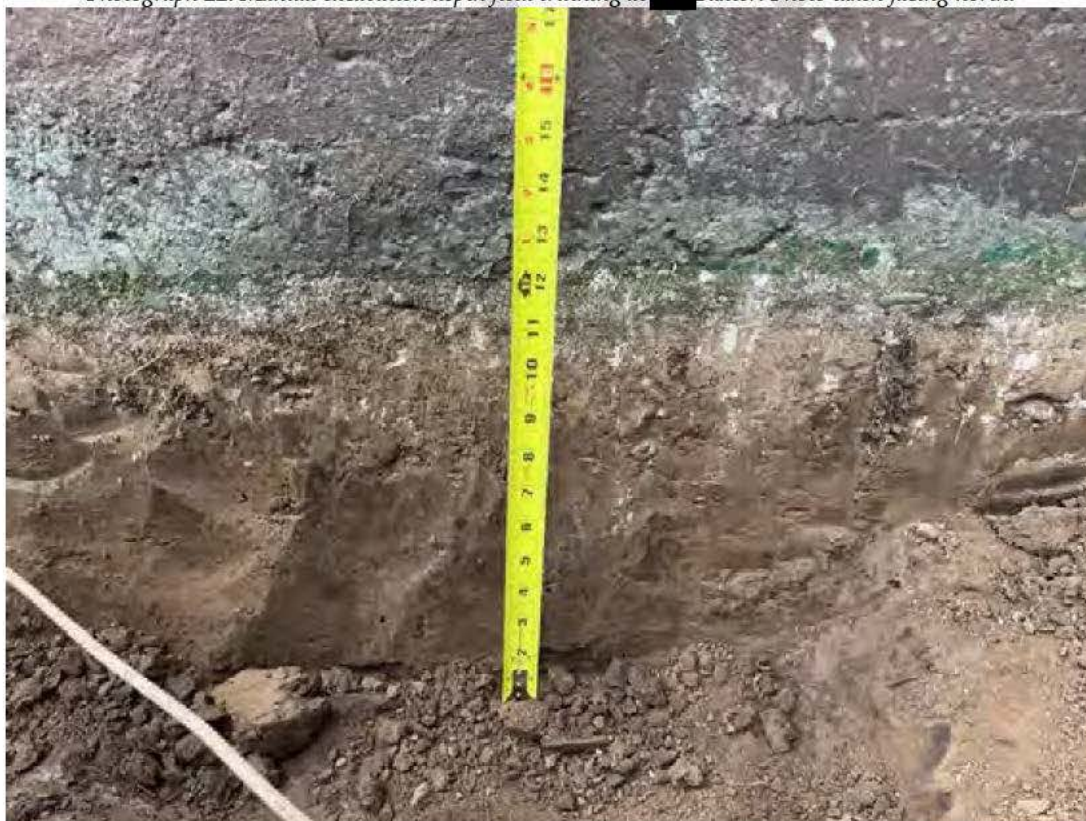
Photograph 22. Manual excavation depth field truthing at [REDACTED] Baxter. Photo taken facing north.

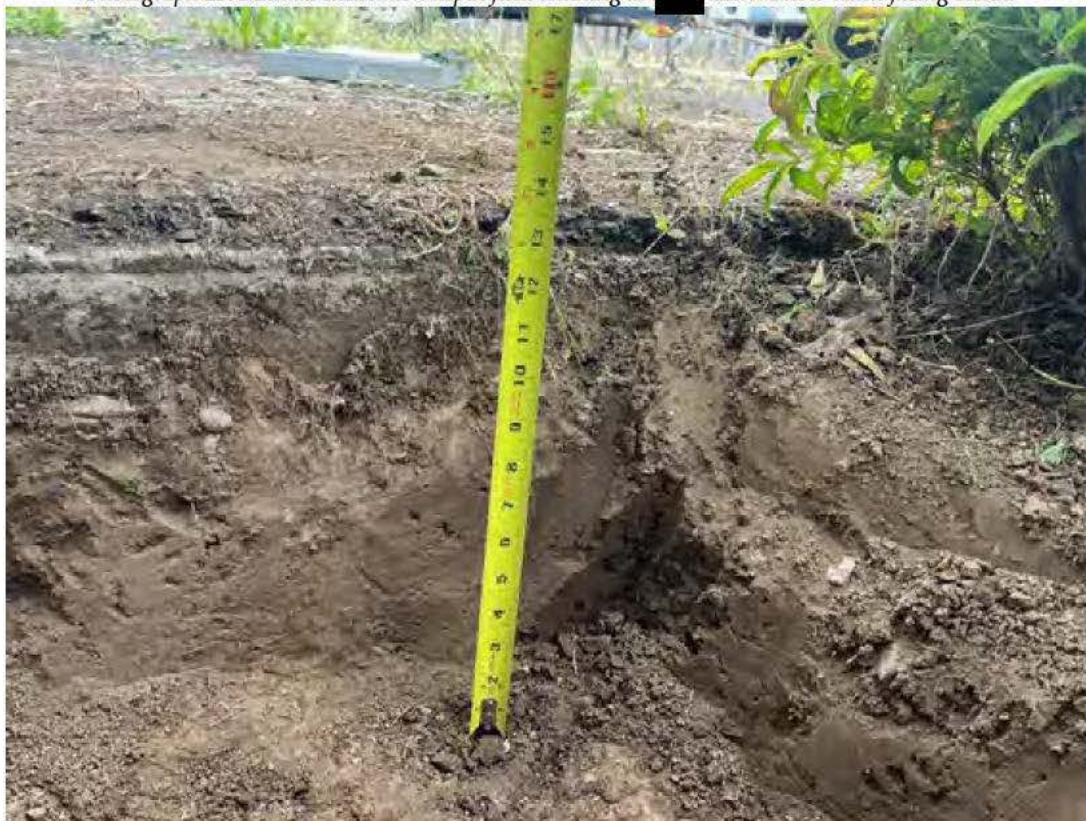
Photograph 23. Manual excavation depth field truthing at [REDACTED] Baxter. Photo taken facing south.

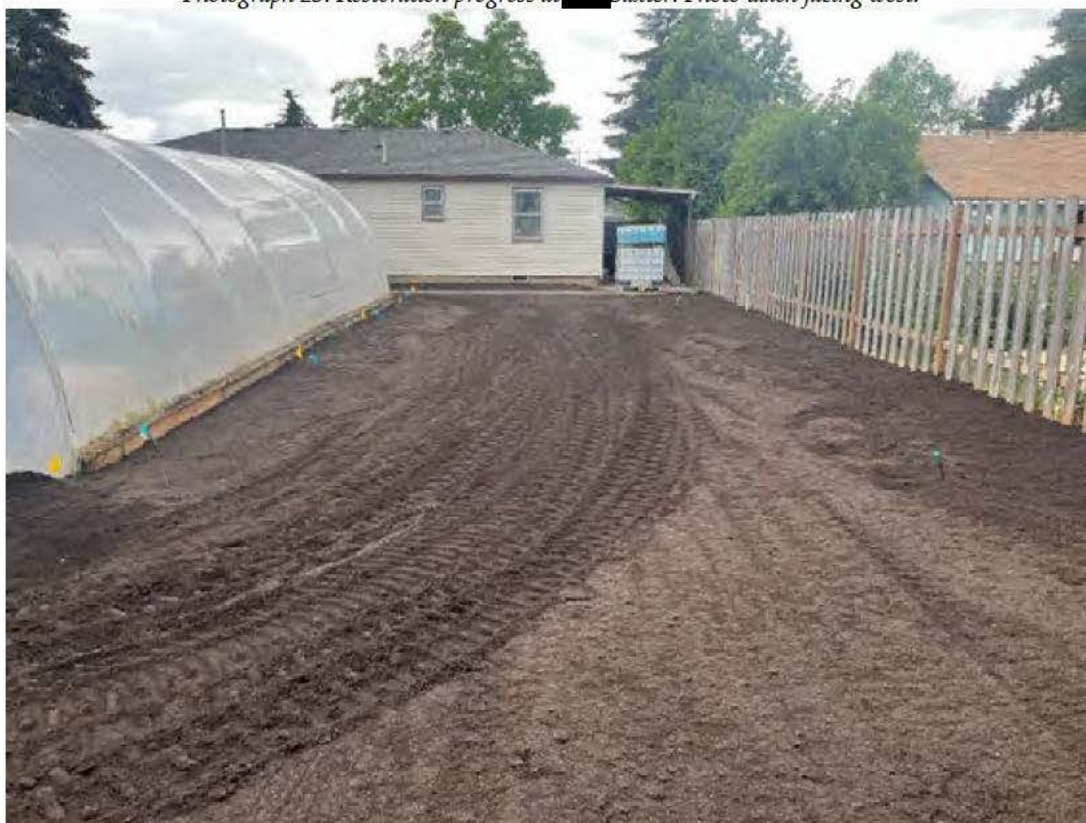
Photograph 25. Restoration progress at [REDACTED] Baxter. Photo taken facing west.

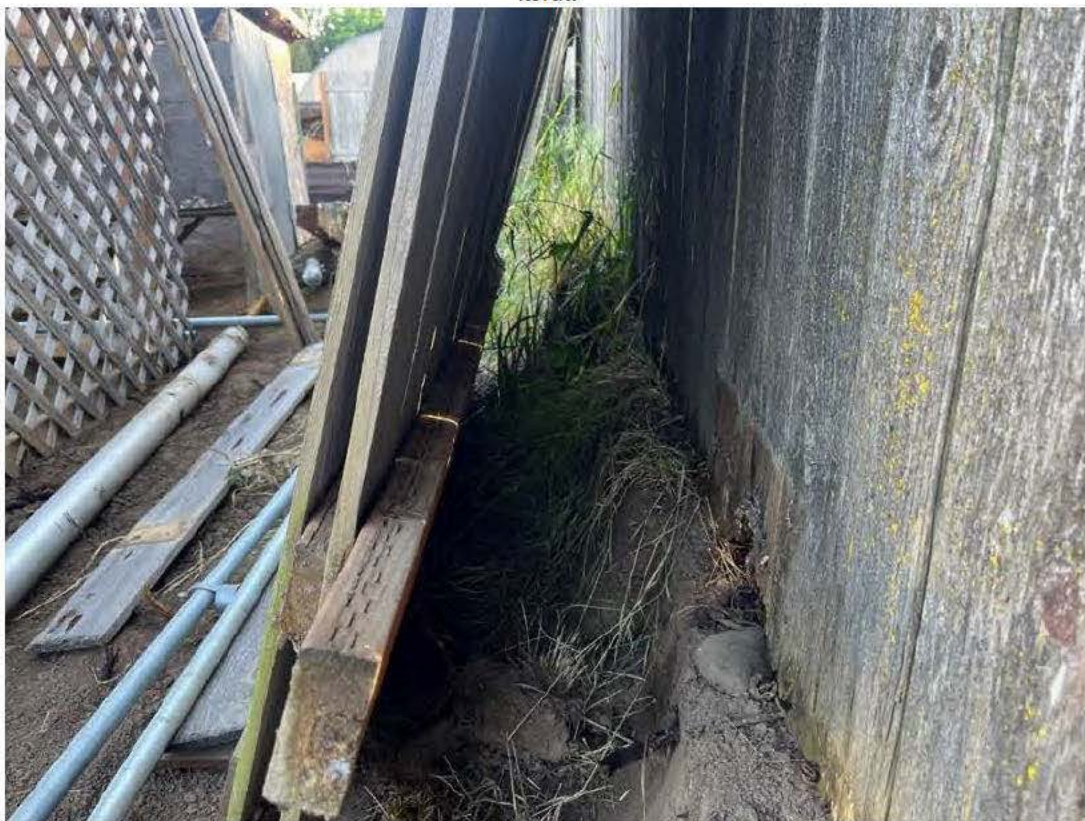
Photograph 1. Material along eastern fence line of [REDACTED] Baxter requiring addiitonal excavation. Photograph taken facing north.

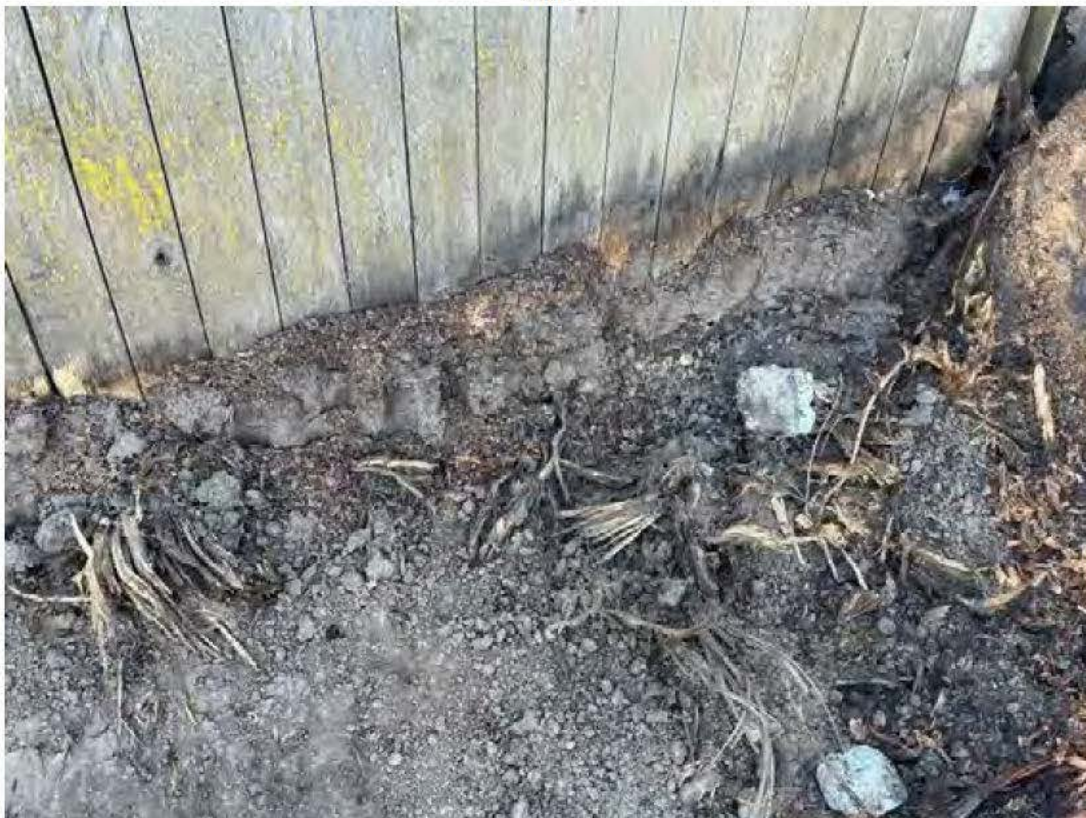
Photograph 2. Material along eastern fence line of [REDACTED] Baxter requiring additional excavation. Photograph taken facing east.

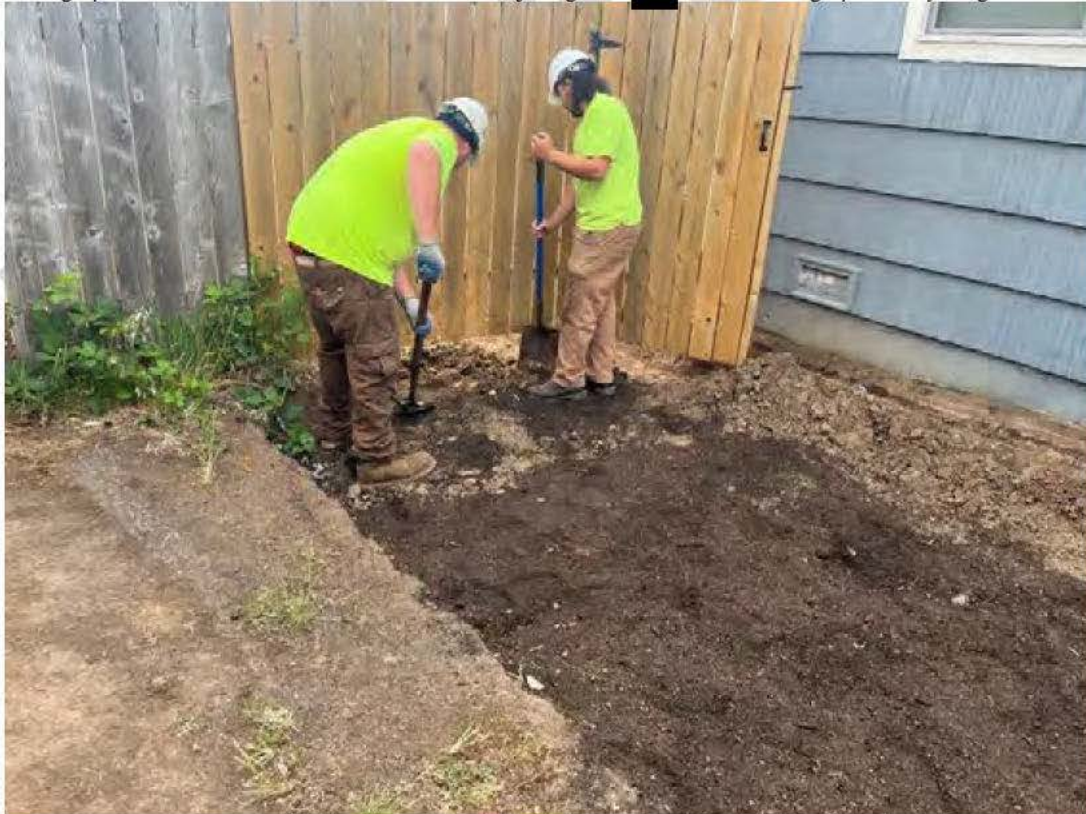
Photograph 3. Hand tool removal beneath north side yard gate at [REDACTED] Baxter. Photograph taken facing southeast.
