APPENDIX B

Daily Field Reports Continued

Phase II RA

OFFSITE REMOVAL ACTION - DAILY FIELD REPORT
JH BAXTER OFFSITE REMEDIAL ACTION
EUGENE, OREGON

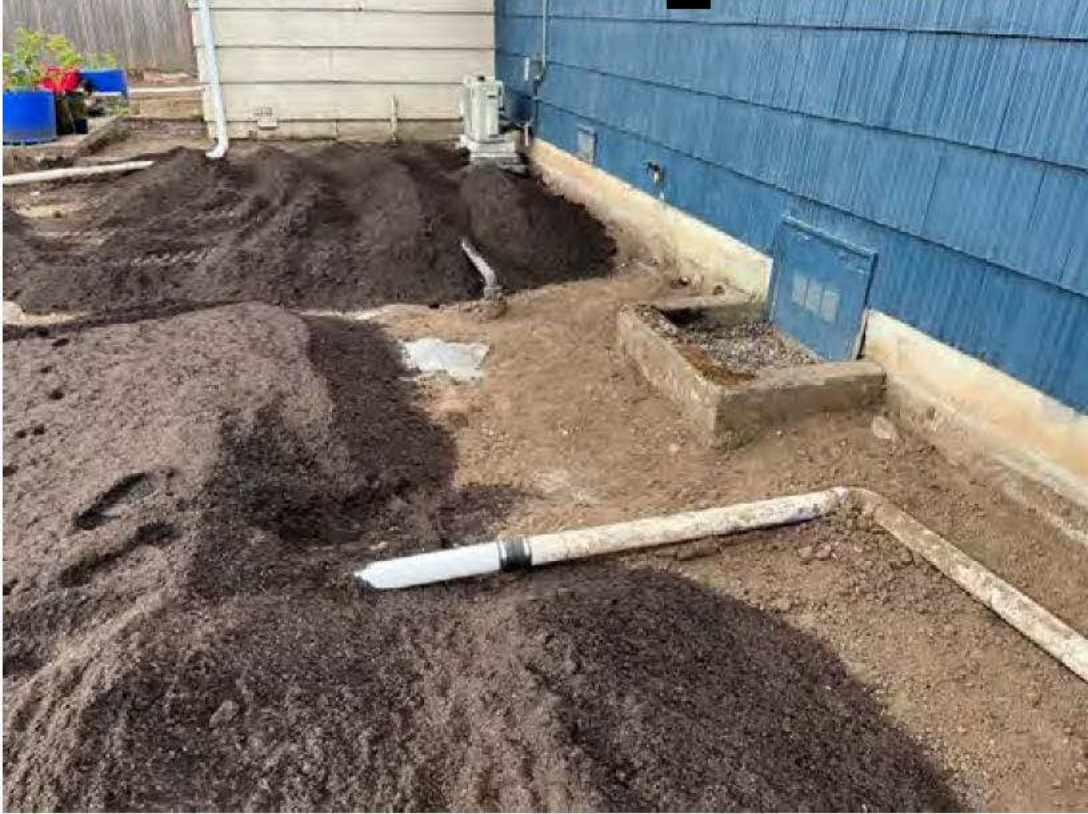
Photograph 4. Backfill placement around repaired utility features at [REDACTED] Baxter. Photograph taken facing south.

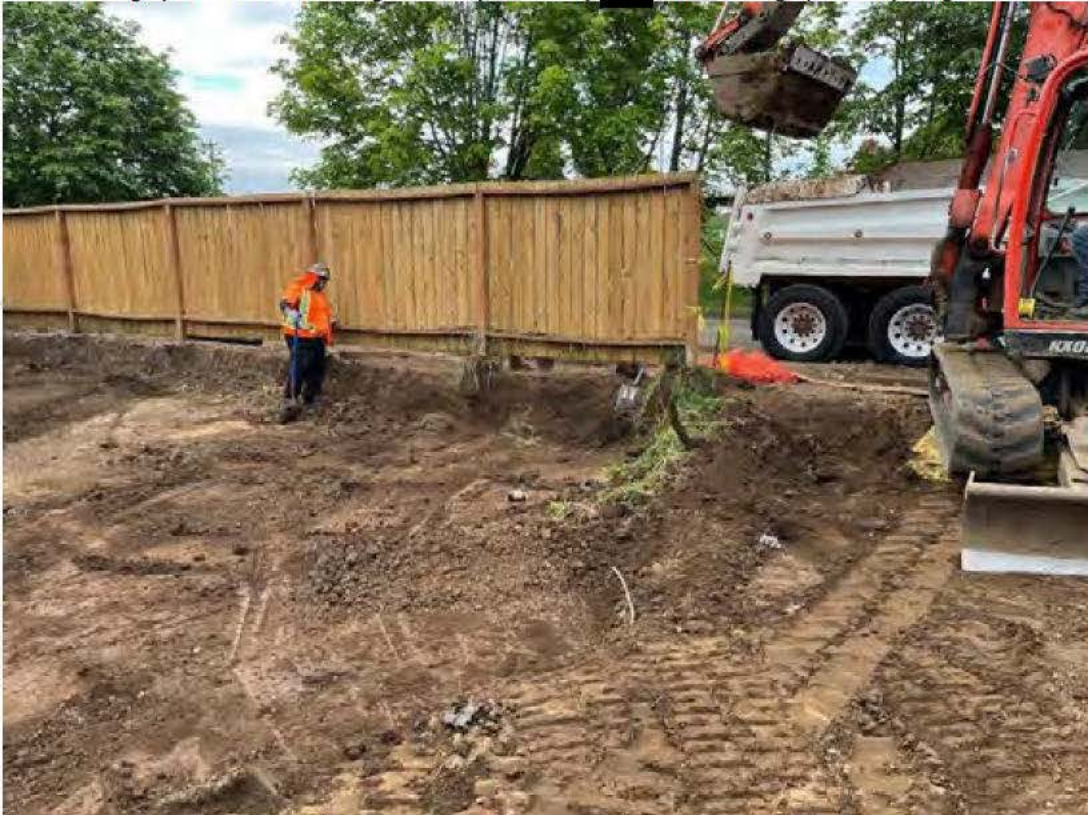
Photograph 5. Excavation along southern fence line of [REDACTED] Baxter. Photograph taken facing south.

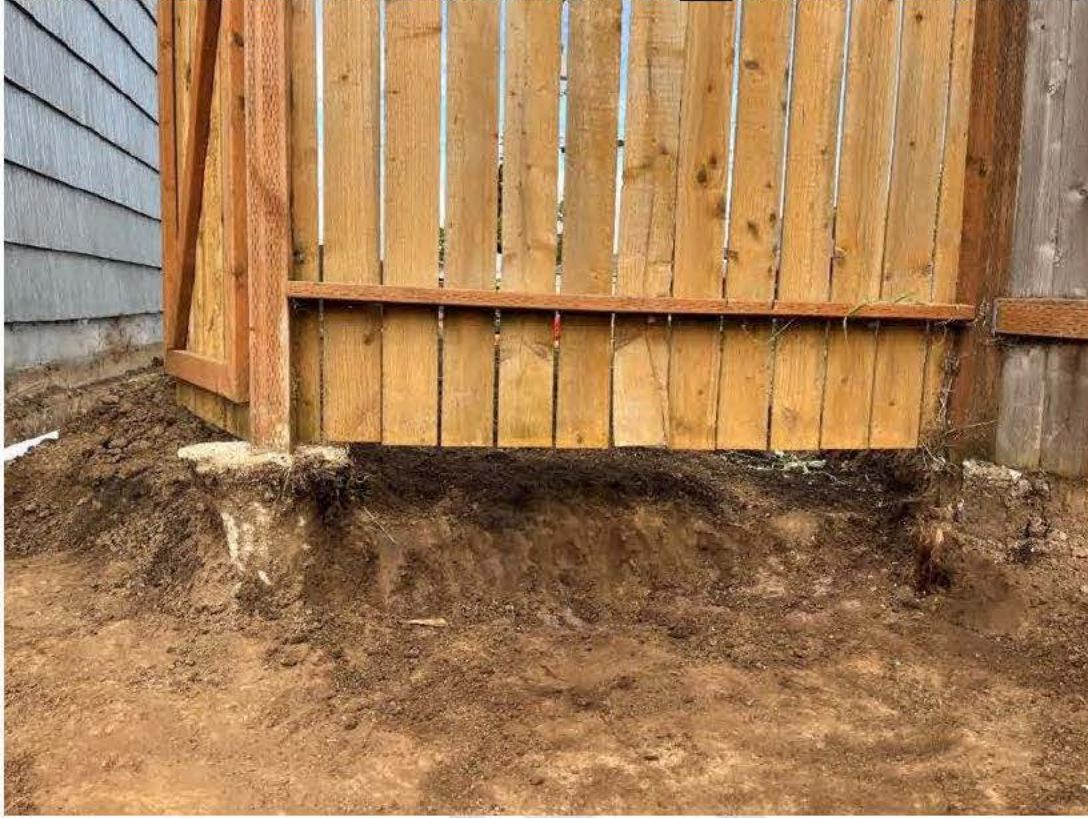
Photograph 6. Excavation extents beneath north sideyard fence/gate at [REDACTED] Baxter. Photograph taken facing west.

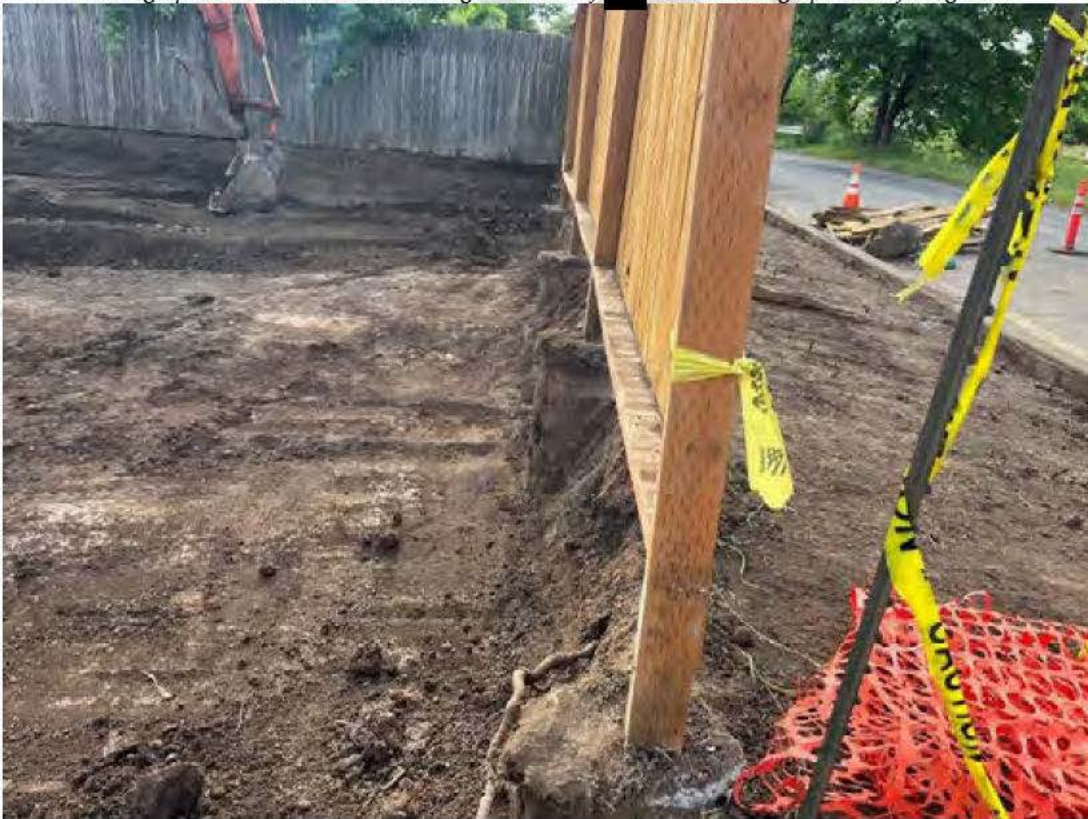
Photograph 7. Excavation extents along south side of [REDACTED] Baxter. Photograph taken facing east.

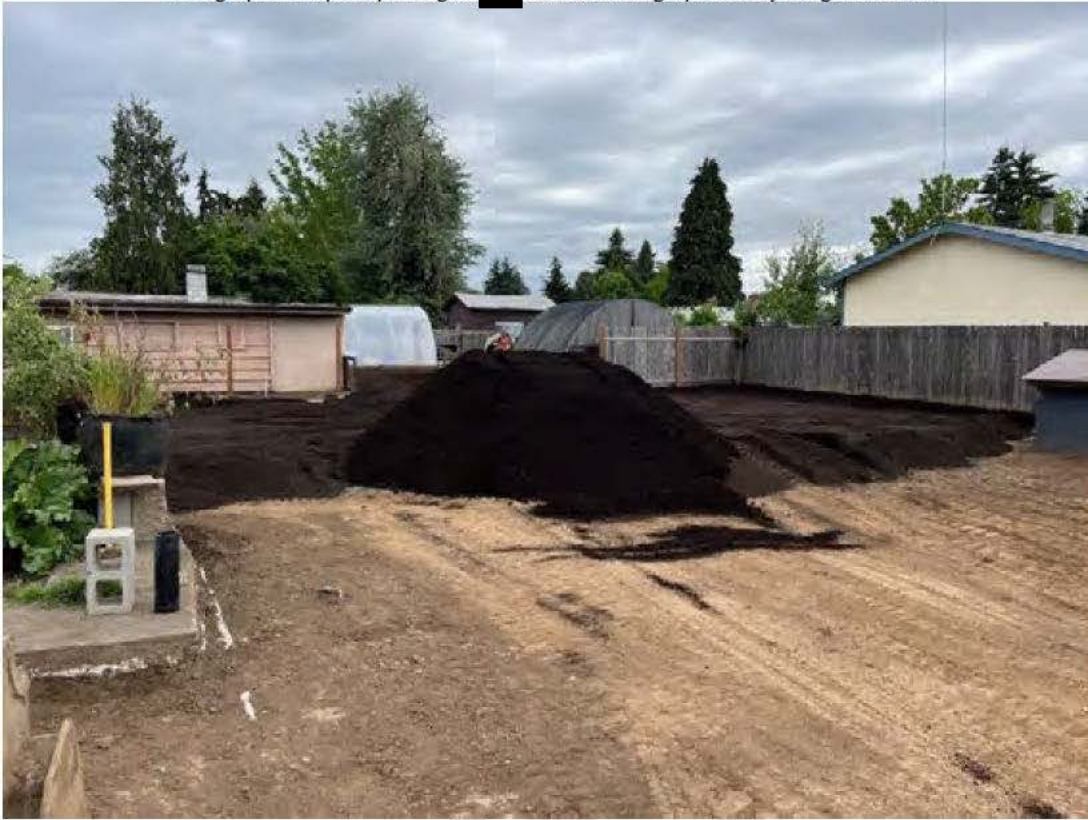
Photograph 8. Topsoil placing at [REDACTED] Baxter. Photograph taken facing northeast.

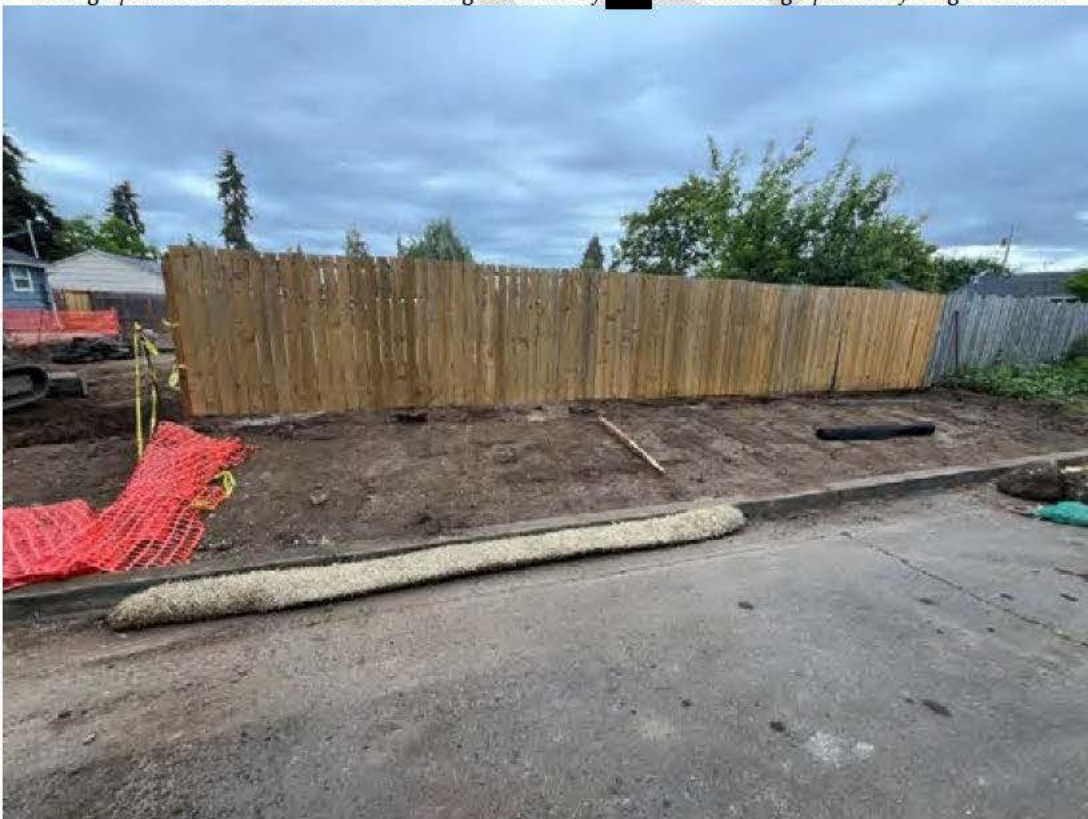
Photograph 9. ROW excavation extents along south side of [REDACTED] Baxter. Photograph taken facing northeast.

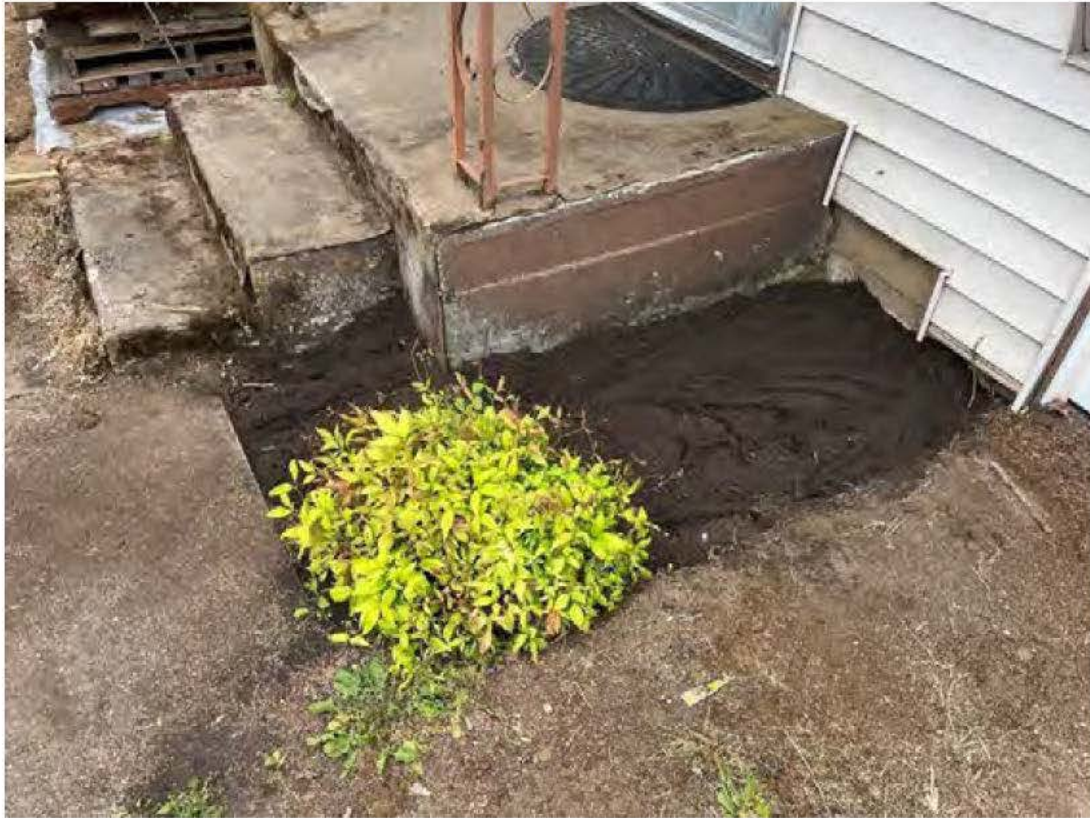
Photograph 10. Topsoil placed and plant saved in area at [REDACTED] Baxter residence front entrance. Photograph taken facing northeast.

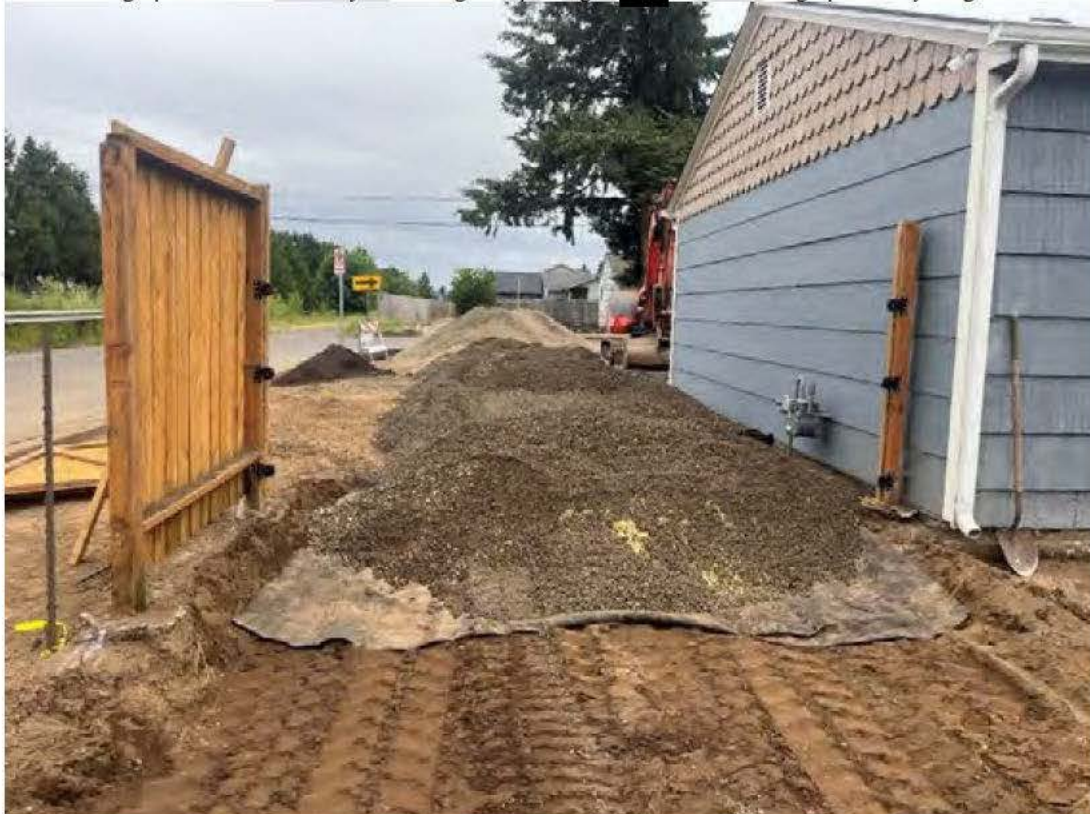
Photograph 11. Demarcation fabric and gravel placing at [REDACTED] Baxter. Photograph taken facing west.

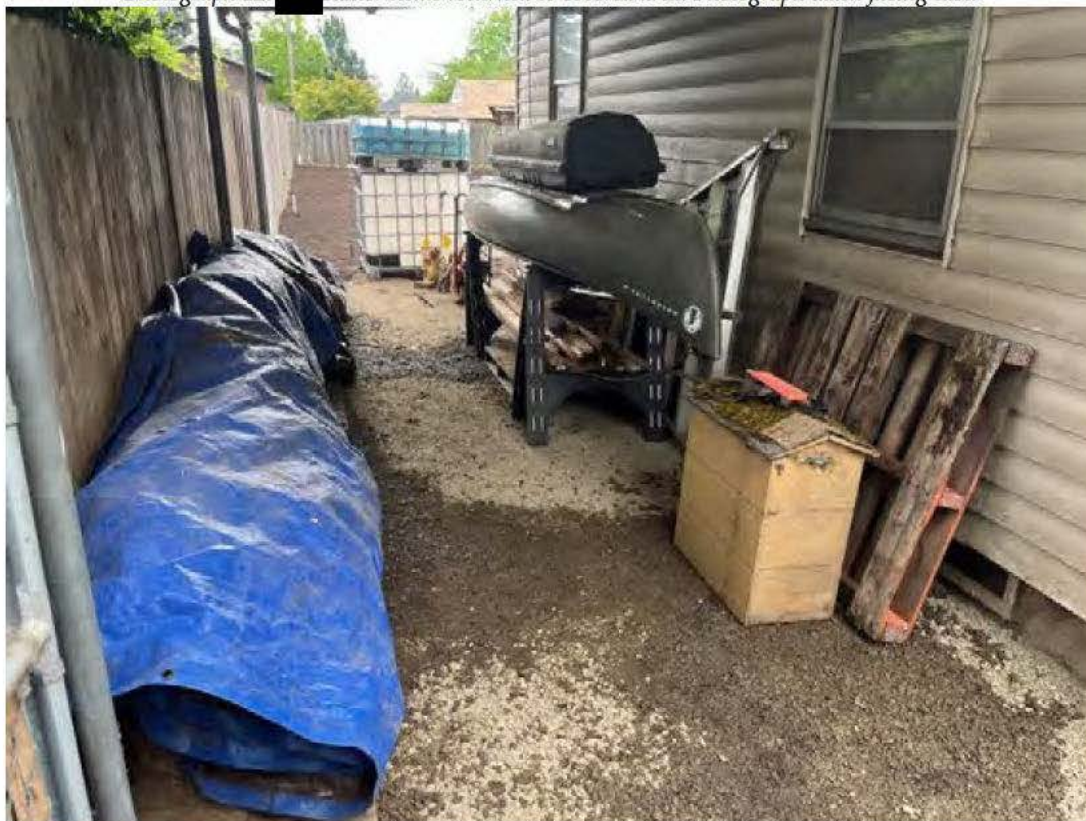
Photograph 12. [REDACTED] Baxter items returned to covered area. Photograph taken facing east.

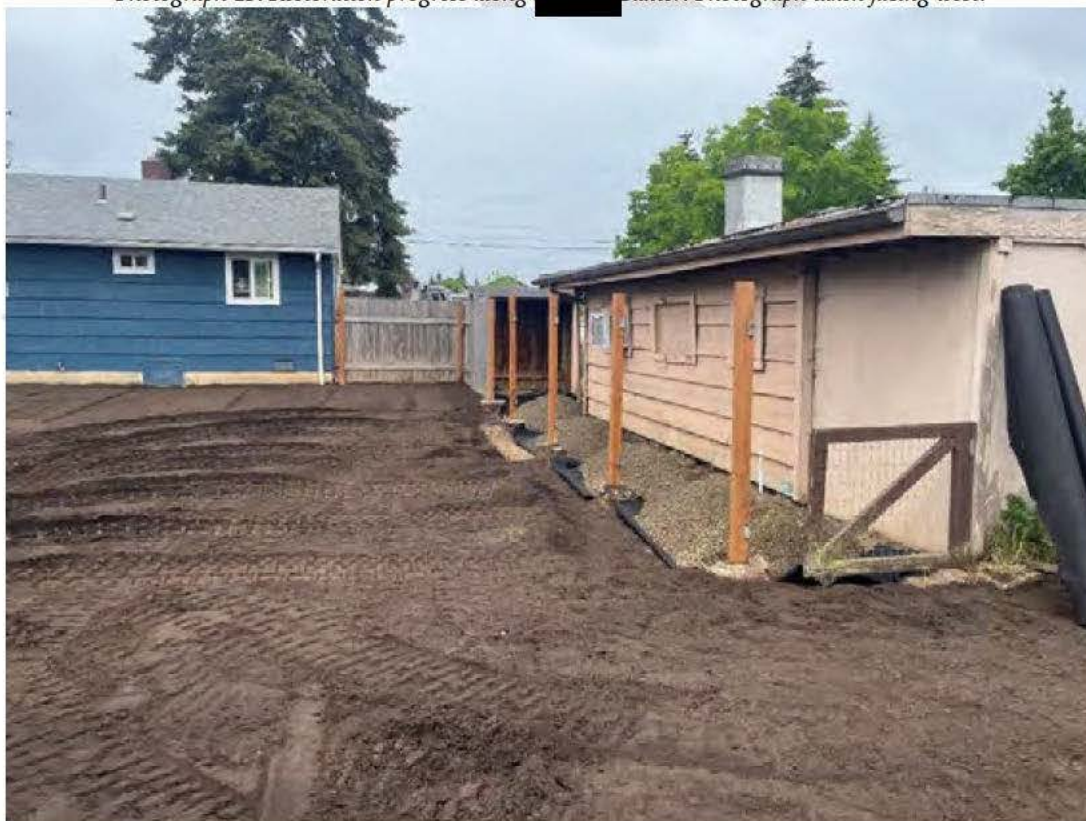
Photograph 15. Restoration progress along [REDACTED] Baxter. Photograph taken facing west.

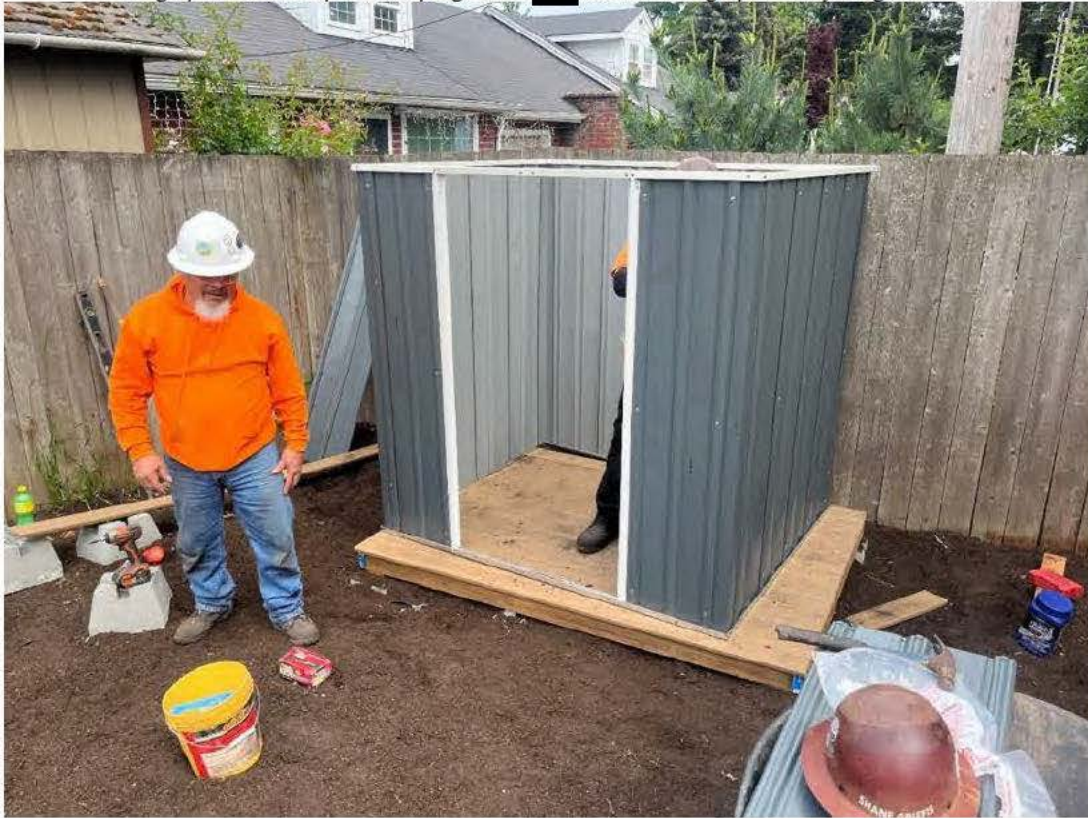
Photograph 16. Shed replacment progress at [REDACTED] Baxter. Photograph taken facing northwest.

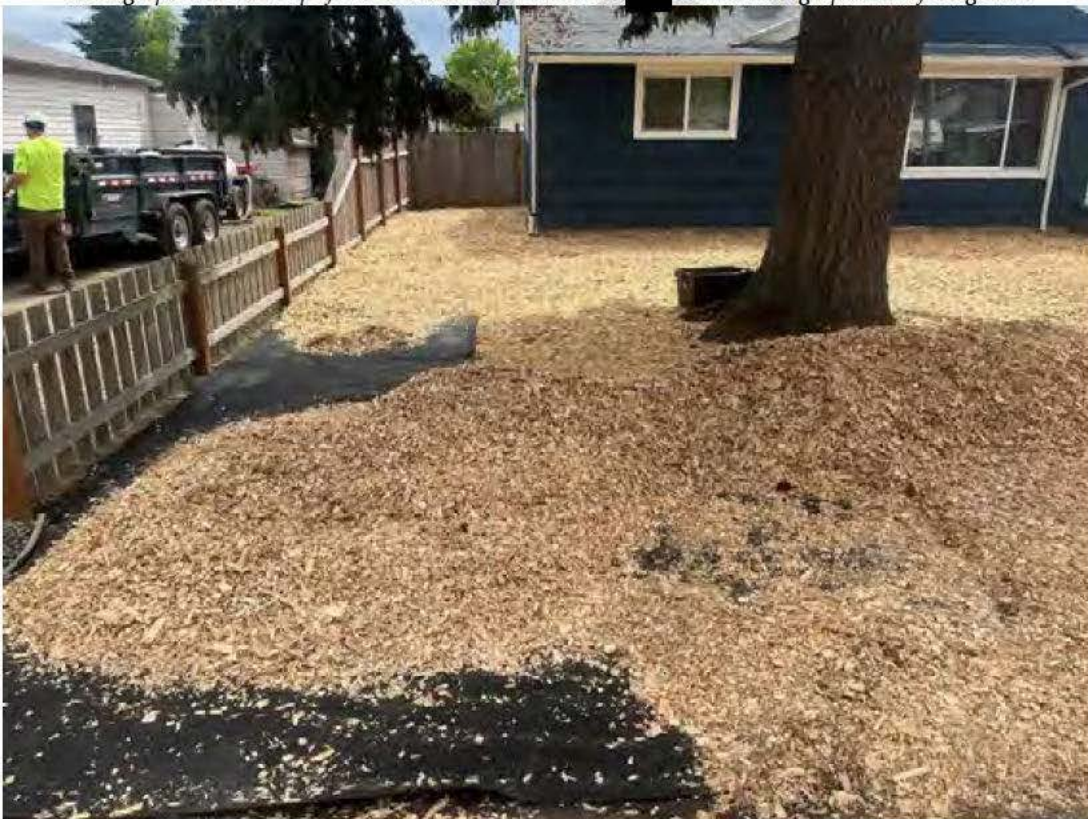
Photograph 17. Landscape fabric and mulch placement at [REDACTED] Baxter. Photograph taken facing east.

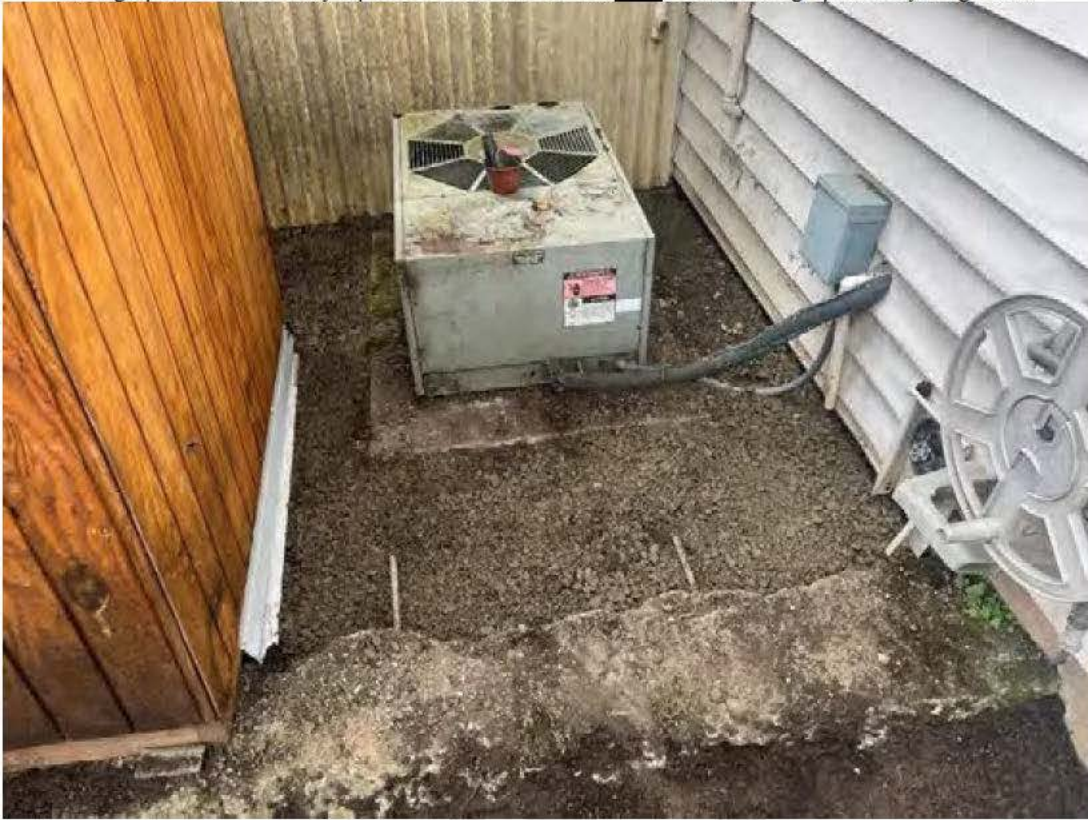
Photograph 18. Gravel backfill placed around AC unit at [REDACTED] Baxter. Photograph taken facing south.

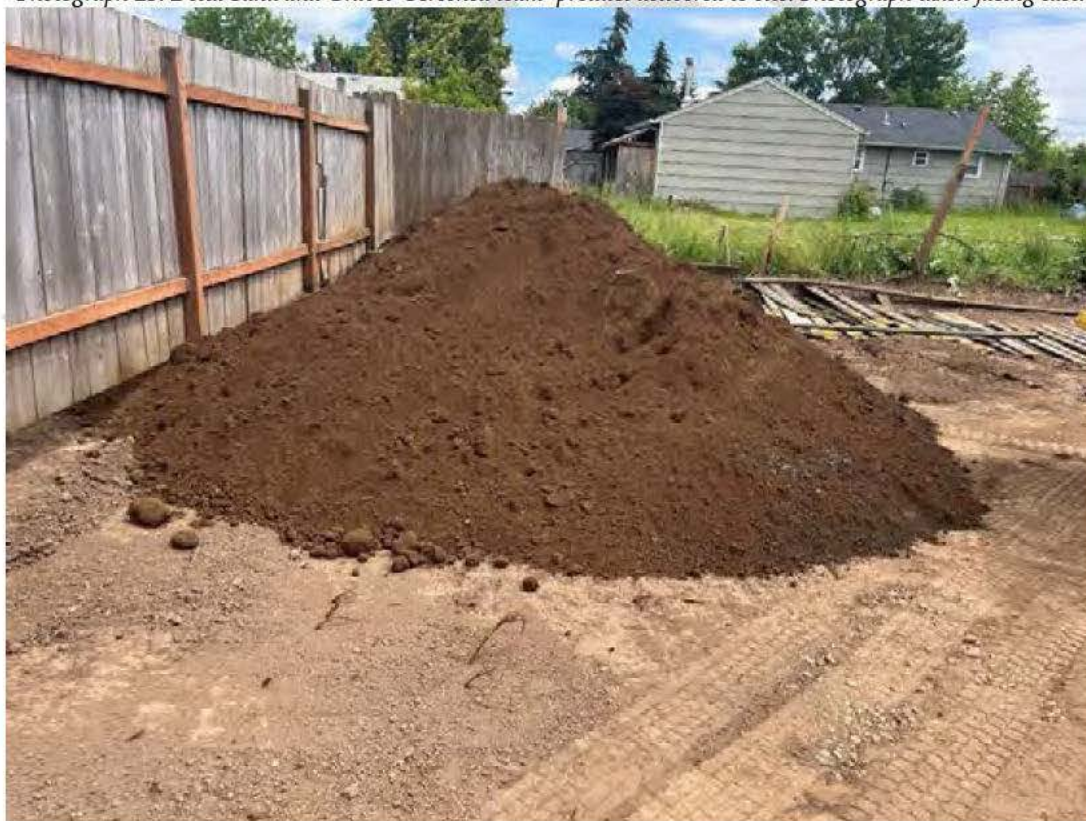
Photograph 24. Removed section of fence from [REDACTED] Alva Park. Photograph taken facing west.

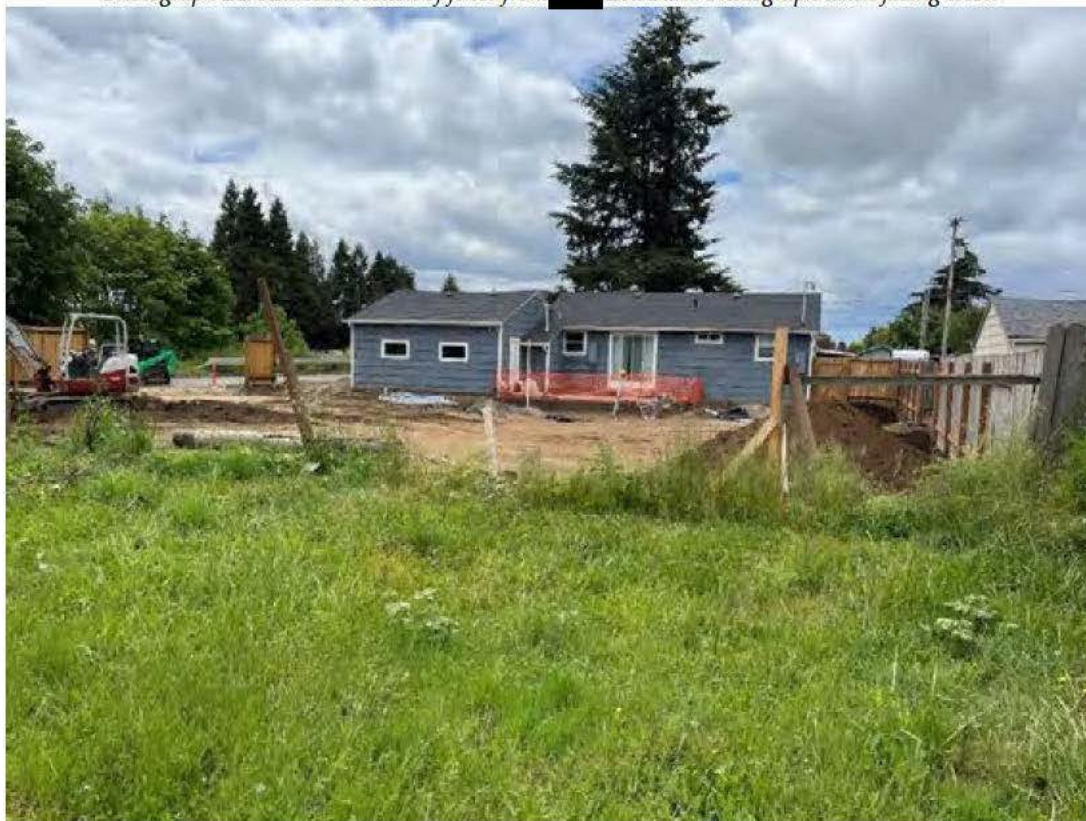
Photograph 25. Manual excavation depth field truthing at [REDACTED] Baxter. Photograph taken facing west.

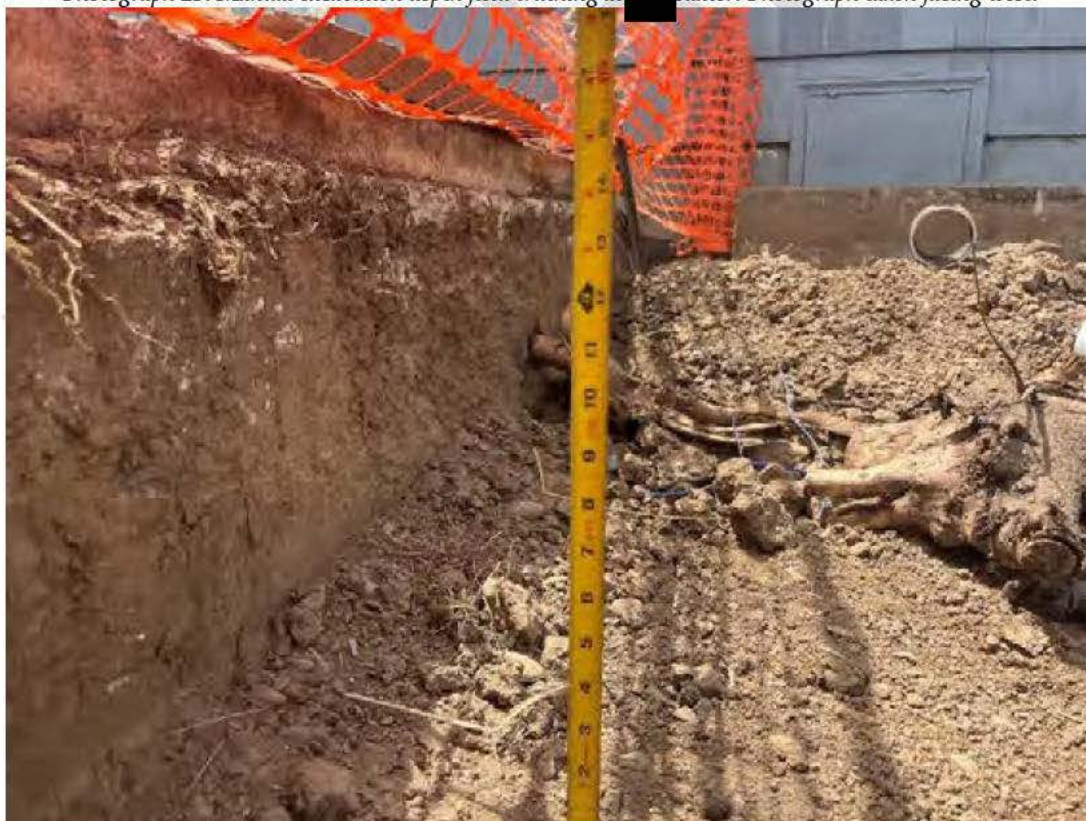
Photograph 26. Manual excavation depth field truthing at [REDACTED] Baxter. Photograph taken facing south.

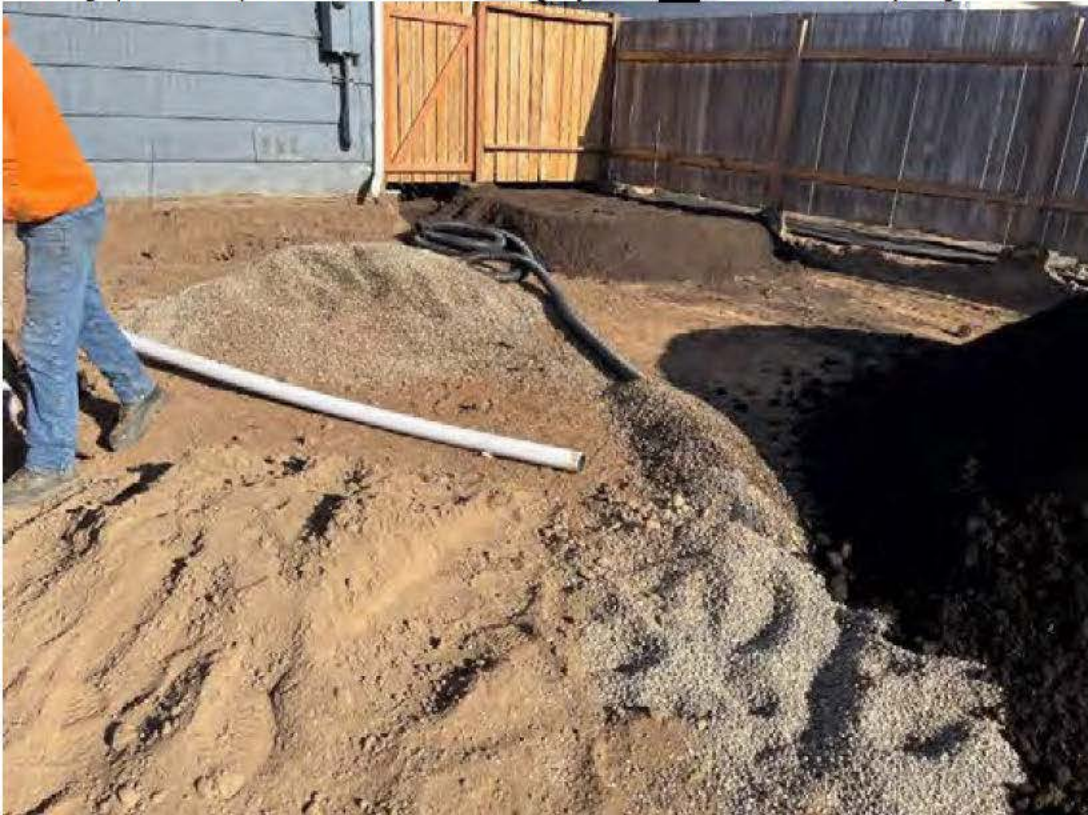
Photograph 7. Covering perforated section of drain line with pea gravel at [REDACTED] Baxter. Photo taken facing southeast.

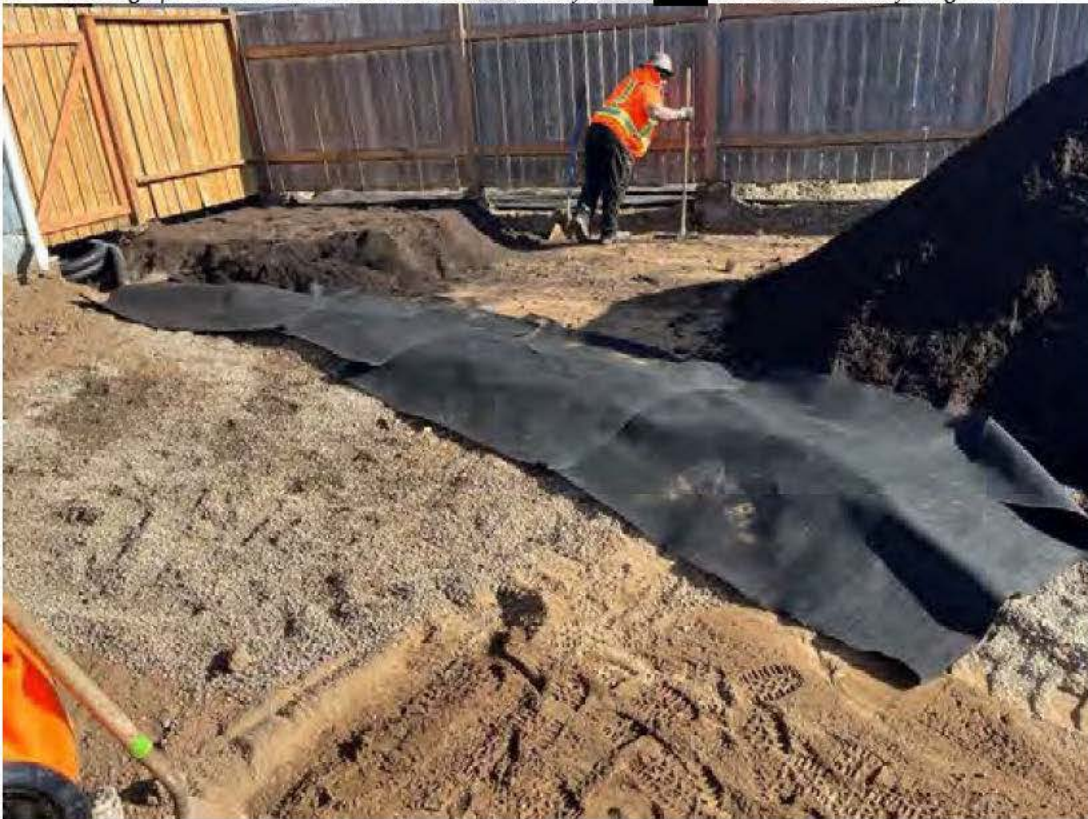
Photograph 9. 3 Kings placing demarcation fabric within greenhouse at [REDACTED] Baxter. Photo taken facing east.

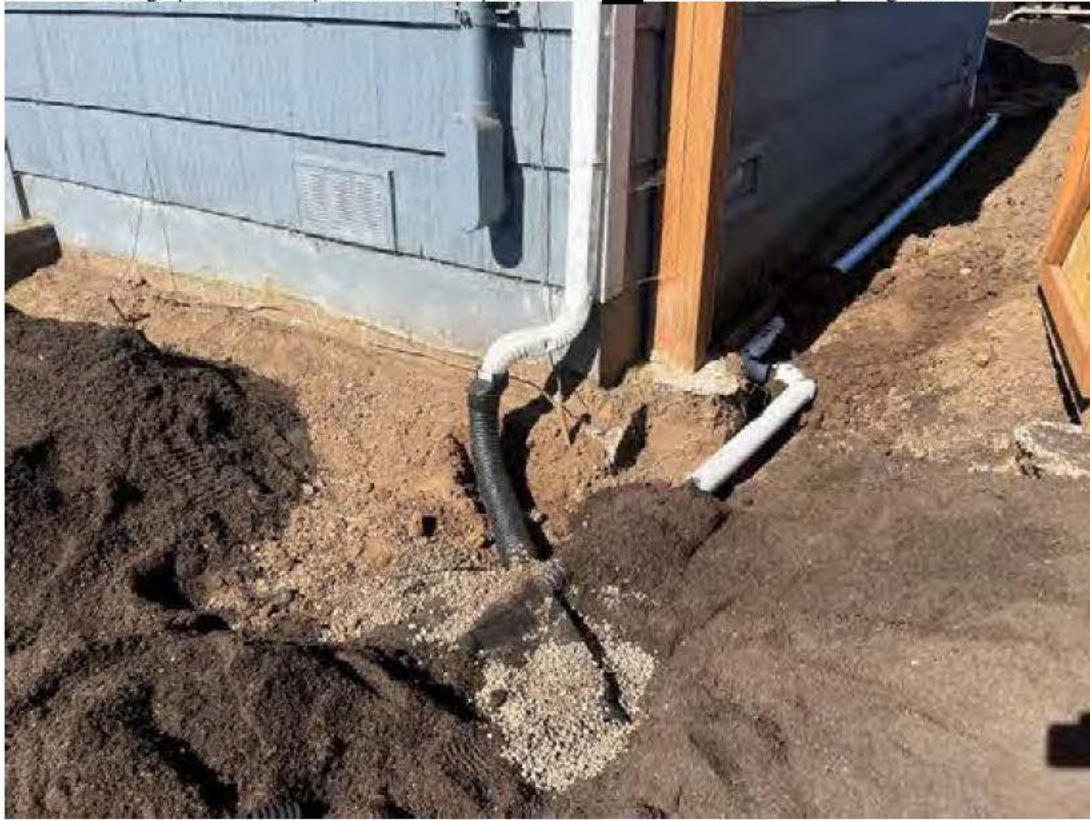
Photograph 12. Additional gravel placed along strip at [REDACTED] Baxter. Photo taken facing west.

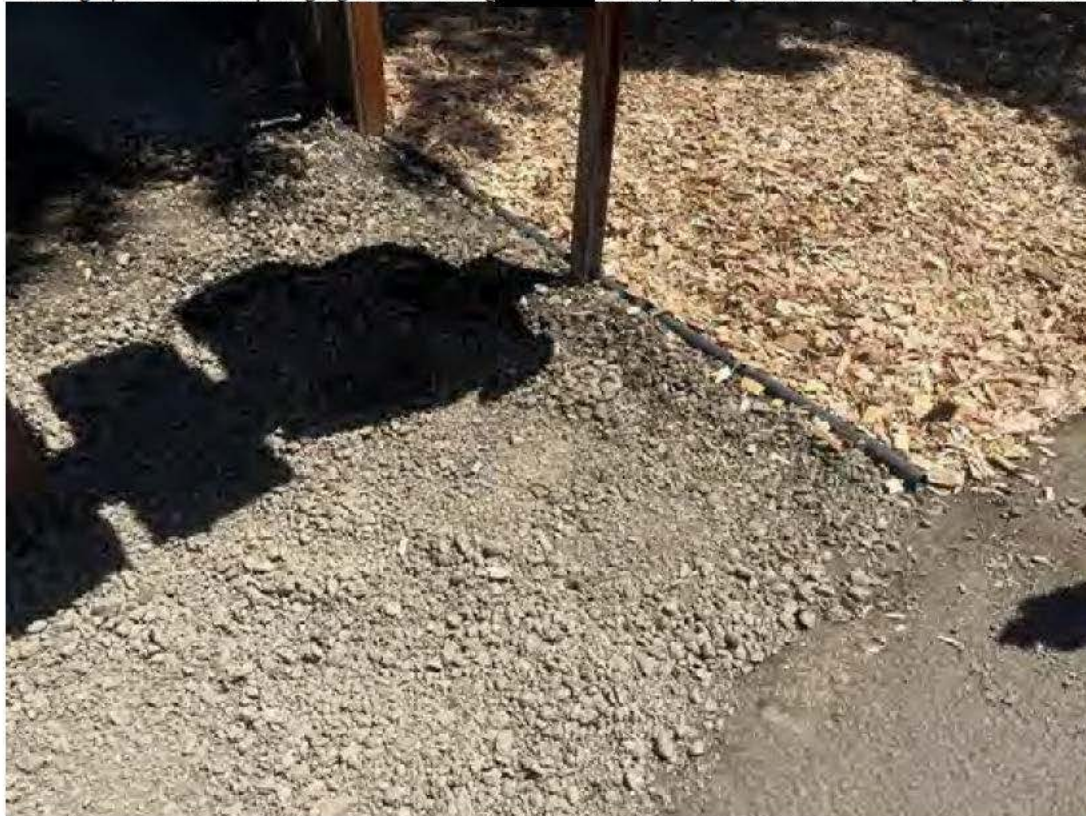
Photograph 20. 3 Kings performing follow up excavation along [REDACTED] Baxter fence line. Photo taken facing east.

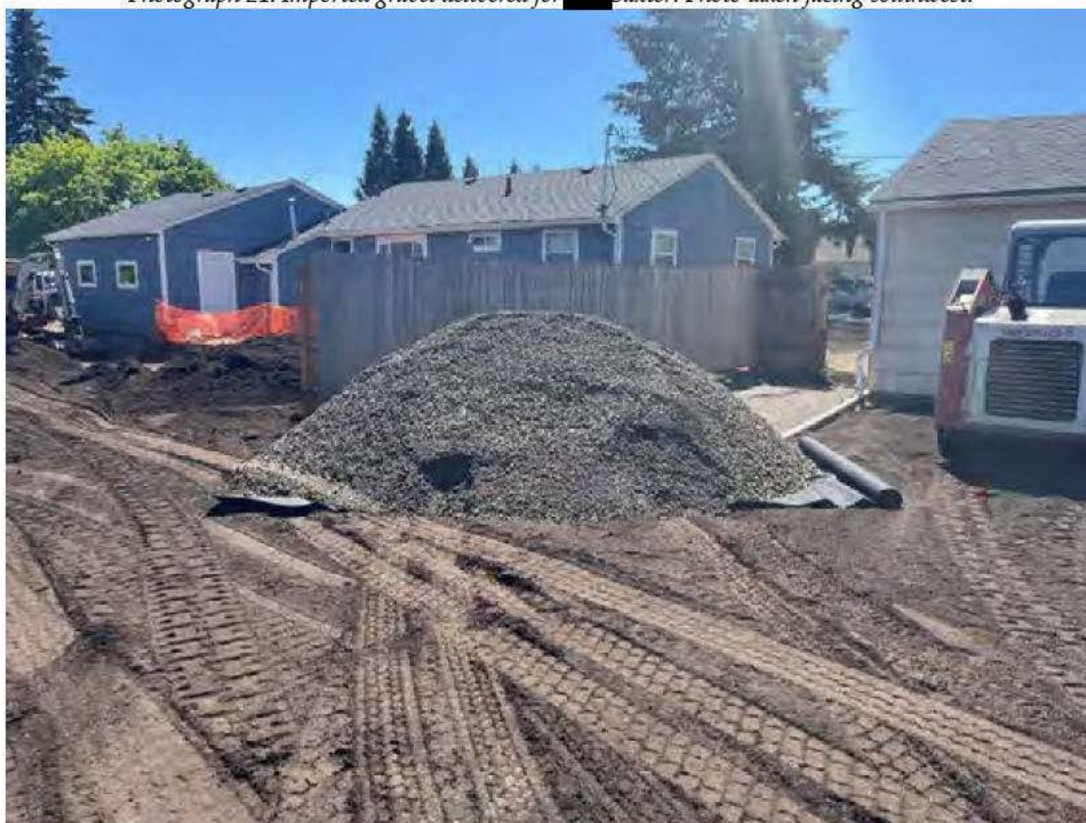
Photograph 22. Fence repair progress at [REDACTED] Baxter. Photo taken facing east.

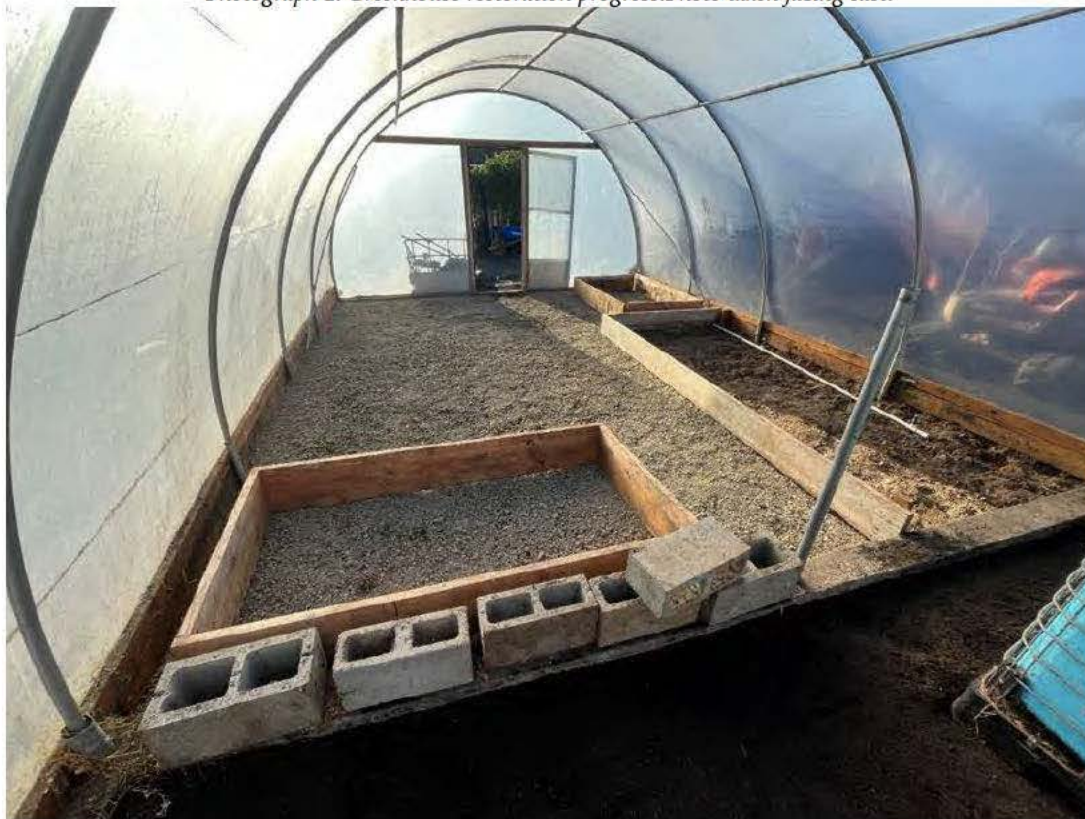
Photograph 2. Downspout drain line repair at [REDACTED] Baxter. Photo taken facing northwest.

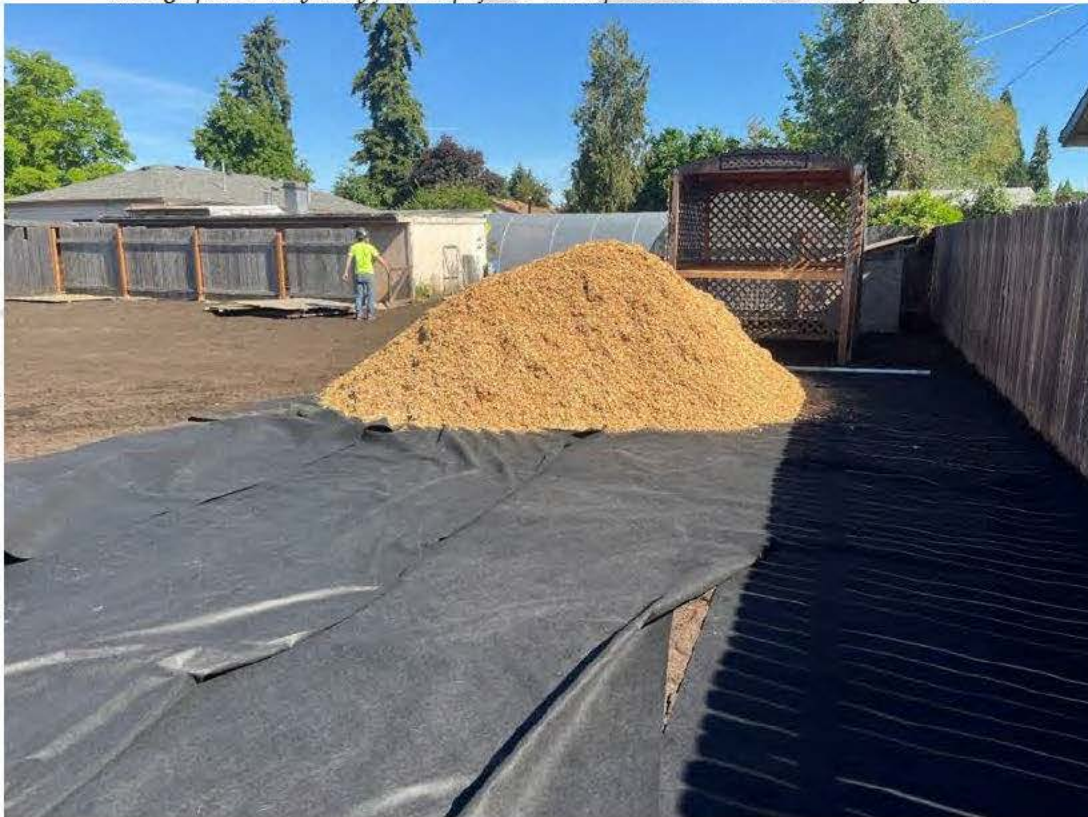
Photograph 11. Pea gravel returned to aquaponic system totes in greenhouse. Photo taken facing northwest.

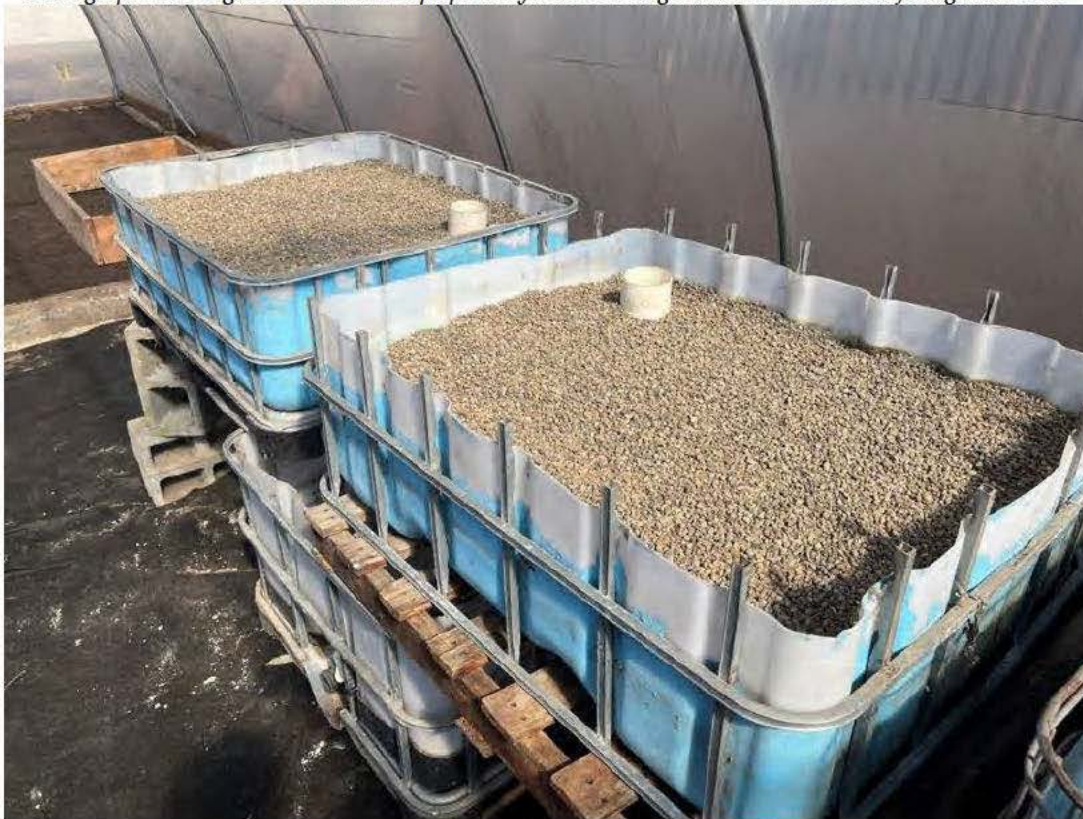
Photograph 12. Fence repair progress at [REDACTED] Baxter. Photo taken facing south.

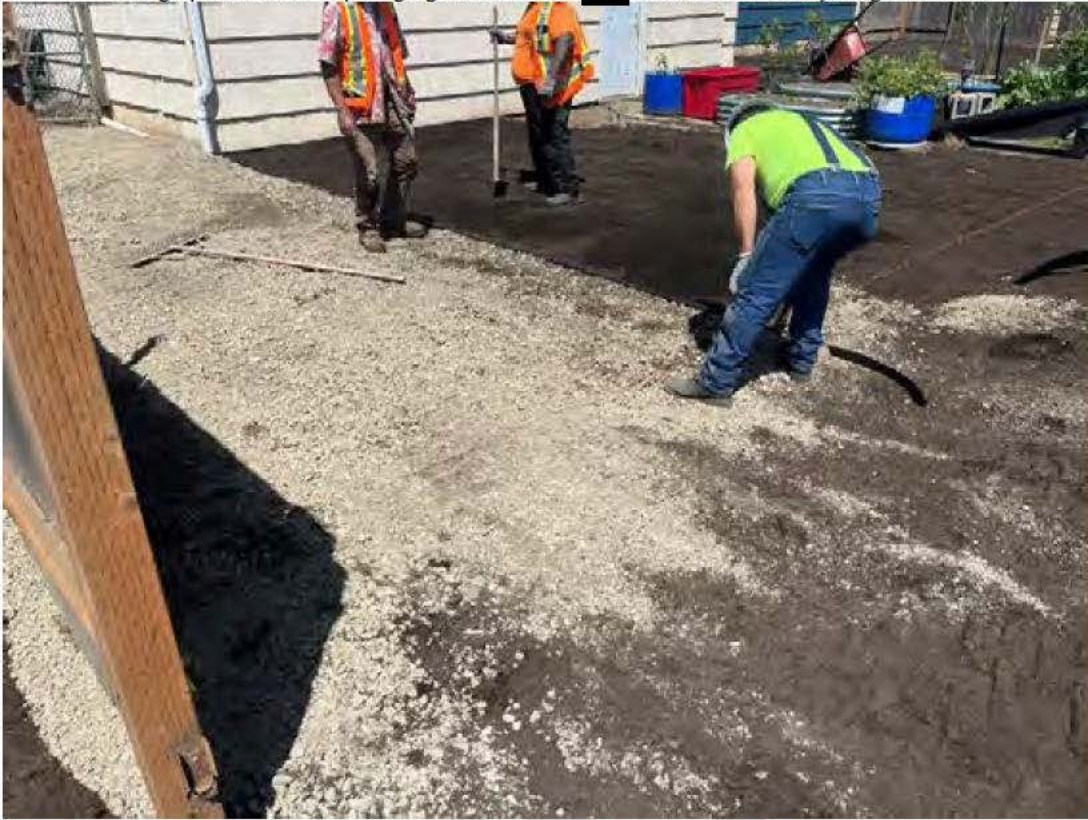
Photograph 16. Gravel surface touched up in front yard of [REDACTED] Baxter. Photo taken facing east.
