APPENDIX B

Daily Field Reports Continued

Phase II RA

OFFSITE REMOVAL ACTION - DAILY FIELD REPORT
JH BAXTER OFFSITE REMEDIAL ACTION
EUGENE, OREGON

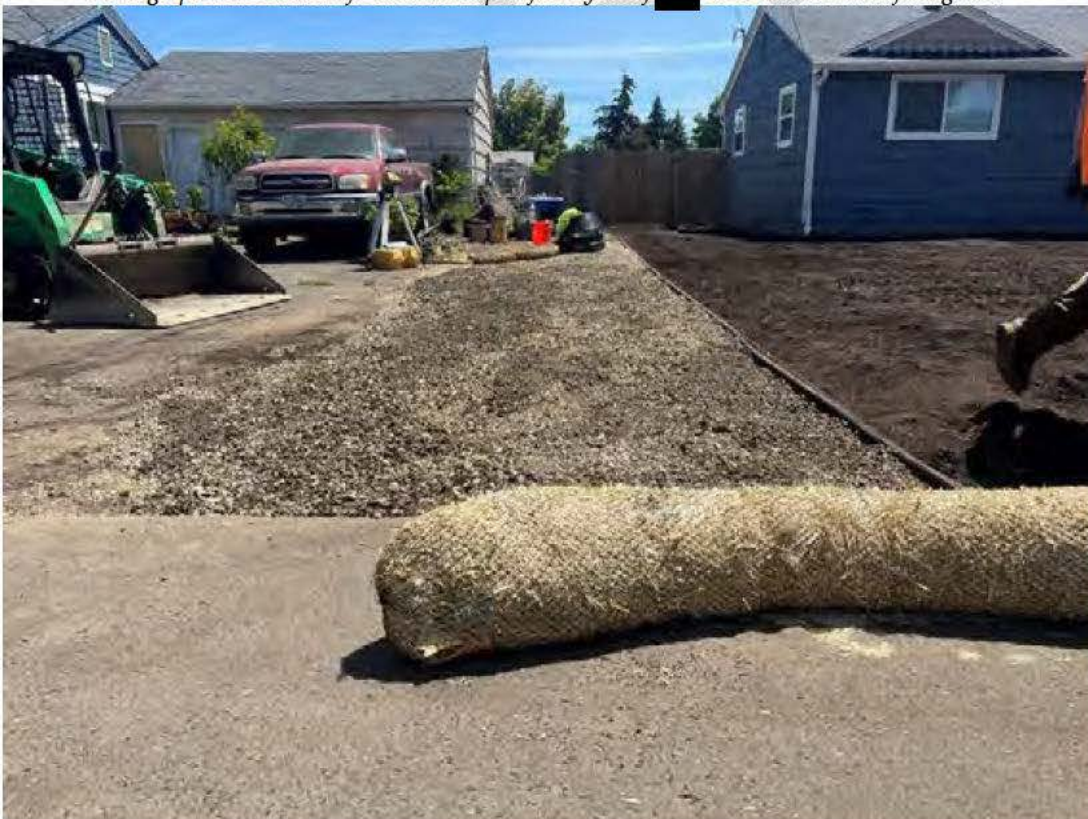
Photograph 17. Surface restoration progress at [REDACTED] Baxter. Photo taken facing southeast.

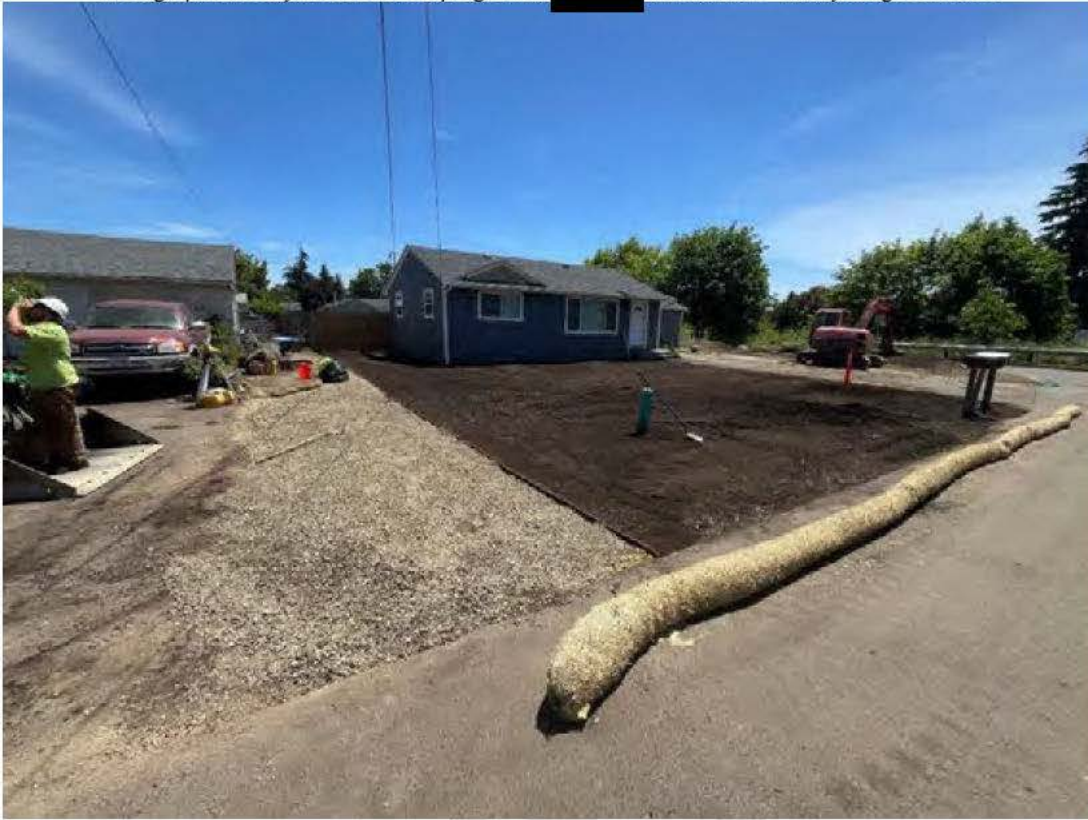
Photograph 18. Gravel pad installation progress at [REDACTED] Baxter. Photo taken facing south.

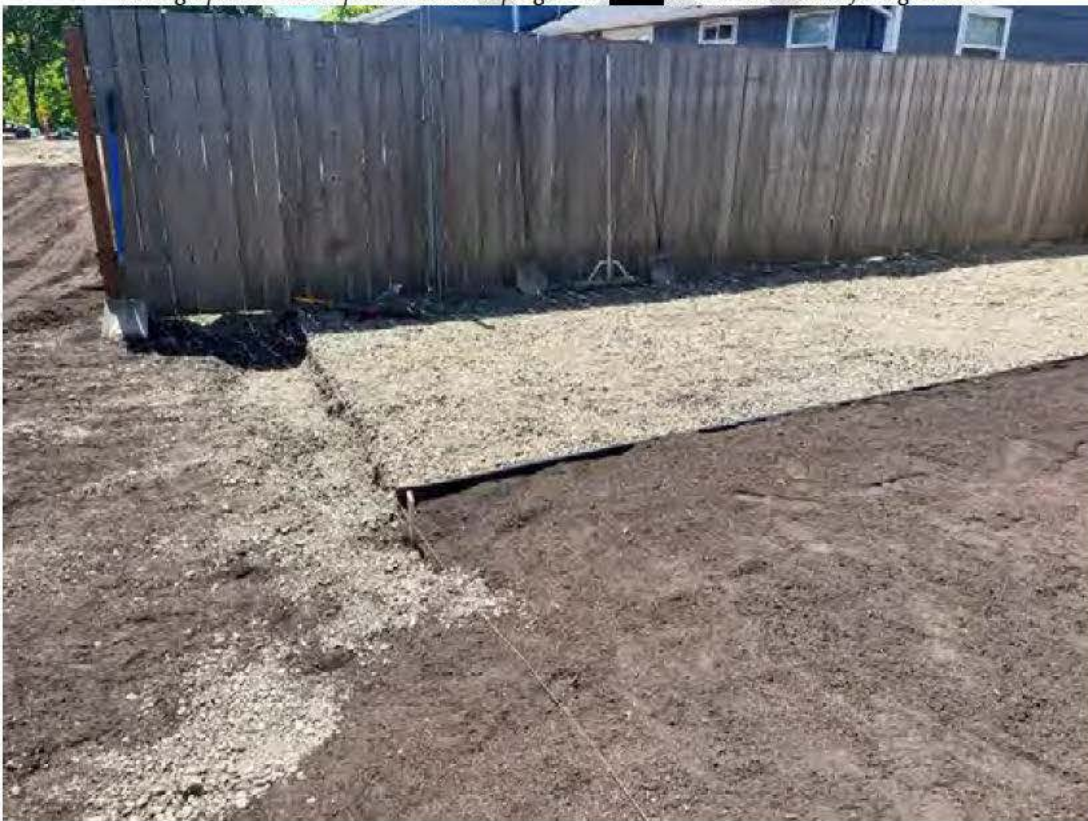
Photograph 19. Gravel pad installed at Baxter. Photo taken facing west.

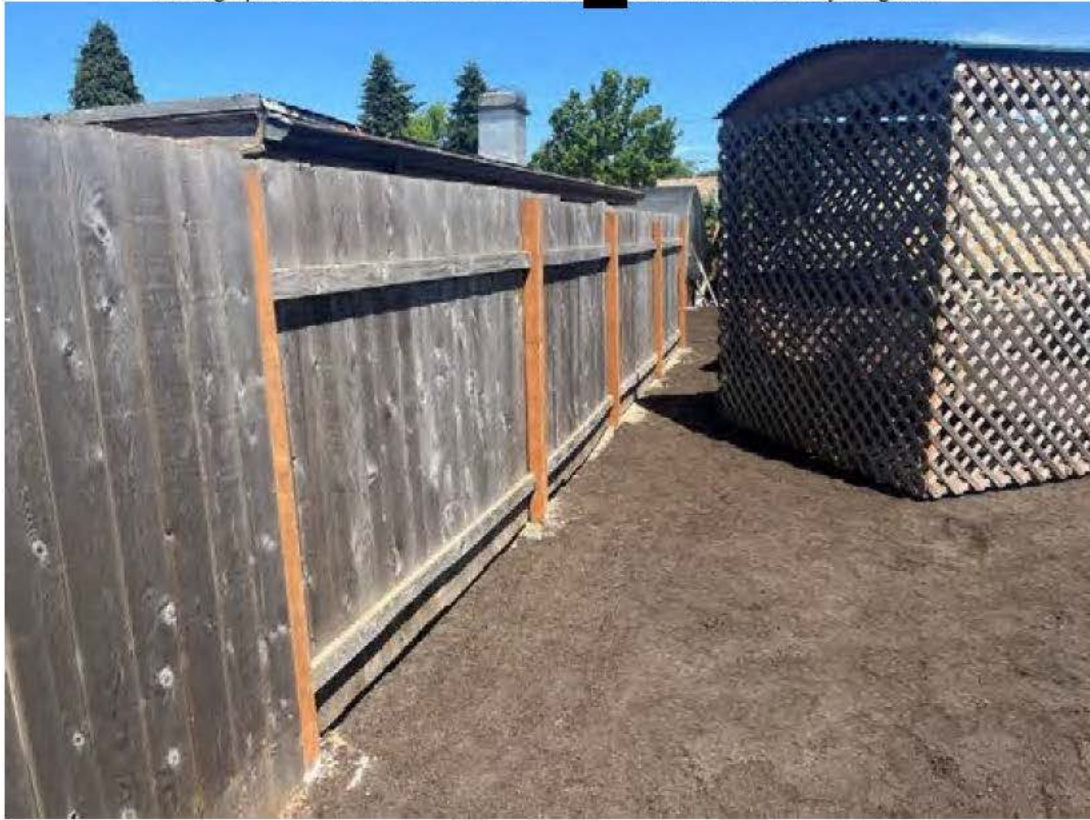
Photograph 24. 3 Kings reinstalling double-wide gate at [REDACTED] Baxter. Photo taken facing northeast.

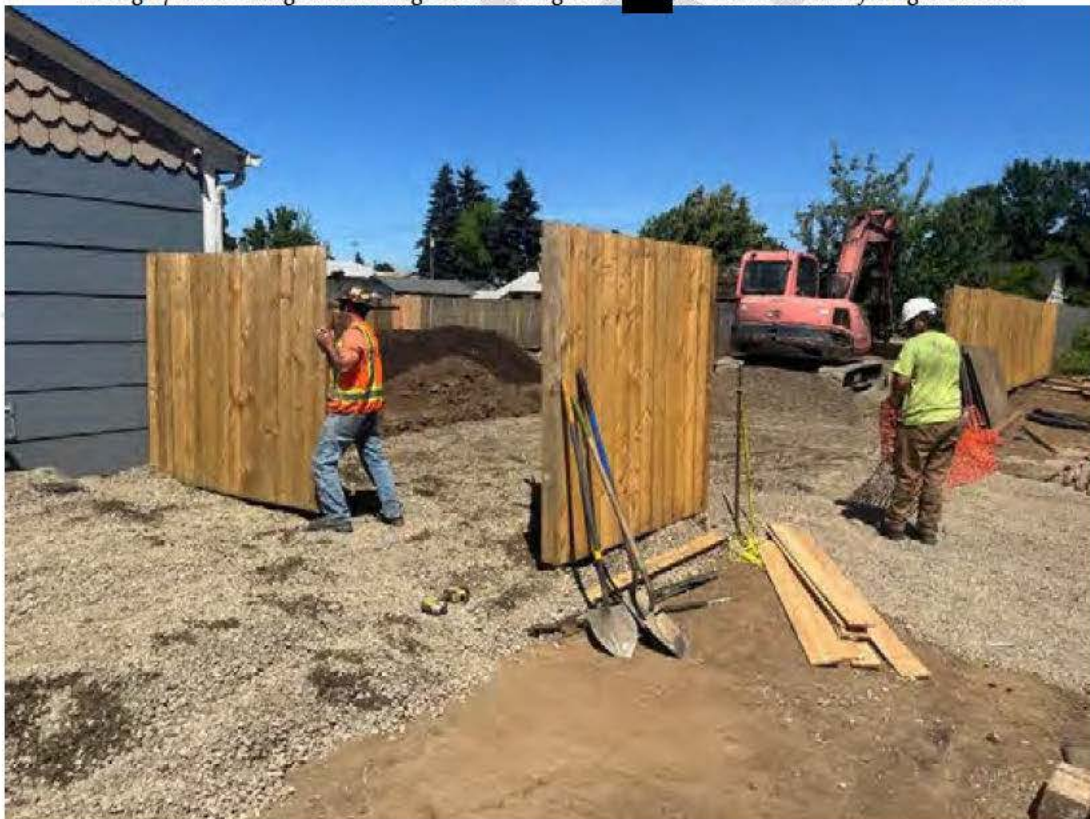
Photograph 25. Site security installed at [REDACTED] Baxter. Photo taken facing north.

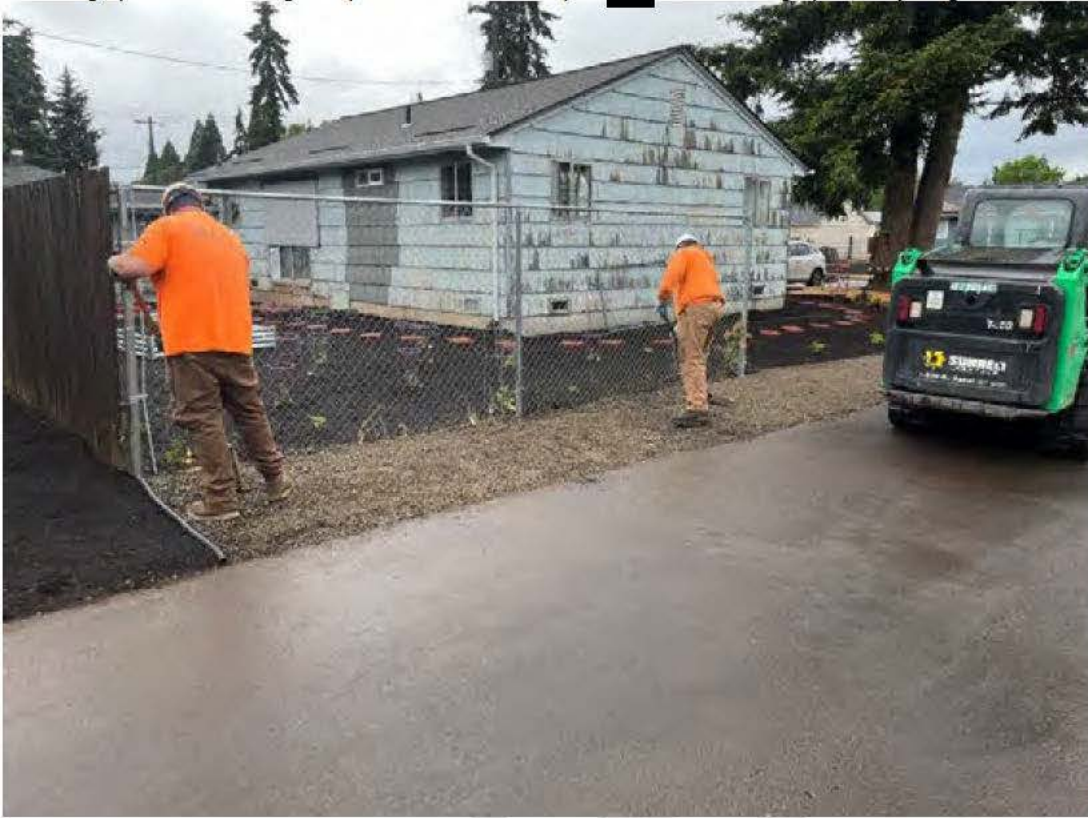
Photograph 1. Additional gravel placement and clean up at [REDACTED] Baxter. Photograph taken facing northeast.

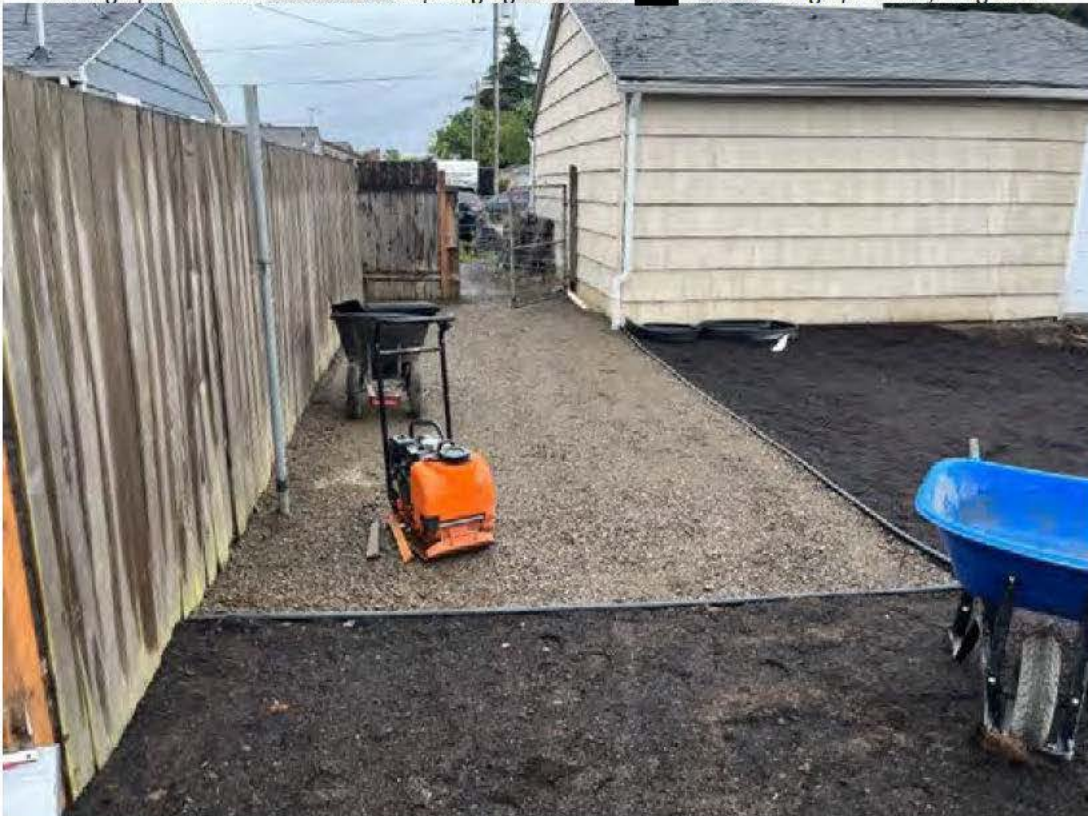
Photograph 2. Gravel area and landscape edging installed at [REDACTED] Baxter. Photograph taken facing west.

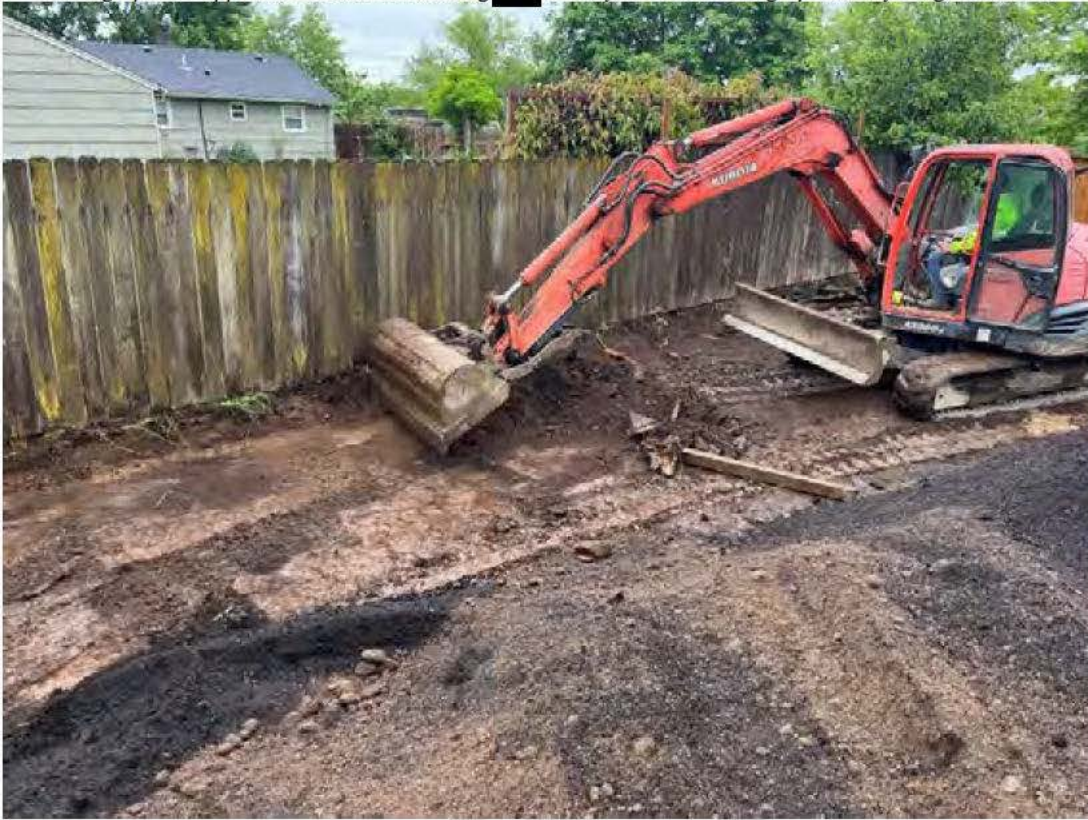
0725 - 3 Kings using excavator to perform follow up excavations along eastern fence line of [REDACTED] Baxter to remove residual contaminated soil left in place due to limited access prior to fence repair. GSI observed that 3 Kings did not appear to be fully meeting required 12-inch excavation depth while removing soil along the property line and asked operator to follow up with some additional soil removal to ensure required grades were met. 3 Kings also to remove some additional material around walnut tree remnants observed in the northeast corner of [REDACTED] Baxter (tree formerly located in southeast corner of [REDACTED] Baxter).

Photograph 3. Supplemental excavation along [REDACTED] Baxter fence line. Photograph taken facing southeast.

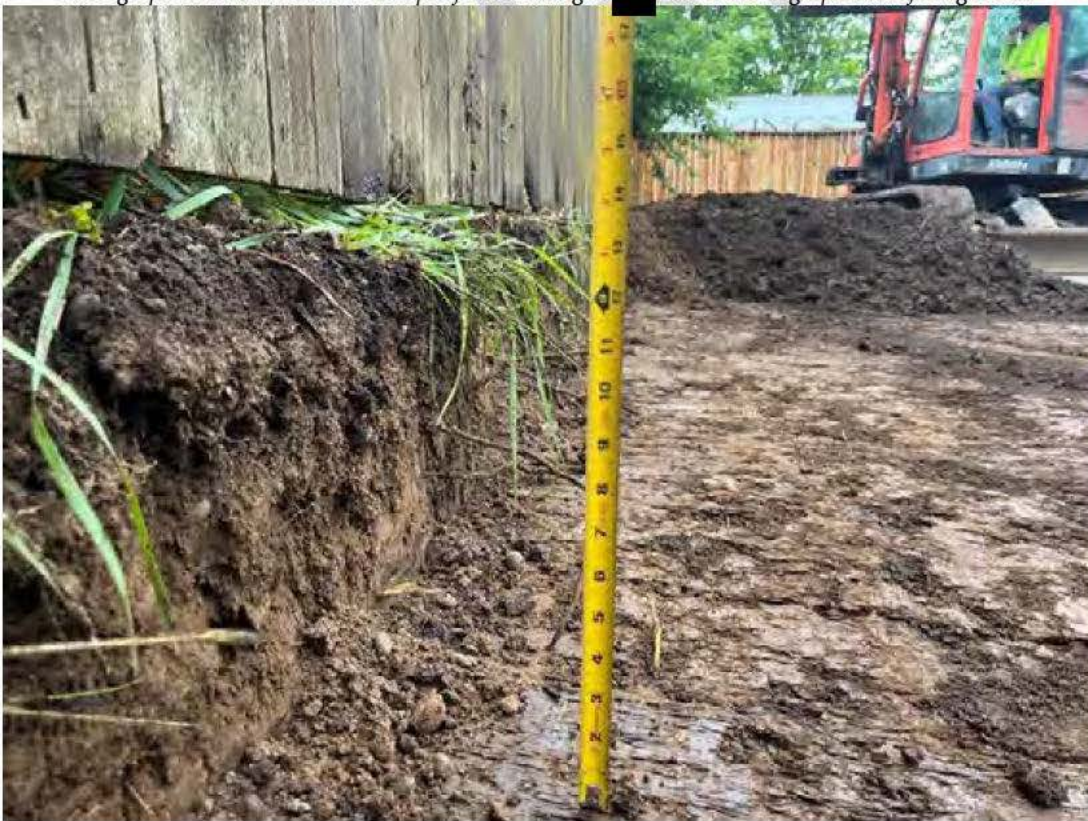
Photograph 4. Manual excavation depth field truthing at [REDACTED] Baxter. Photograph taken facing south.

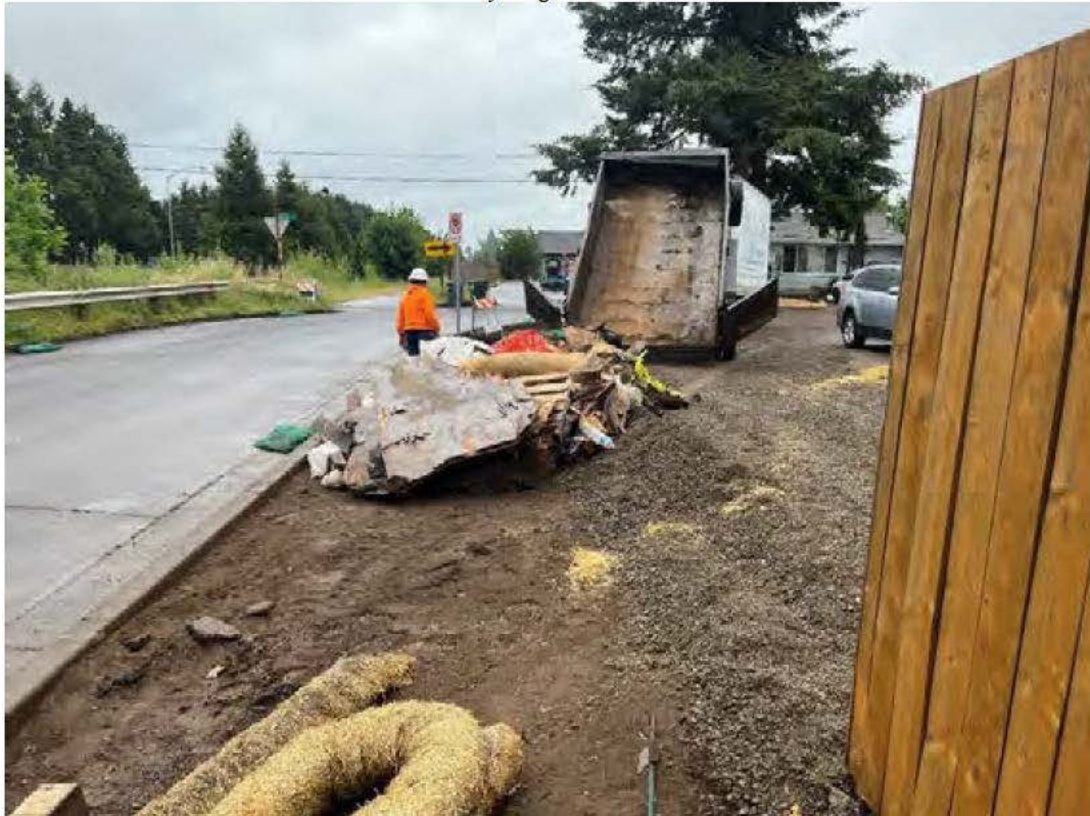
0745 – GSI observed that 3 Kings had dumped out job trailer contents including some excavated soil from [REDACTED] Baxter and miscellaneous refuse onto the ROW/south side of [REDACTED] Baxter. 3 Kings intending to transfer this material to haul truck for transport to the landfill. GSI indicated to 3 Kings operators that they would now need to over excavate some of the underlying soil and/or gravel beneath the material dumped here to eliminate potential cross contamination from impacted soils being placed on clean leave surfaces. 3 Kings indicated they were aware of this and would remove extra material as needed when loading the soil/debris into the haul truck.

Photograph 5. Miscellaneous refuse and some contaminated soil temporarily dumped at [REDACTED] Baxter. Photograph taken facing west.

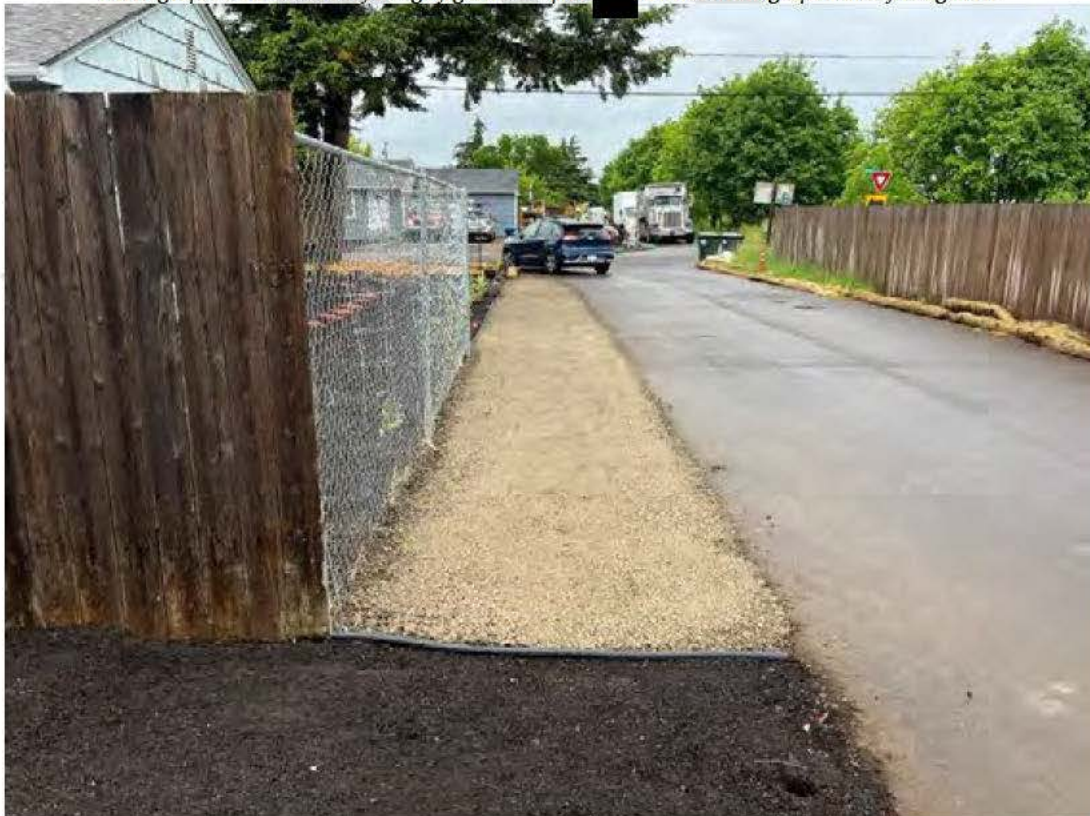
Photograph 6. Finished surfacing of gravel strip at [REDACTED] Baxter. Photograph taken facing east.

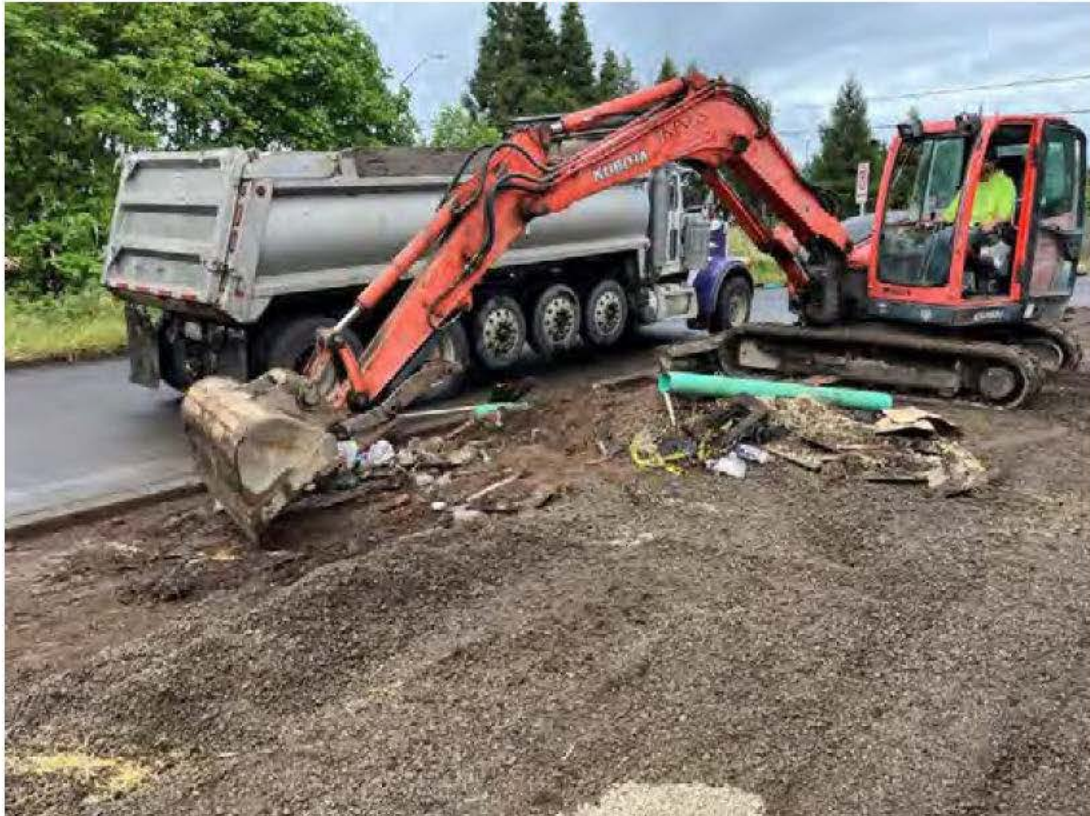
Photograph 7. 3 Kings cleaning up soil and refuse temporarily dumped at [REDACTED] Baxter. Photograph taken facing southwest.

0805 – 3 Kings loading dumped soil from job trail and construction related refuse into haul truck. GSI observed 3 Kings using excavator and hand tools to slightly over dig around the footprint of where this material was placed to ensure residual impacted soil temporarily placed here was fully removed.

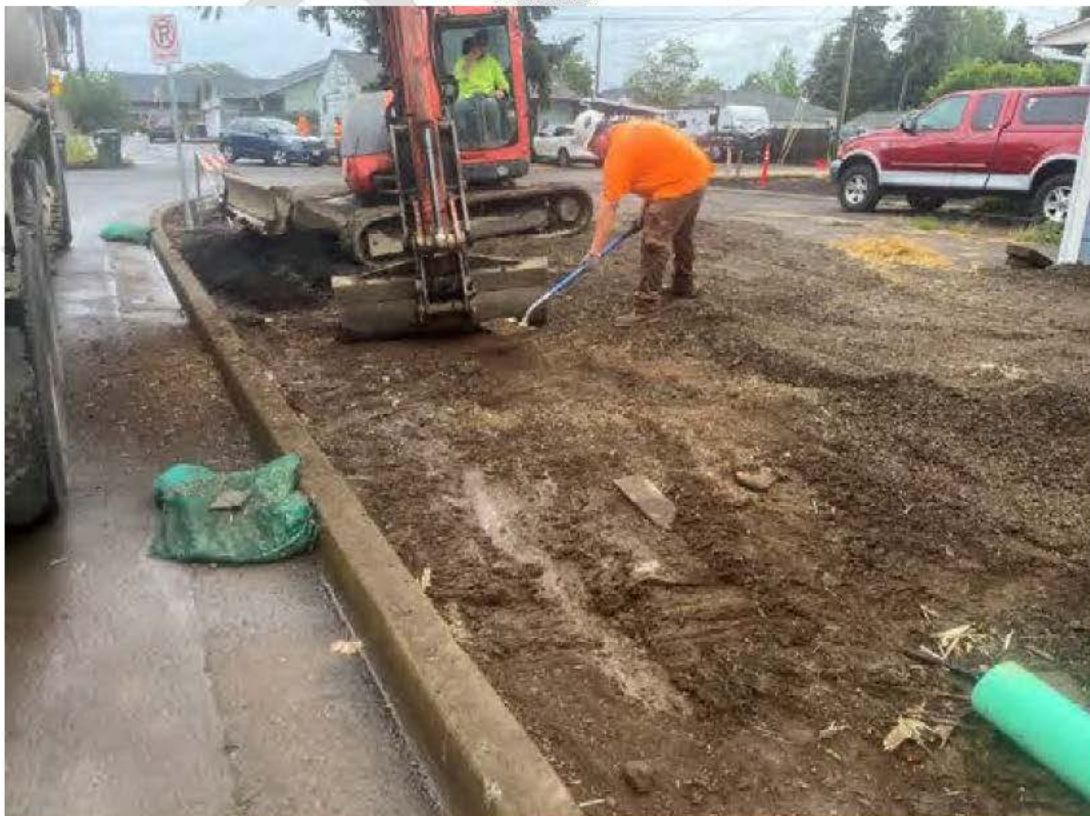
Photograph 8. 3 Kings slightly over digging where refuse and soil were dumped at [REDACTED] Baxter. Photograph taken facing northwest.

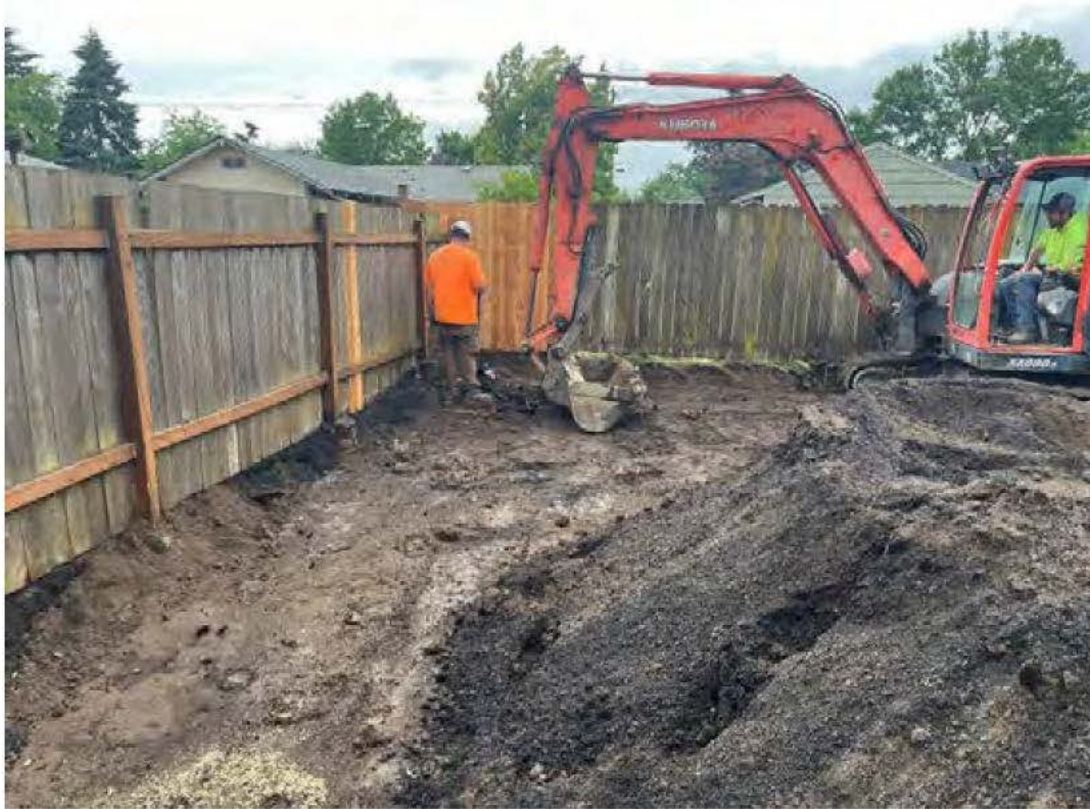
Photograph 9. 3 Kings removing additional soil from walnut stump remnants in northeast corner of [REDACTED] Baxter.
Photograph taken facing east.

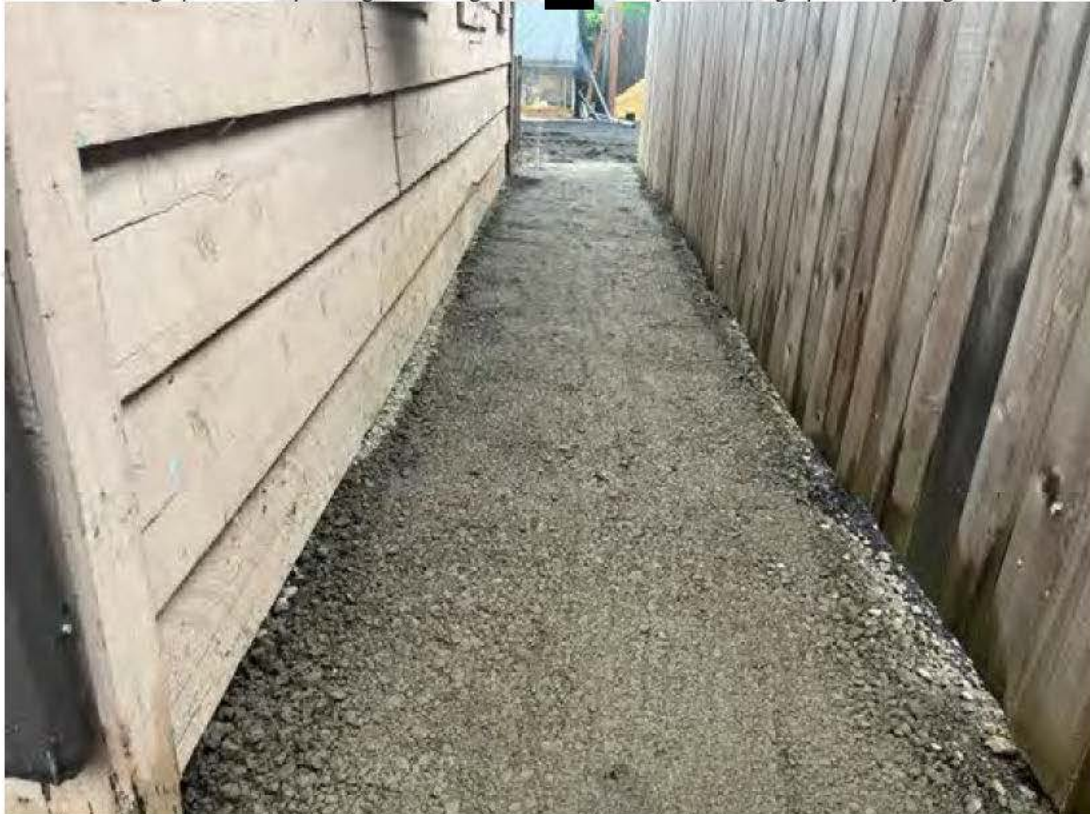
Photograph 10. Compacted gravel along south [REDACTED] Baxter fence. Photograph taken facing east.

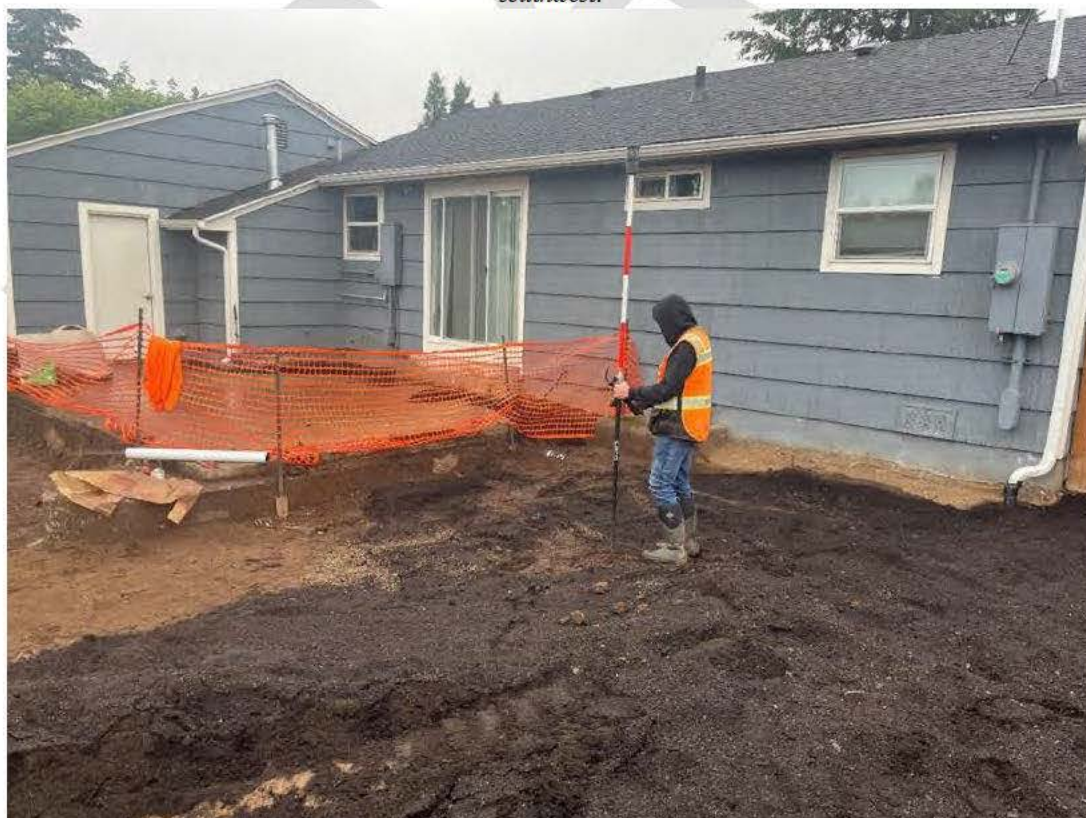
Photograph 12. Surveyor checking excavation grade to north of back porch at [REDACTED] Baxter. Photograph taken facing southwest.

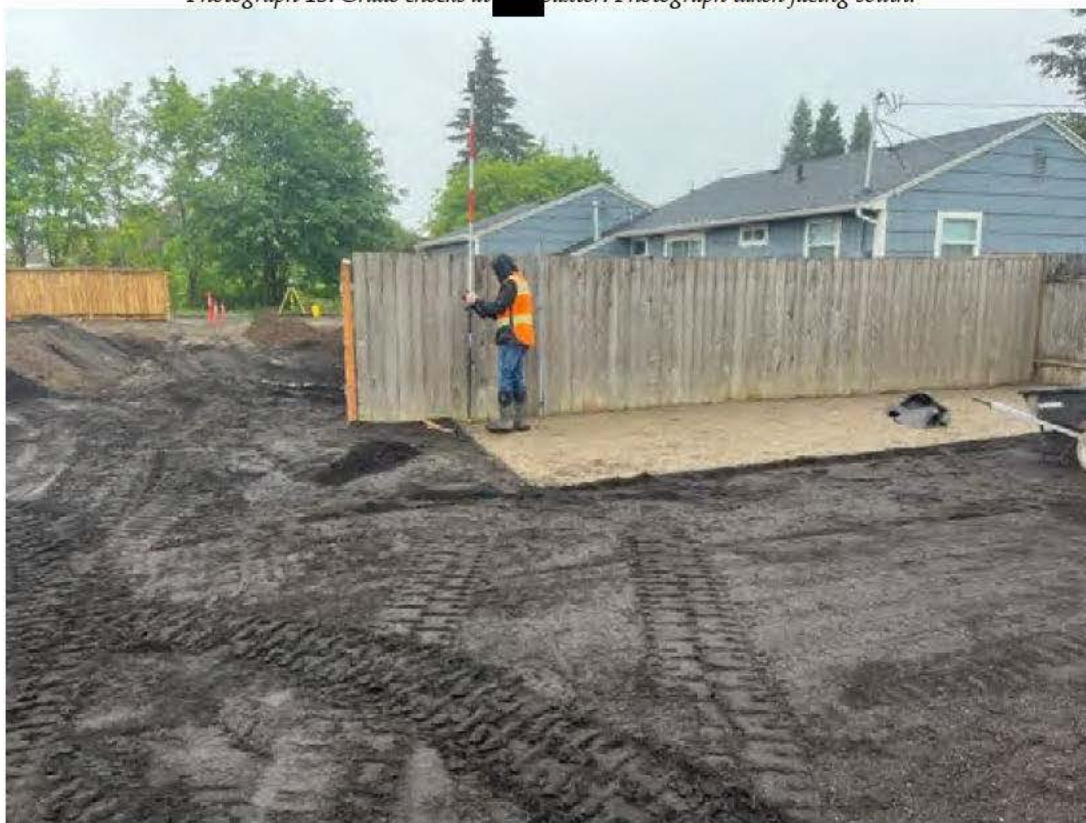
1015 – Minister & Glaeser marking out some areas that were backfilled approximately four tenths of a foot too low relative to required backfill grades within the backyard of [REDACTED] Baxter. GSI/3 Kings discussed how to approach regrading this area. GSI recommended referencing concrete slab elevation (or just above) within the back yard of the property and trying to grade out areas relatively flat to this approximate elevation to help fill in low points, ensure that required restoration elevations are generally met, and provide a level restoration surface for the residents.

Photograph 13. Grade checks at [REDACTED] Baxter. Photograph taken facing south.

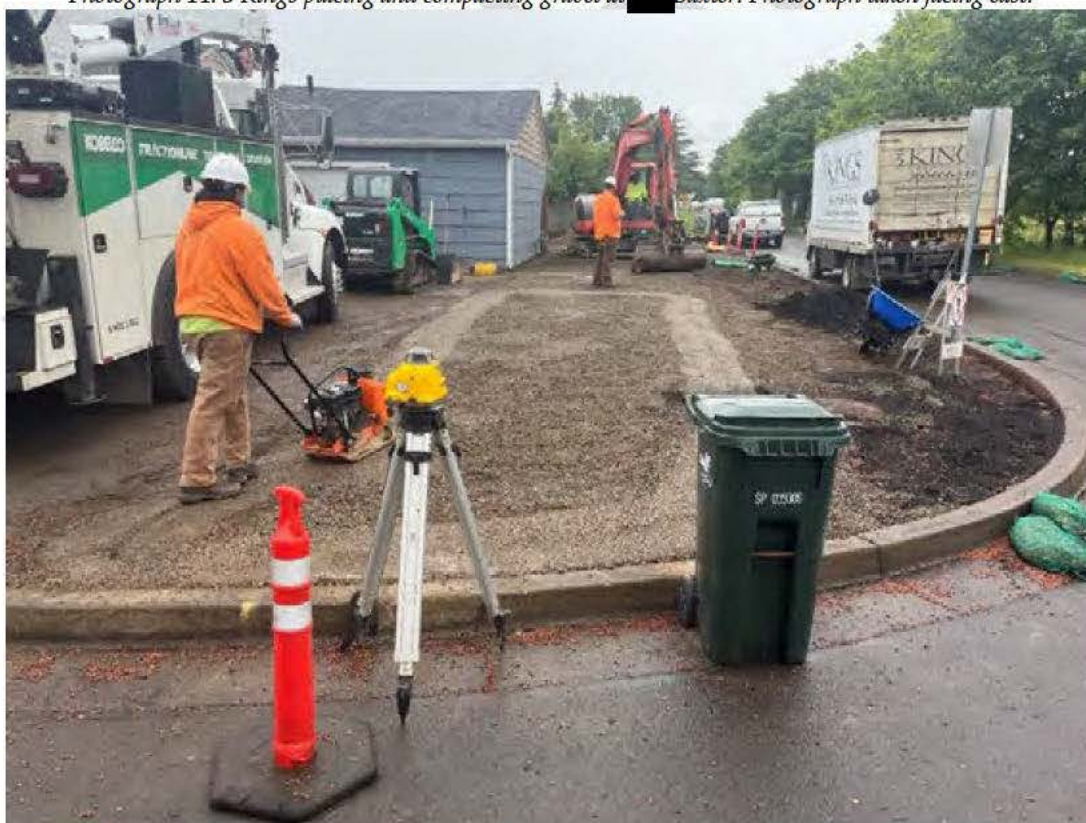
Photograph 14. 3 Kings placing and compacting gravel at [REDACTED] Baxter. Photograph taken facing east.

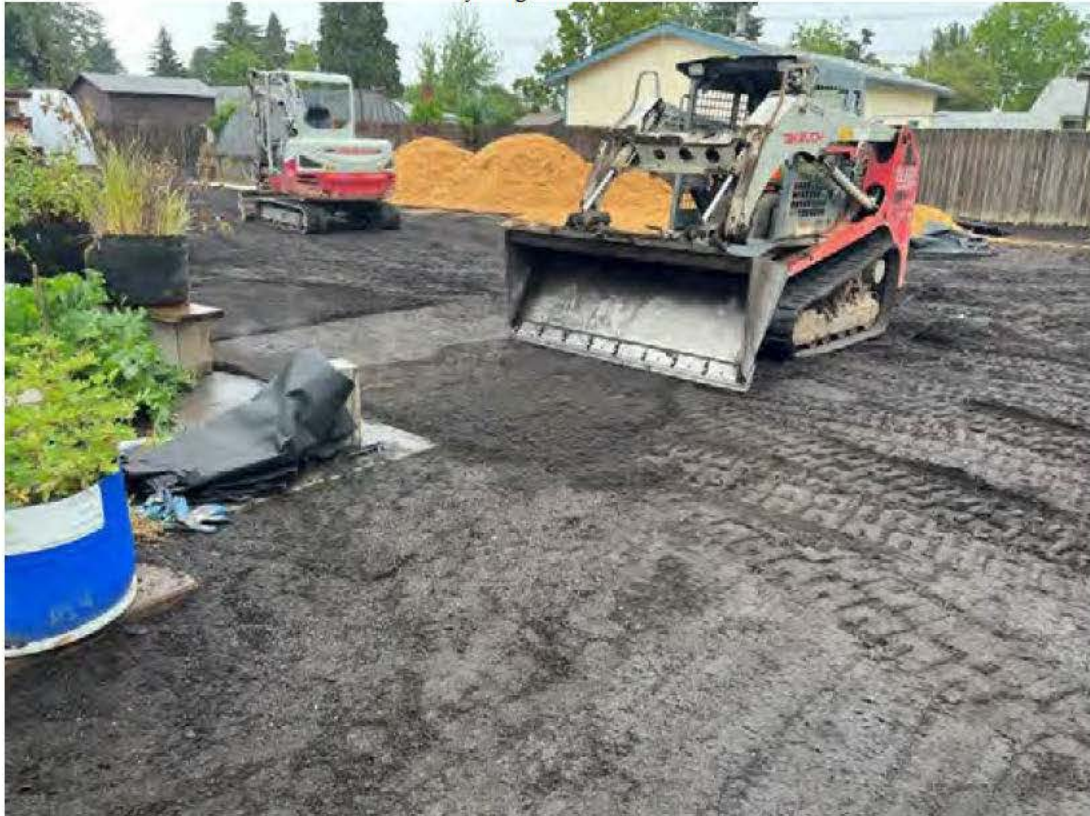
Photograph 15. 3 Kings placing some additional topsoil and regrading [REDACTED] Baxter per surveyor input. Photograph taken facing northeast.

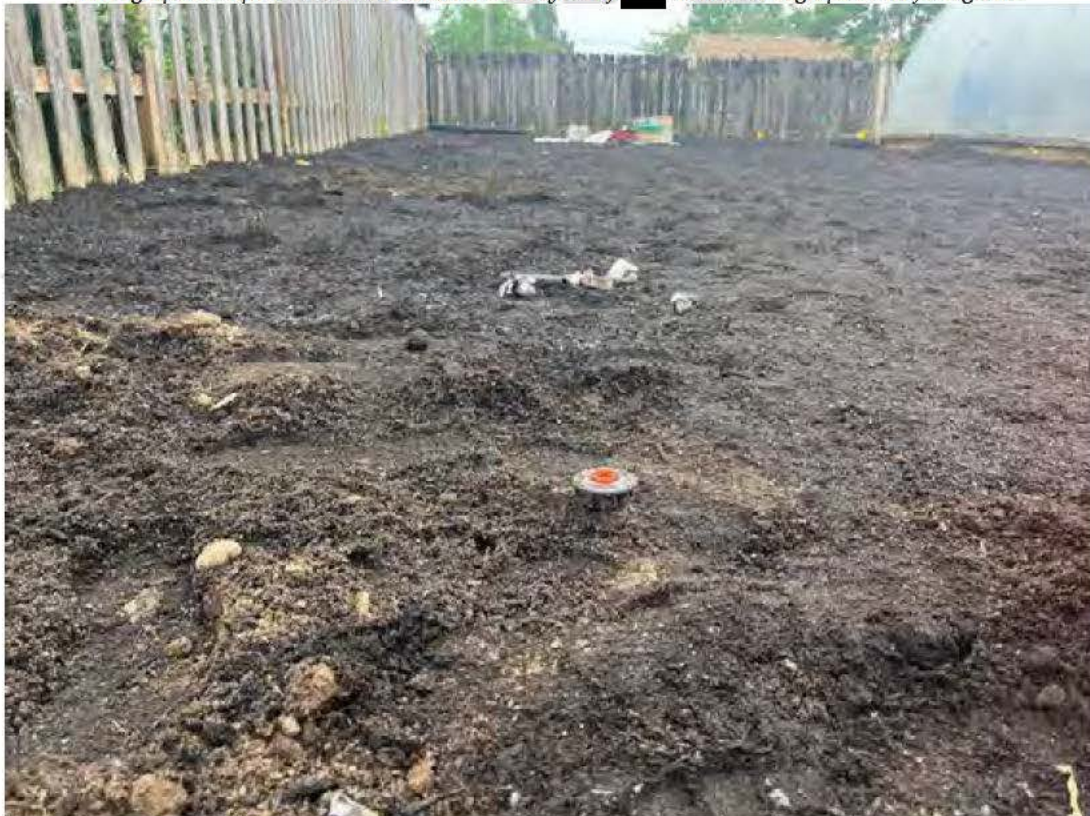
Photograph 16. Sprinkler heads installed in back yard of [REDACTED] Baxter. Photograph taken facing east.

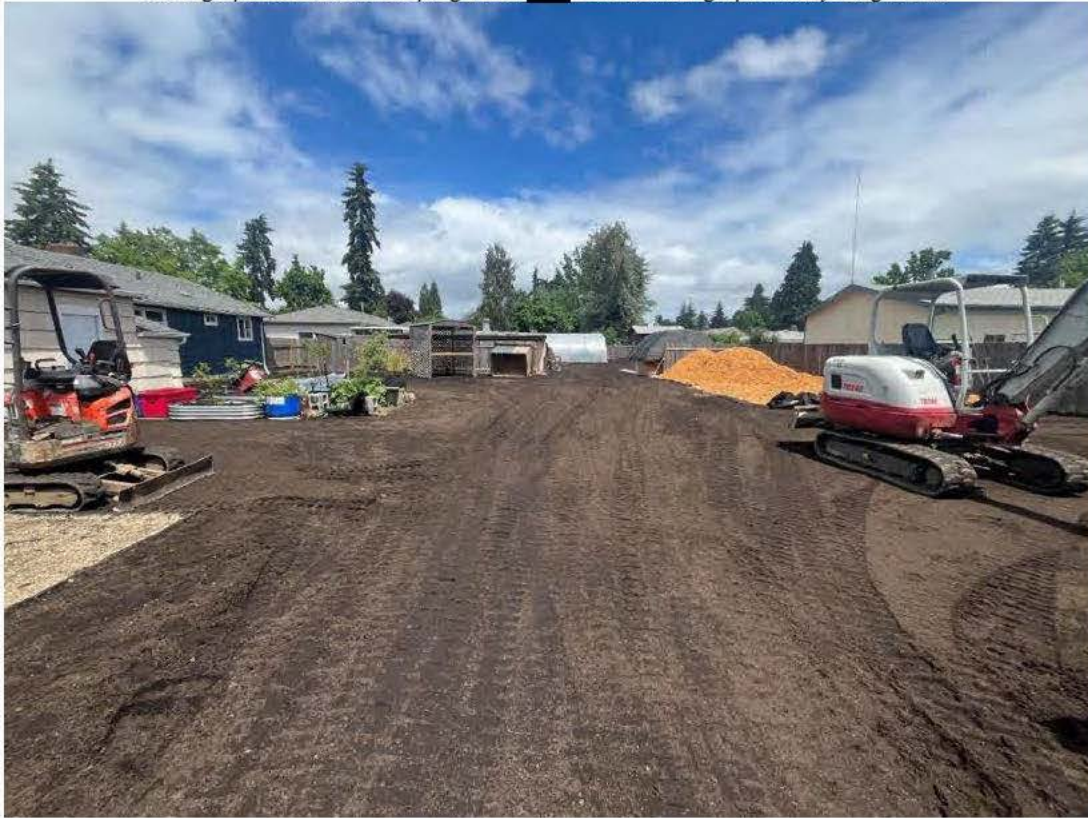
Photograph 17. Restoration progress at [REDACTED] Baxter. Photograph taken facing north.

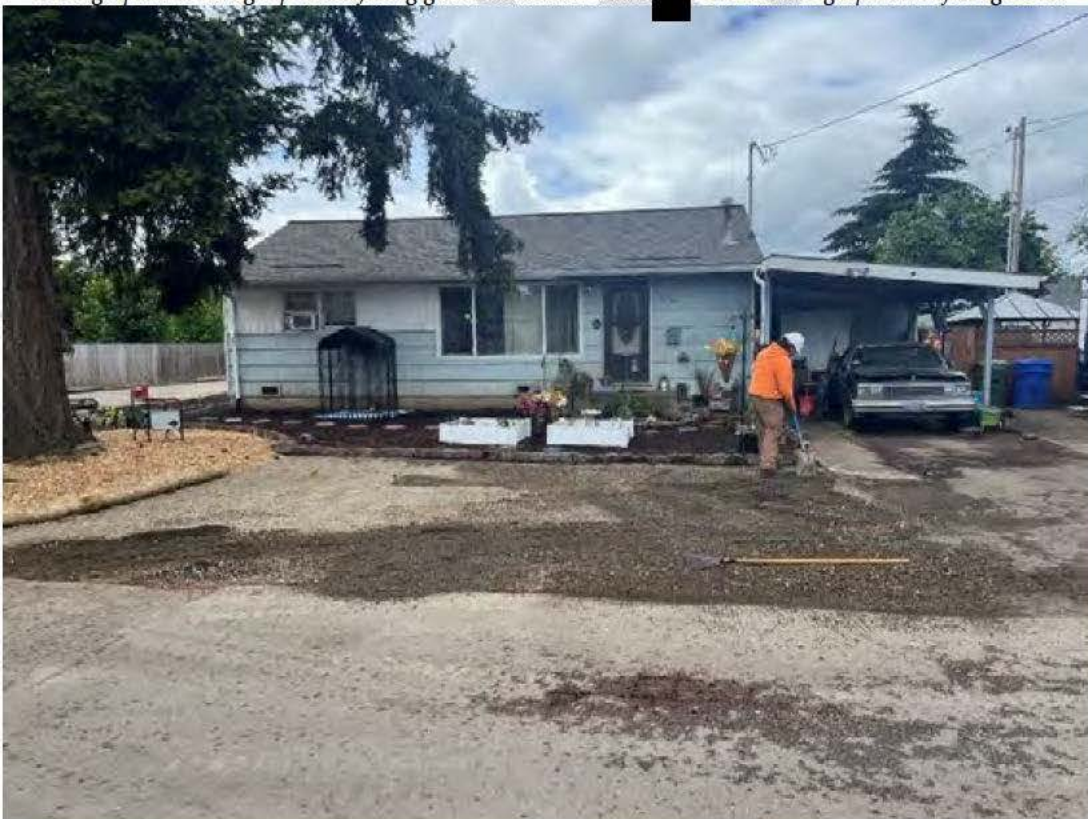
Photograph 18. 3 Kings spot backfilling gravel area in ROW at [REDACTED] Baxter. Photograph taken facing west.

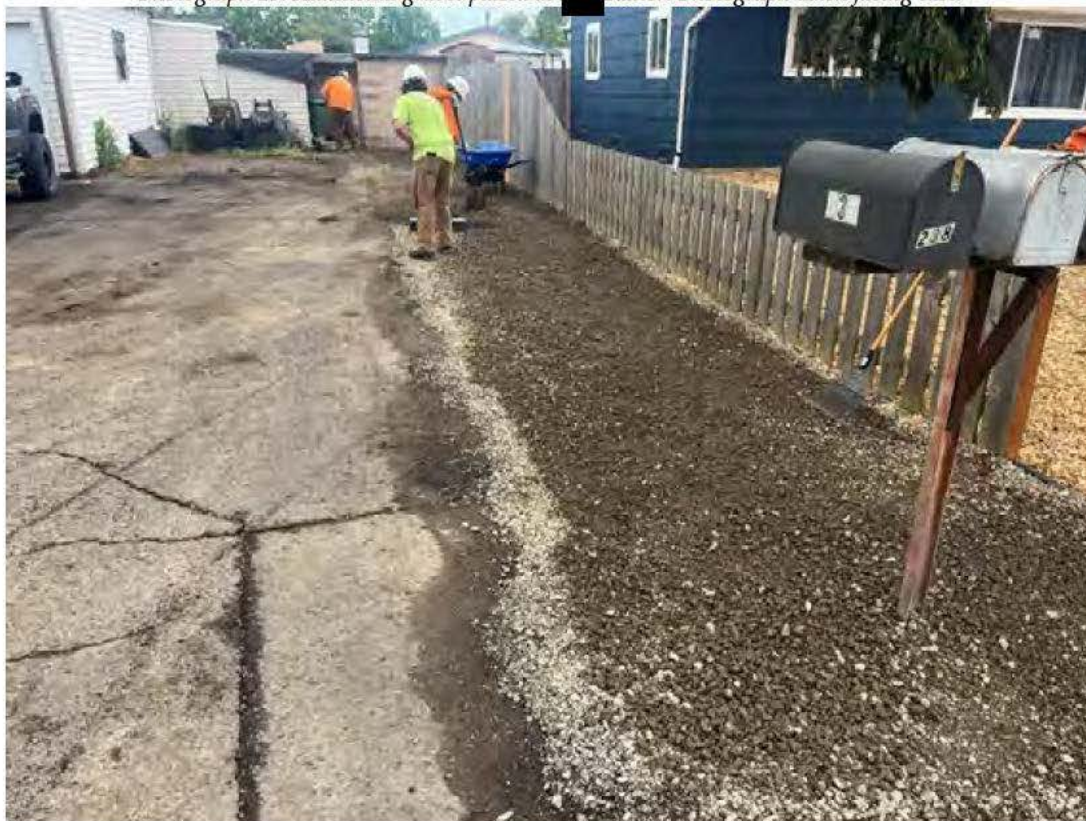
Photograph 19. Additional gravel placed at [REDACTED] Baxter. Photograph taken facing east.

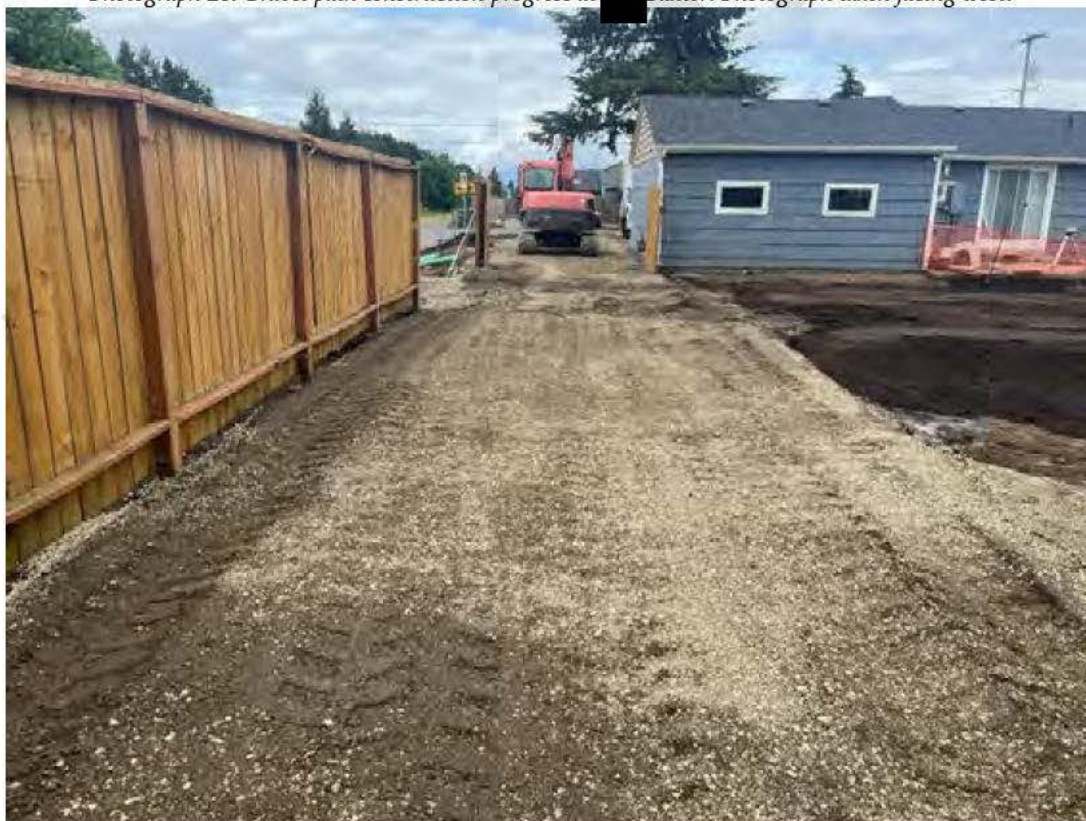
Photograph 20. Gravel path construction progress at [REDACTED] Baxter. Photograph taken facing west.
