APPENDIX B

Daily Field Reports Continued

Phase II RA

OFFSITE REMOVAL ACTION - DAILY FIELD REPORT
JH BAXTER OFFSITE REMEDIAL ACTION
EUGENE, OREGON

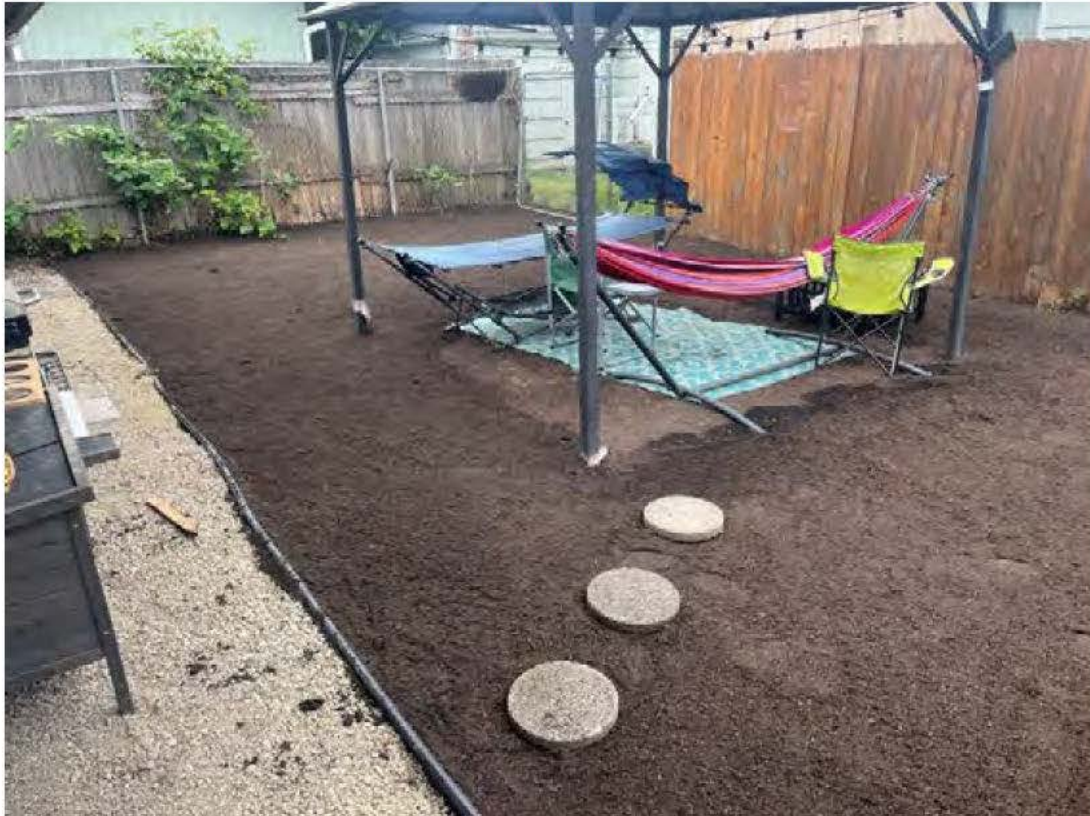
Photograph 21. Additional topsoil placed in northwest [REDACTED] Baxter after surveyor input. Photograph taken facing northwest.

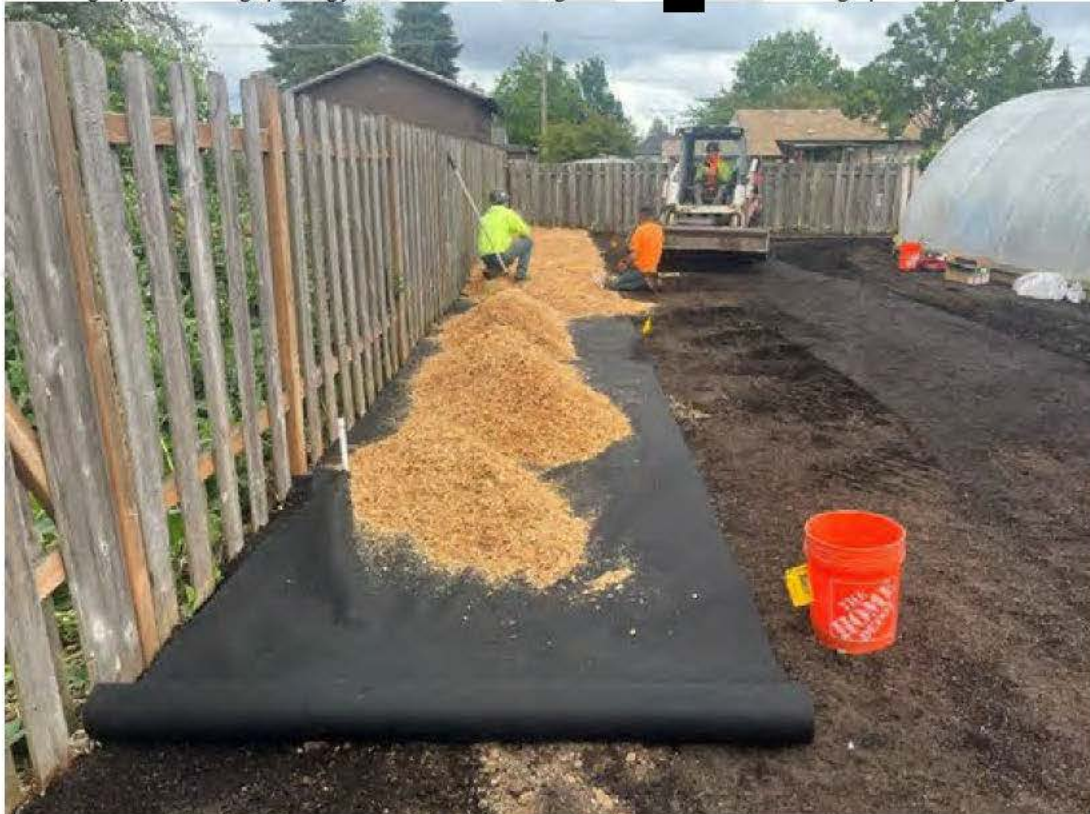
Photograph 22. 3 Kings placing fabric and mulch along northern [REDACTED] Baxter. Photograph taken facing east.

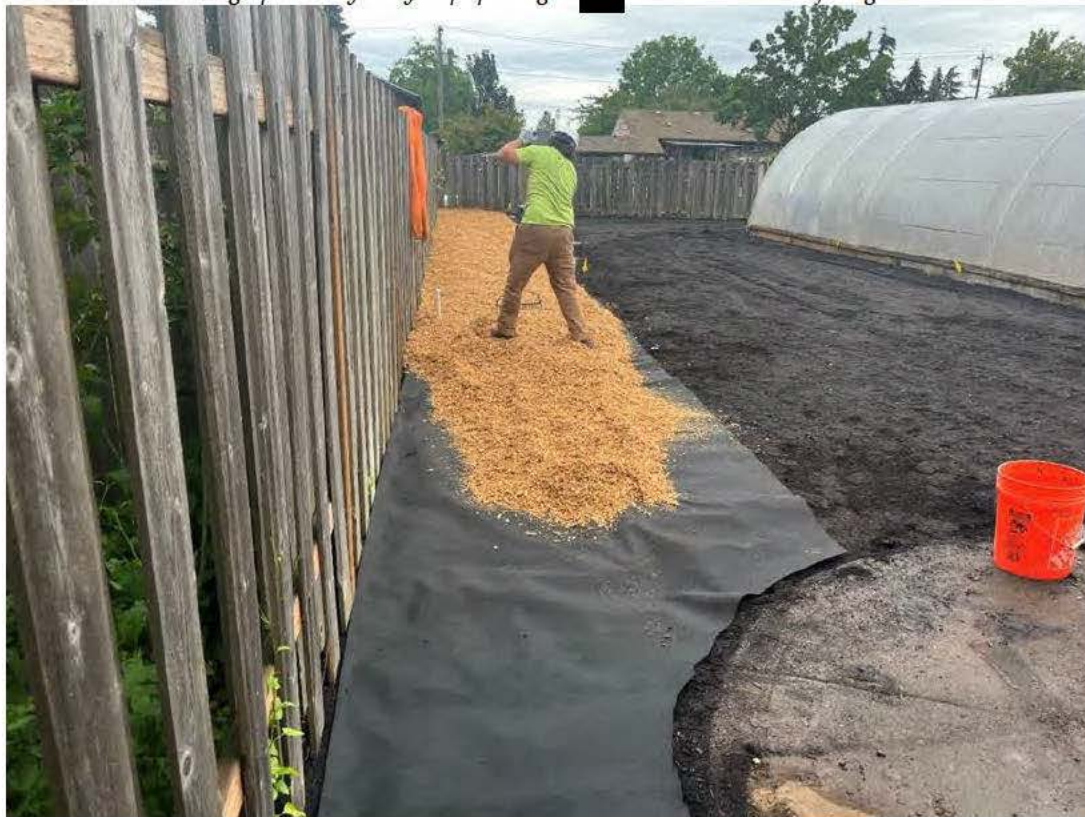
Photograph 2. Restoration progress at [REDACTED] Baxter. Photo taken facing south.

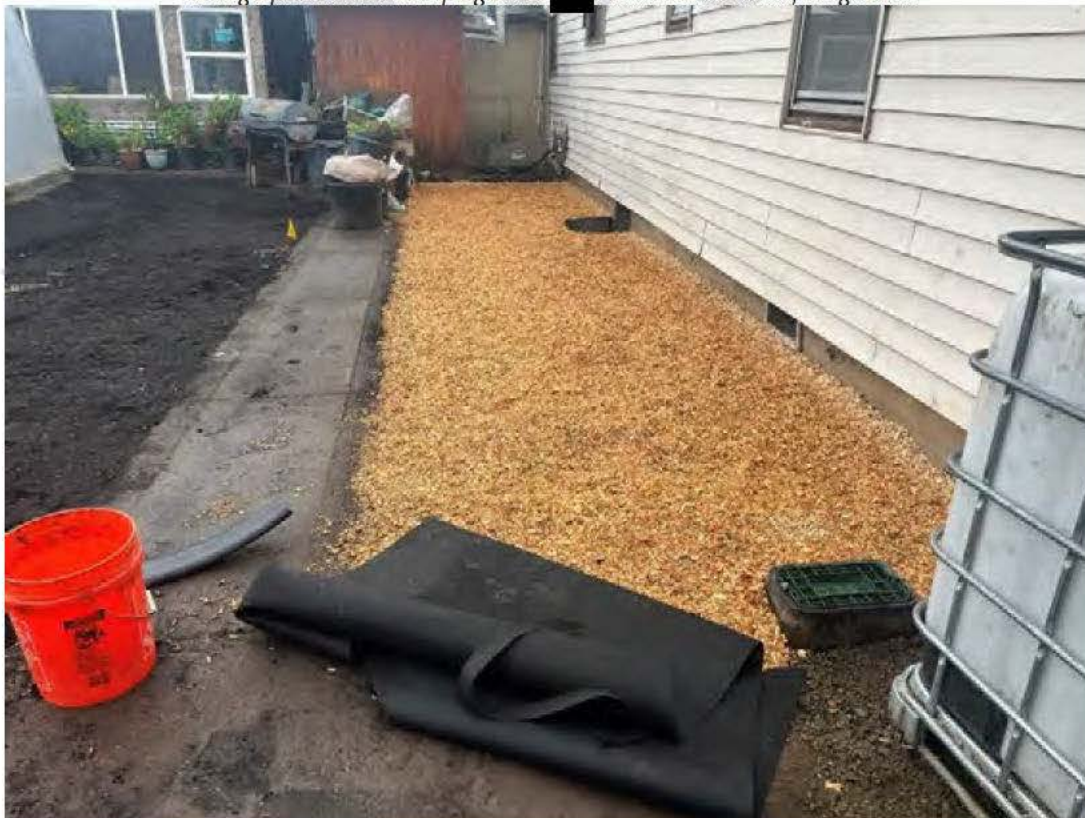
Photograph 3. Demarcation fabric/weed barrier and PlayAway fiber chip placing at [REDACTED] Baxter. Photo taken facing north.

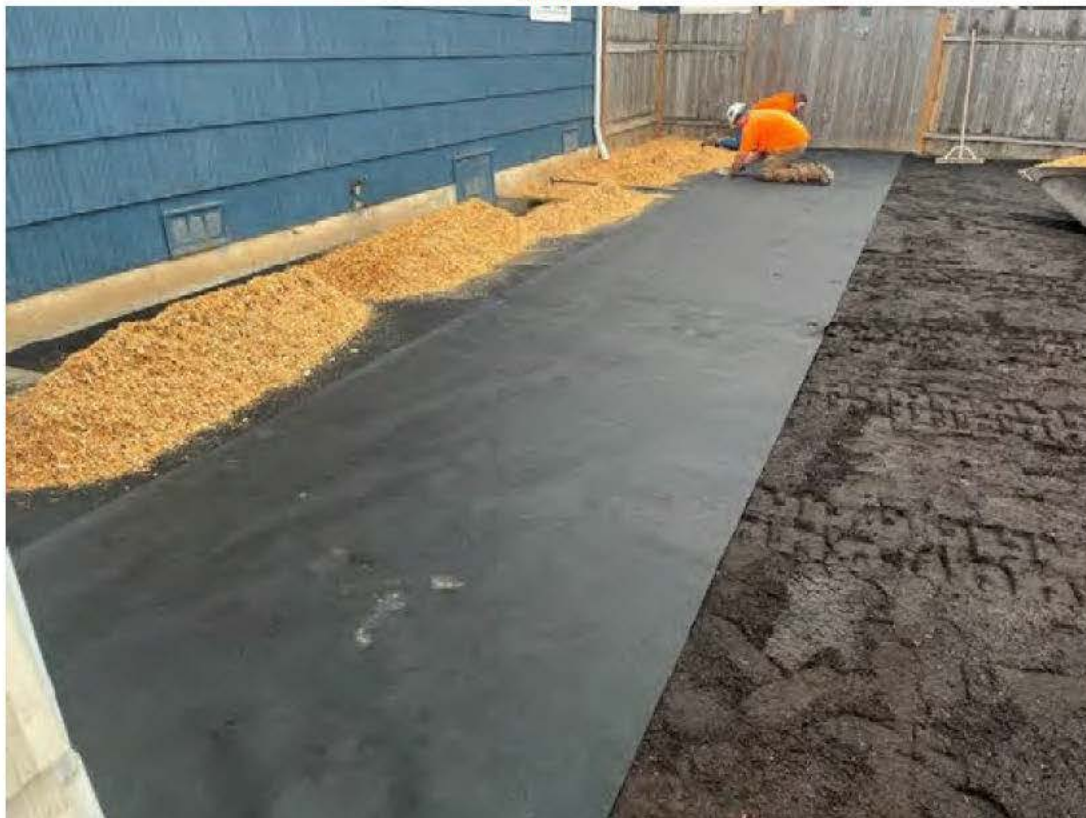
Photograph 4. Fiber chip spreading via hand tools at [REDACTED] Baxter. Photo taken facing southwest.

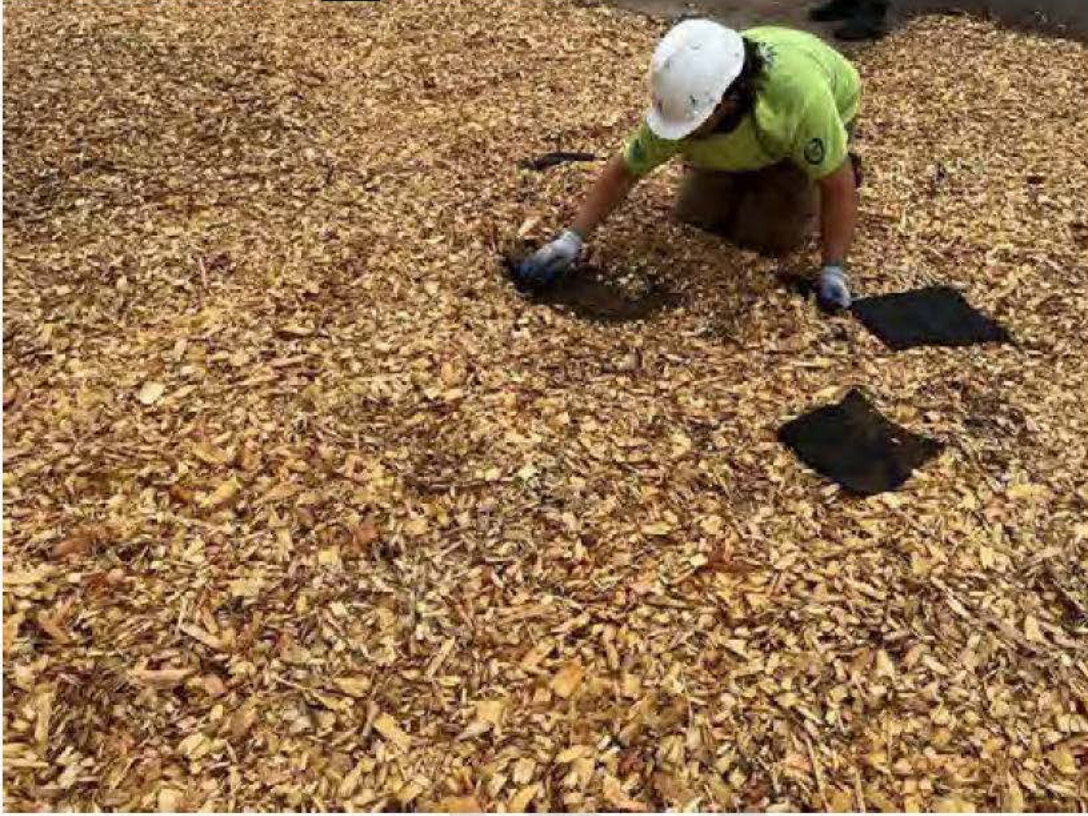
Photograph 8. Damaged section of concrete cut out at [REDACTED] Baxter. Photo taken facing south.

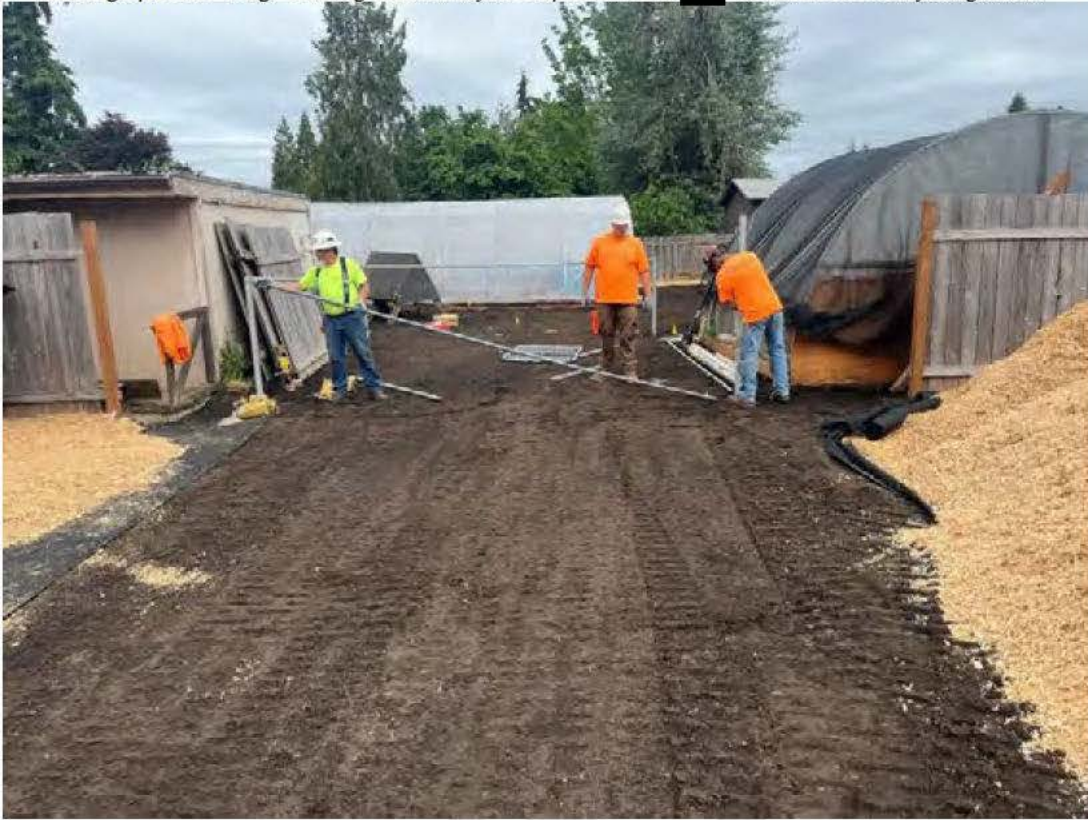
Photograph 12. Installing new concrete pad at [REDACTED] Baxter. Photo taken facing northwest.

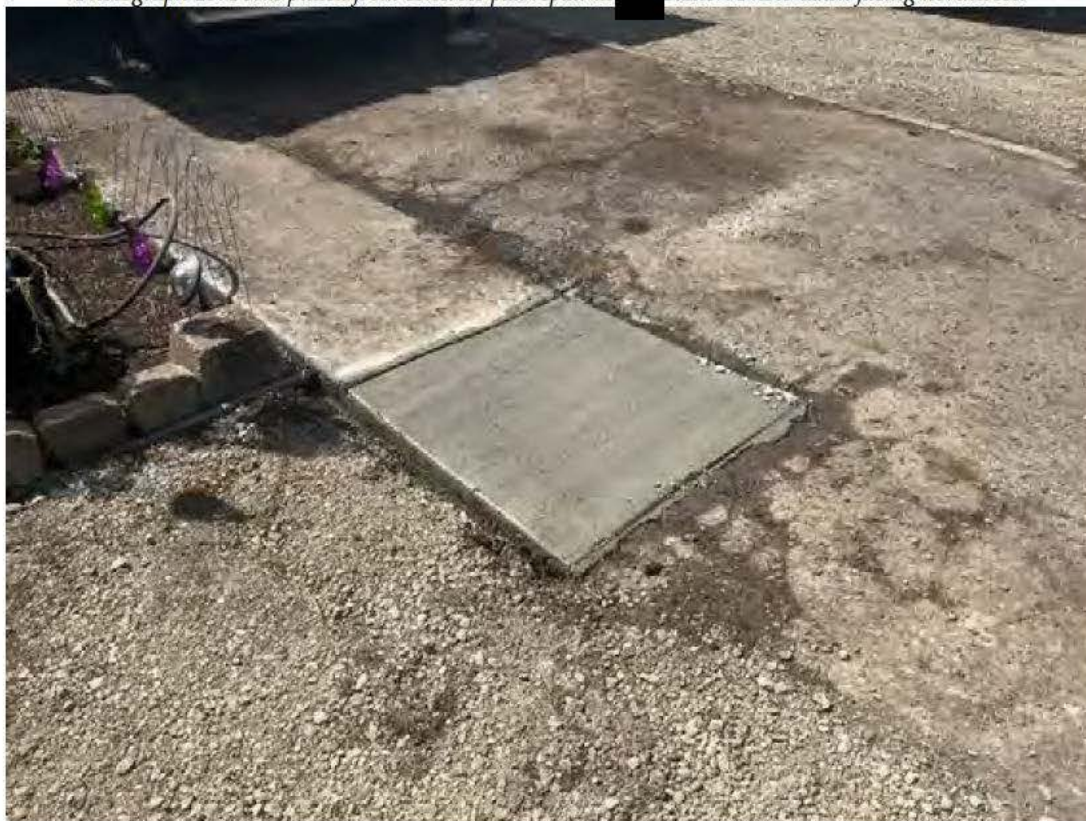
Photograph 19. Form pulled from concrete pad repair at [REDACTED] Baxter. Photo taken facing northwest.

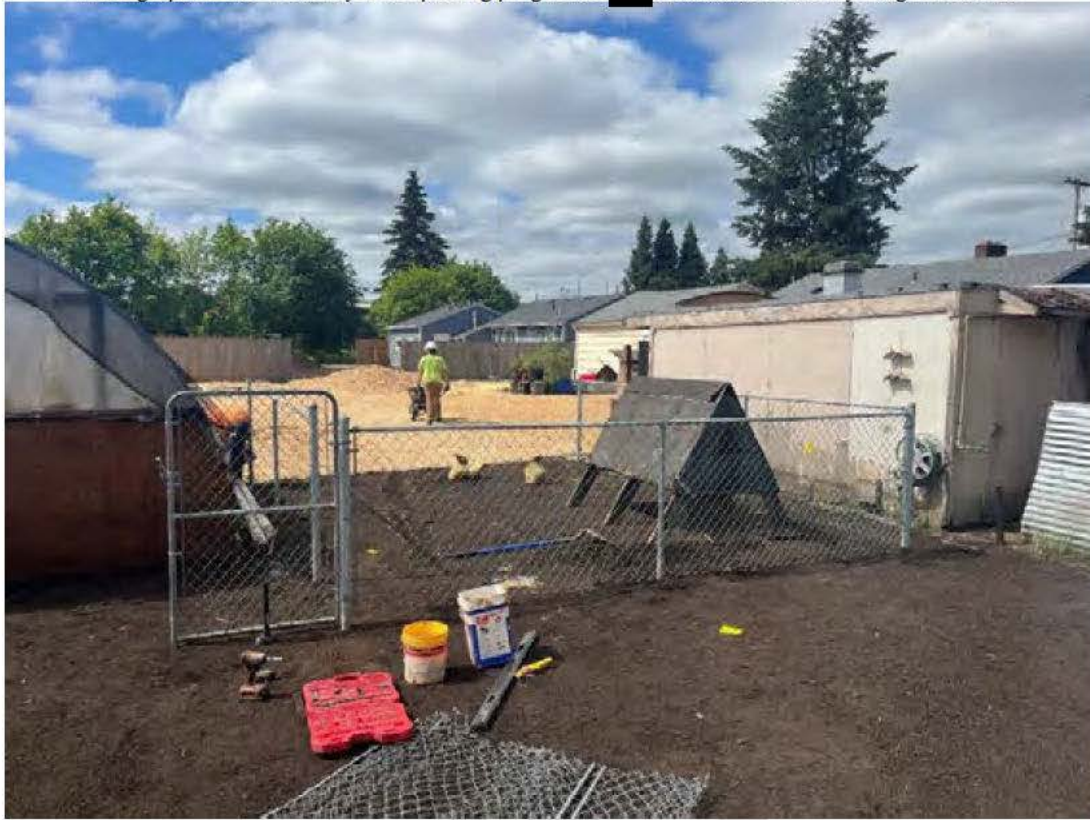
Photograph 9. Chicken run fence replacing progress at [REDACTED] Baxter. Photo taken facing southwest.

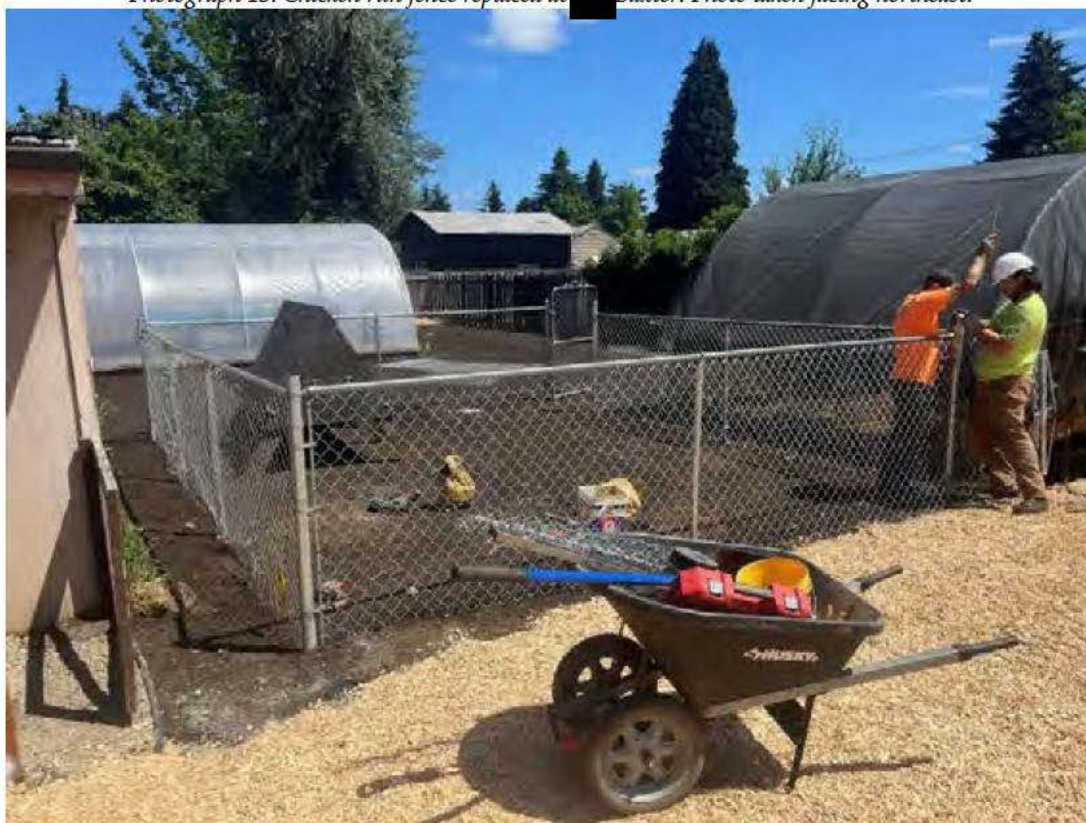
Photograph 13. Chicken run fence replaced at [REDACTED] Baxter. Photo taken facing northeast.

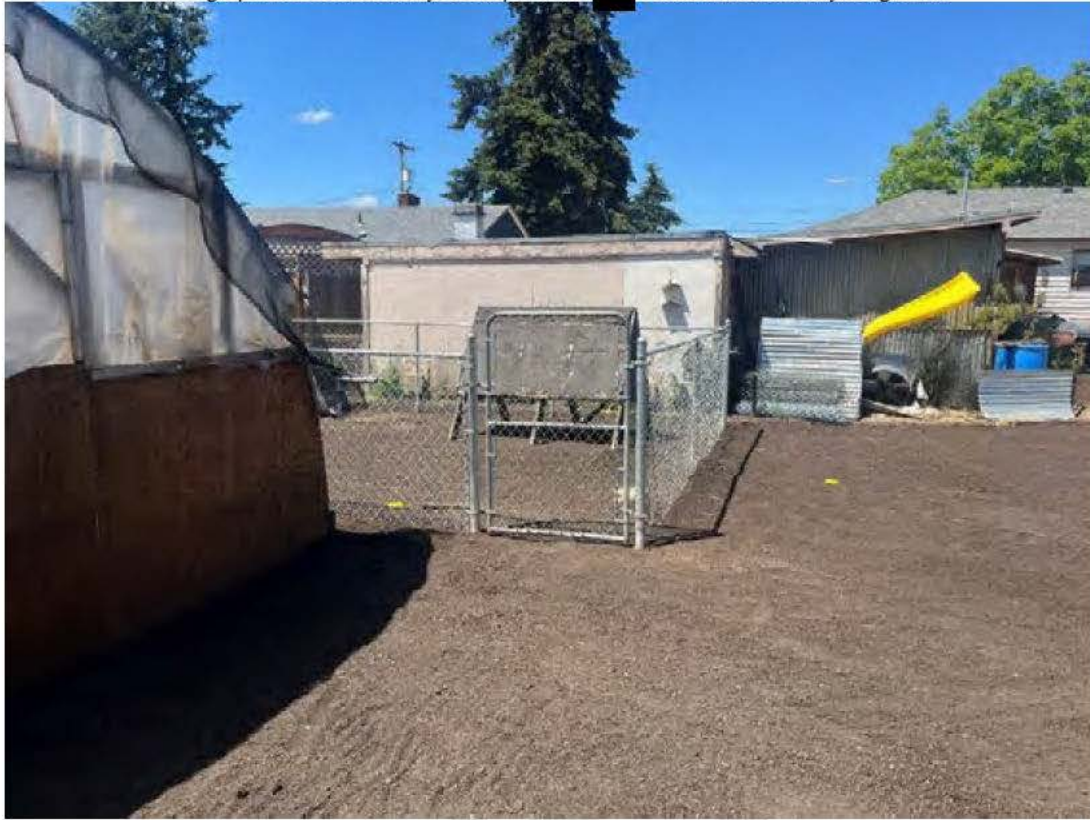
Photograph 15. Chicken run fence replaced at [REDACTED] Baxter. Photo taken facing west.

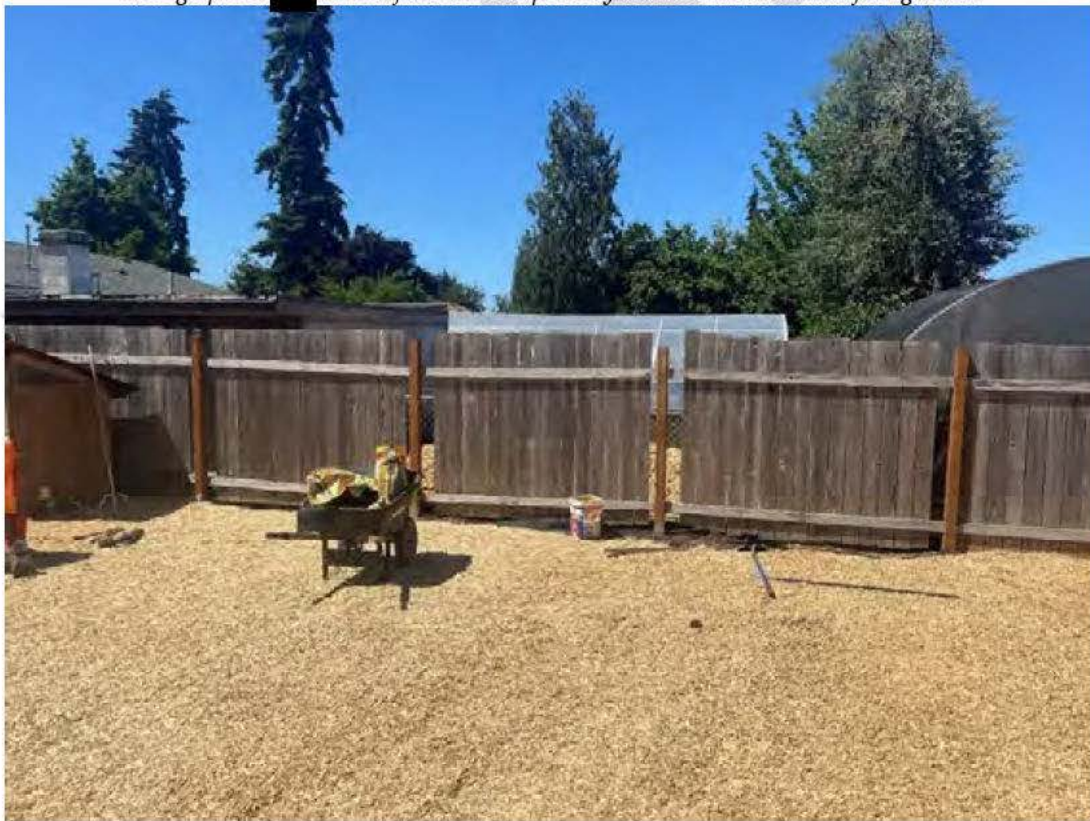
Photograph 20. [REDACTED] Baxteer fence sections partially reinstalled. Photo taken facing north.

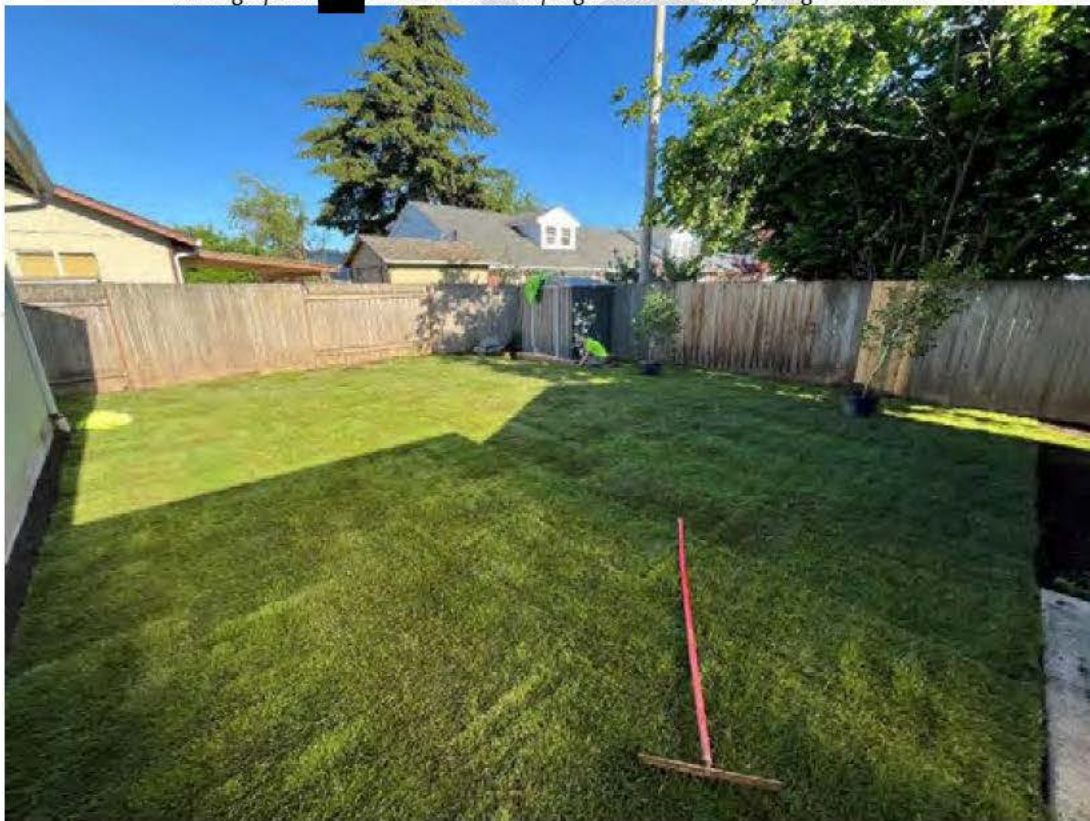
Photograph 5. Landscape edging installation completed in front yard of [REDACTED] Baxter. Photo taken facing east.

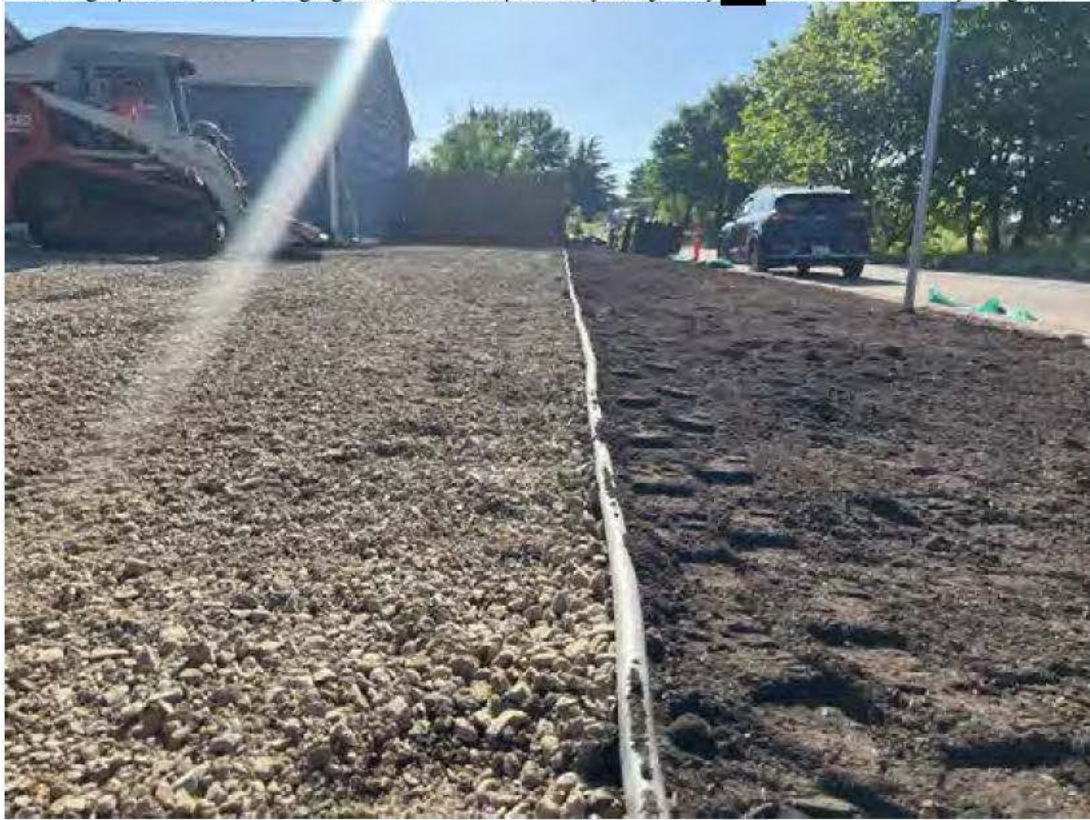
Photograph 6. Resident selected plant locations for Rexius. Photo taken facing northwest.

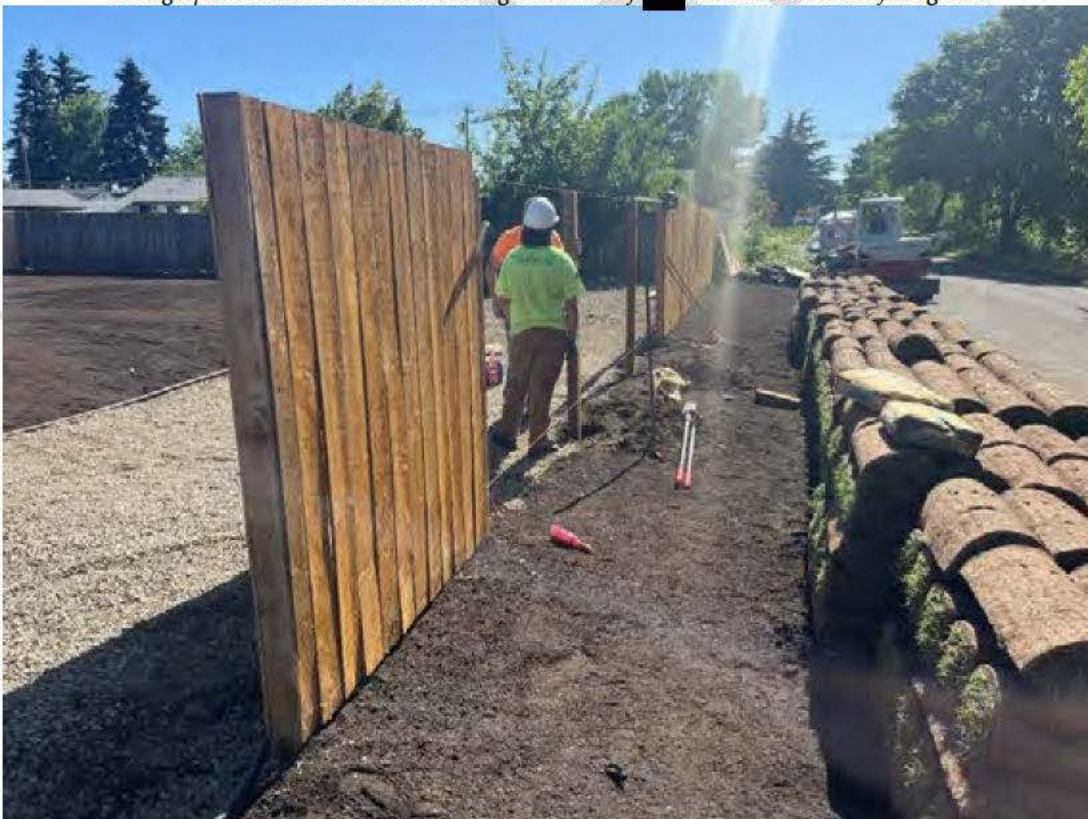
Photograph 11. Fence reinstallation progress at [REDACTED] Baxter. Photo taken facing north.

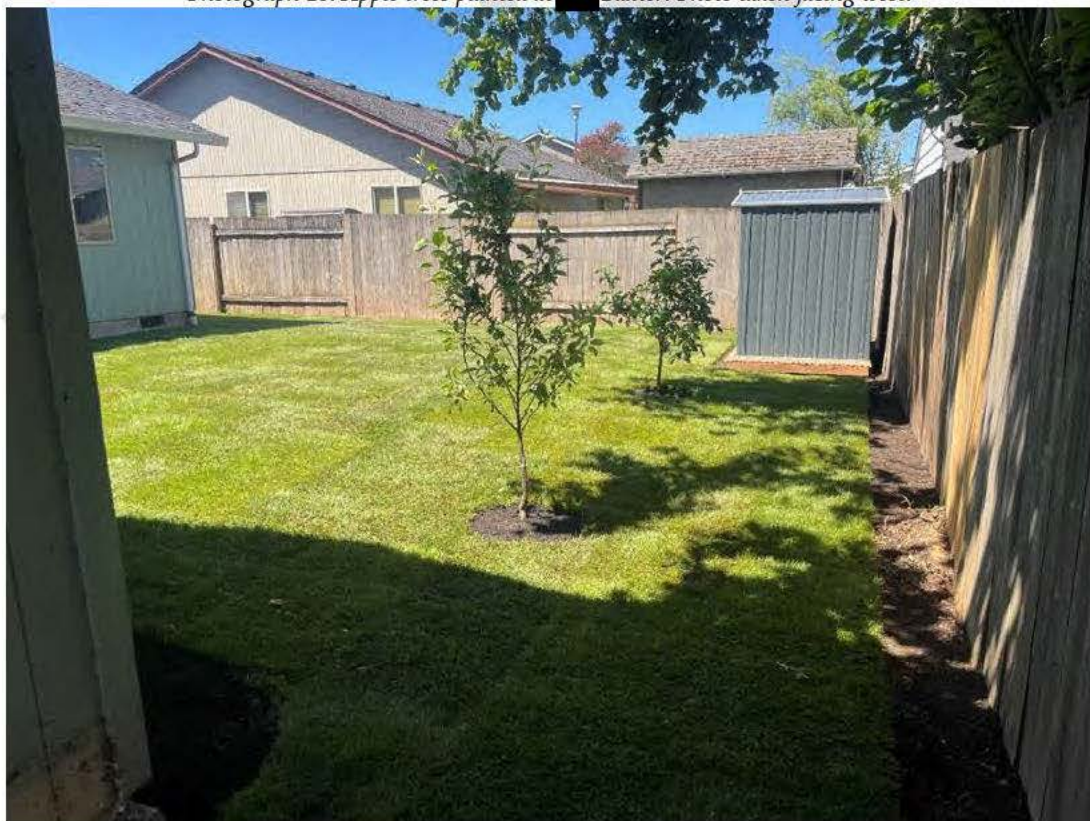
Photograph 17. Bare soil patch and staged plants at [REDACTED] Baxter. Photo taken facing southeast.

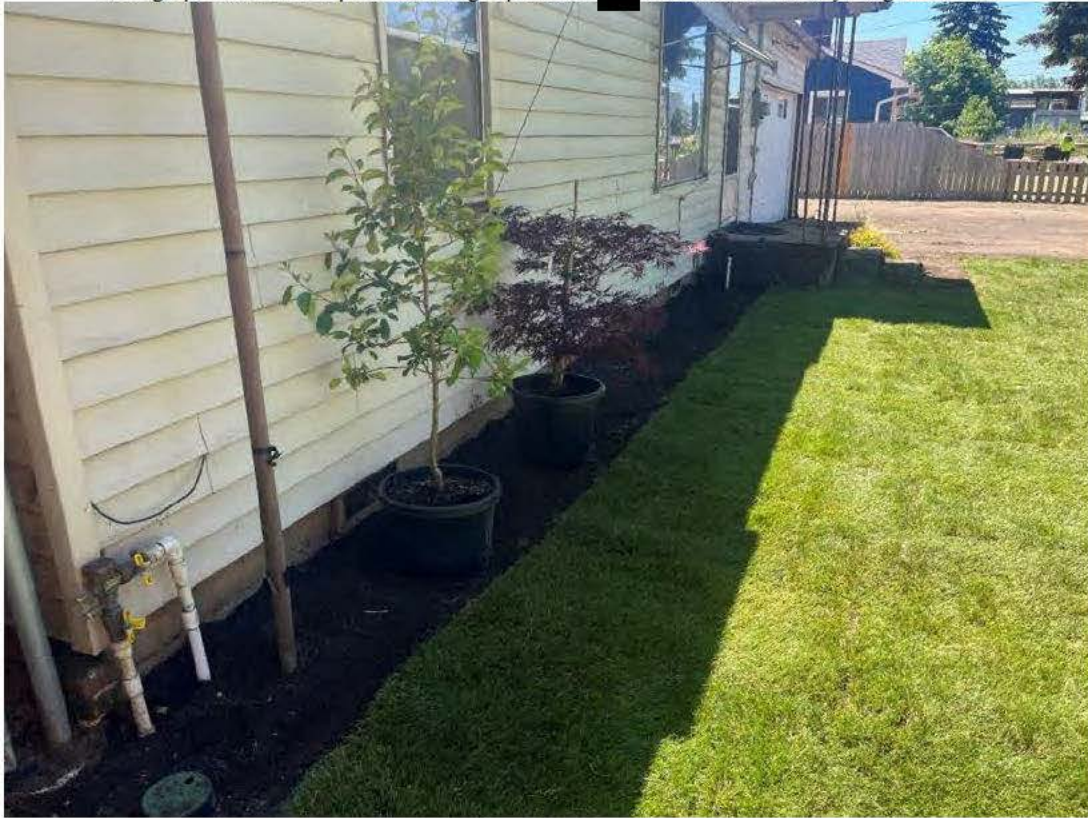
Photograph 18. Surface restoration progress at [REDACTED] Baxter. Photo taken facing southeast.

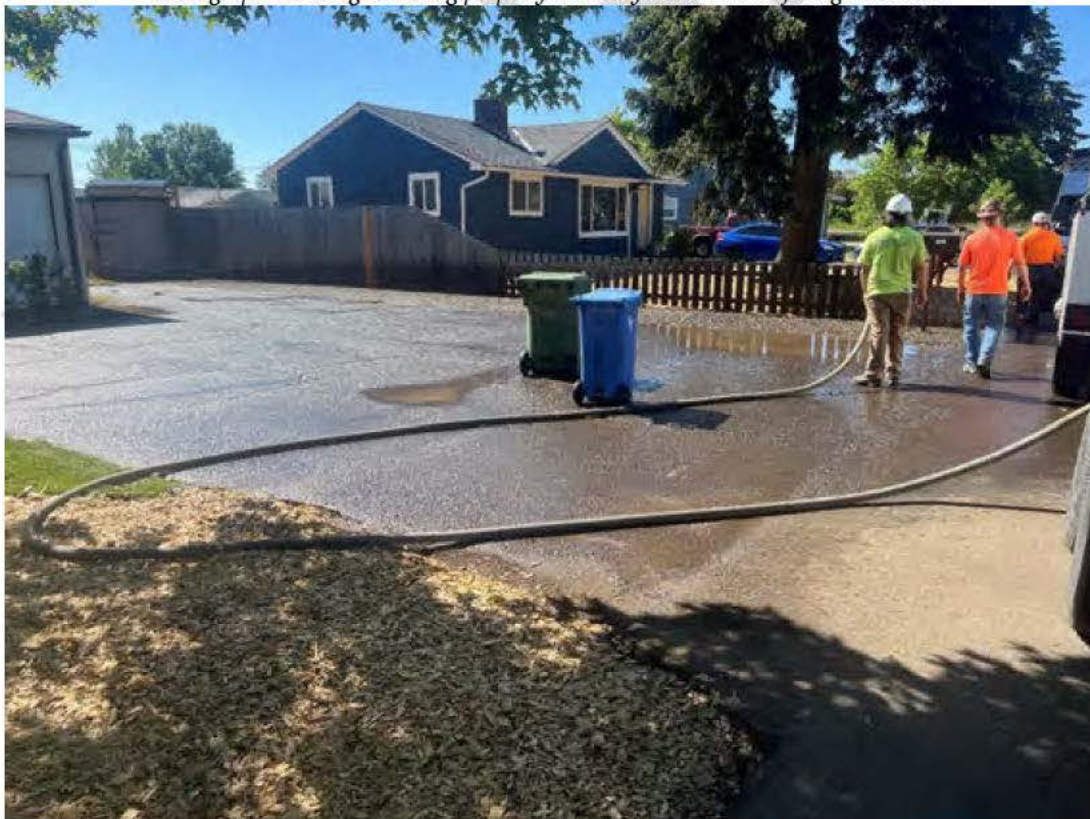
Photograph 4. Planting area installed along [REDACTED] Baxter residence. Photo taken facing south.

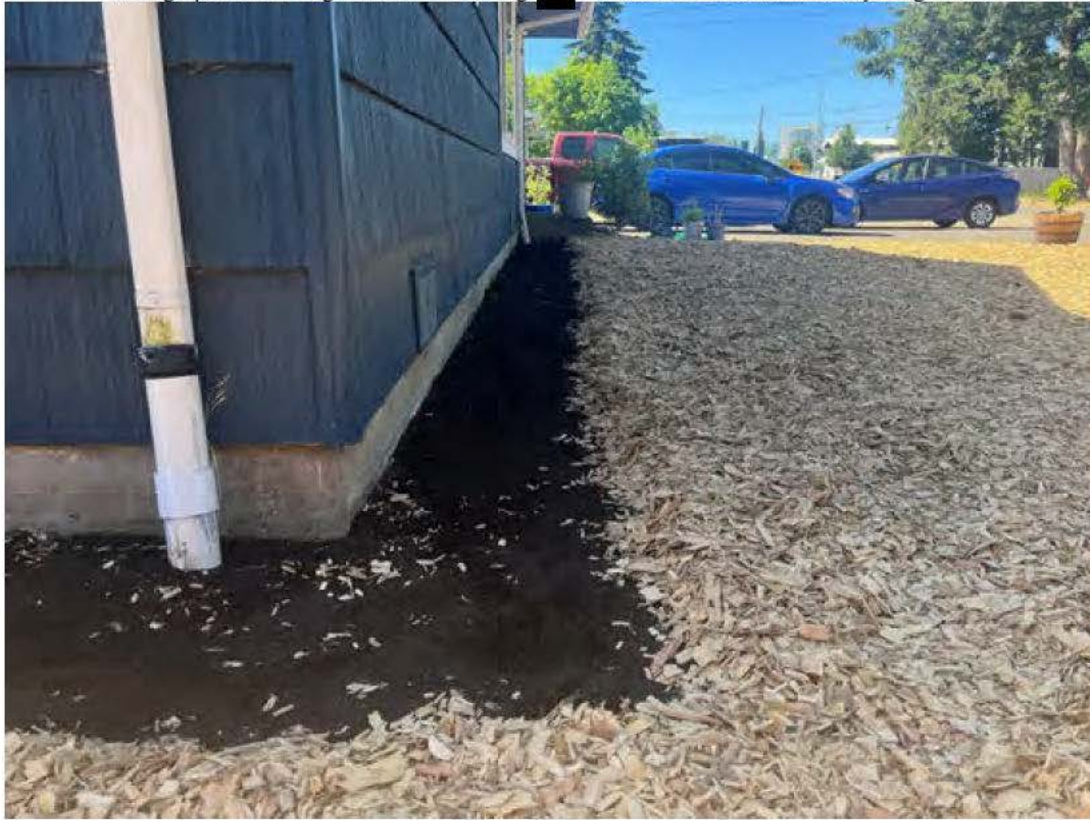
Photograph 5. Wood chips installed around Tupelo tree per landscaper recommendation. Photo taken facing southwest.

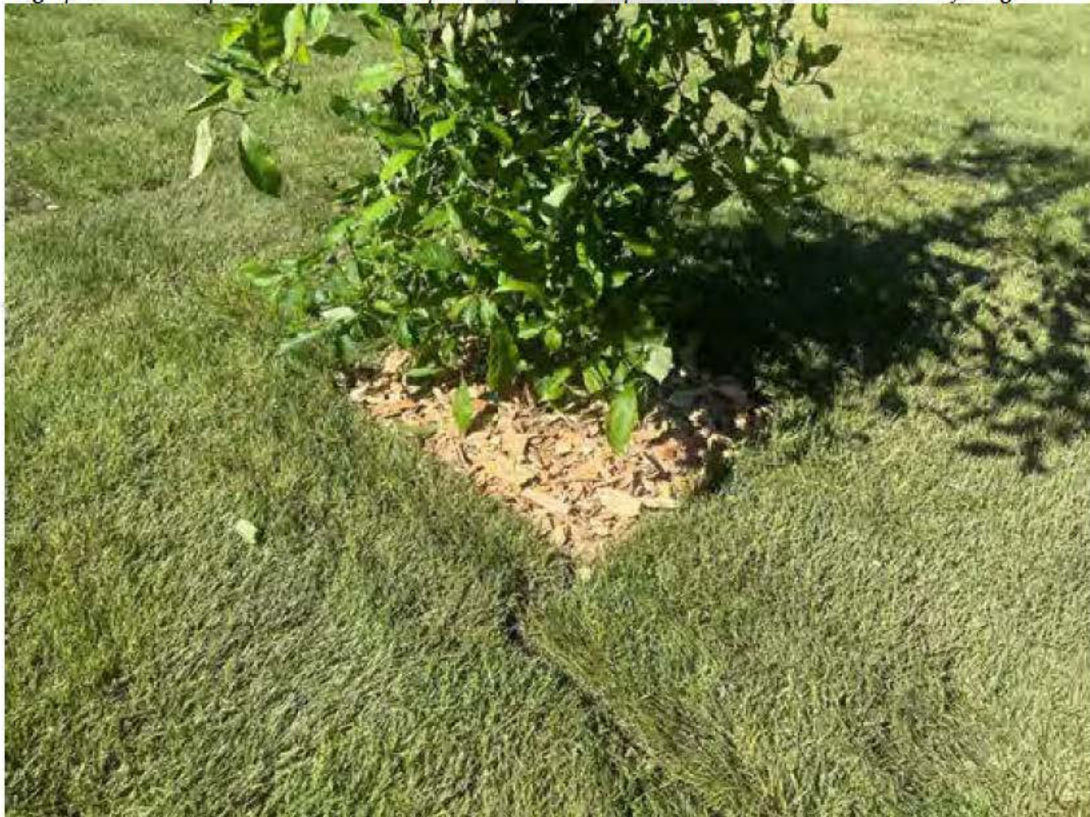
Photograph 6. Wood chips installed around plum tree per landscaper recommendation. Photo taken facing northwest.

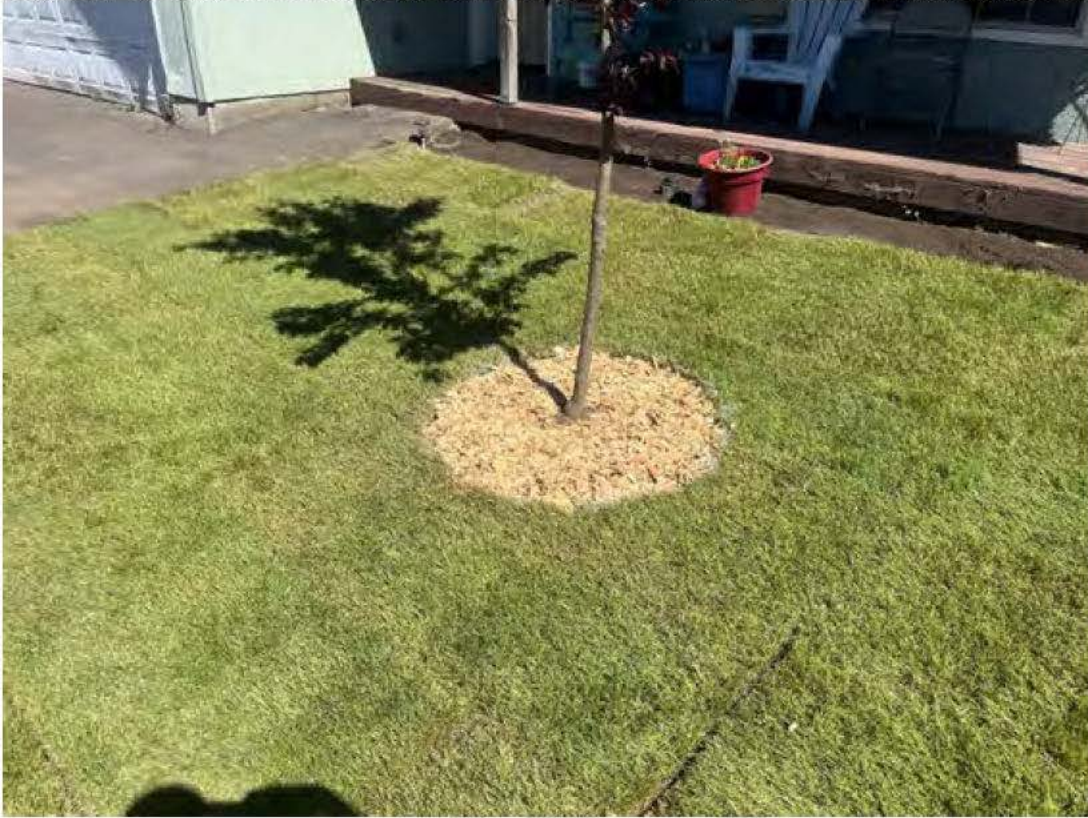
Photograph 7. Wood chips installed around apple trees. Photo taken facing northeast.

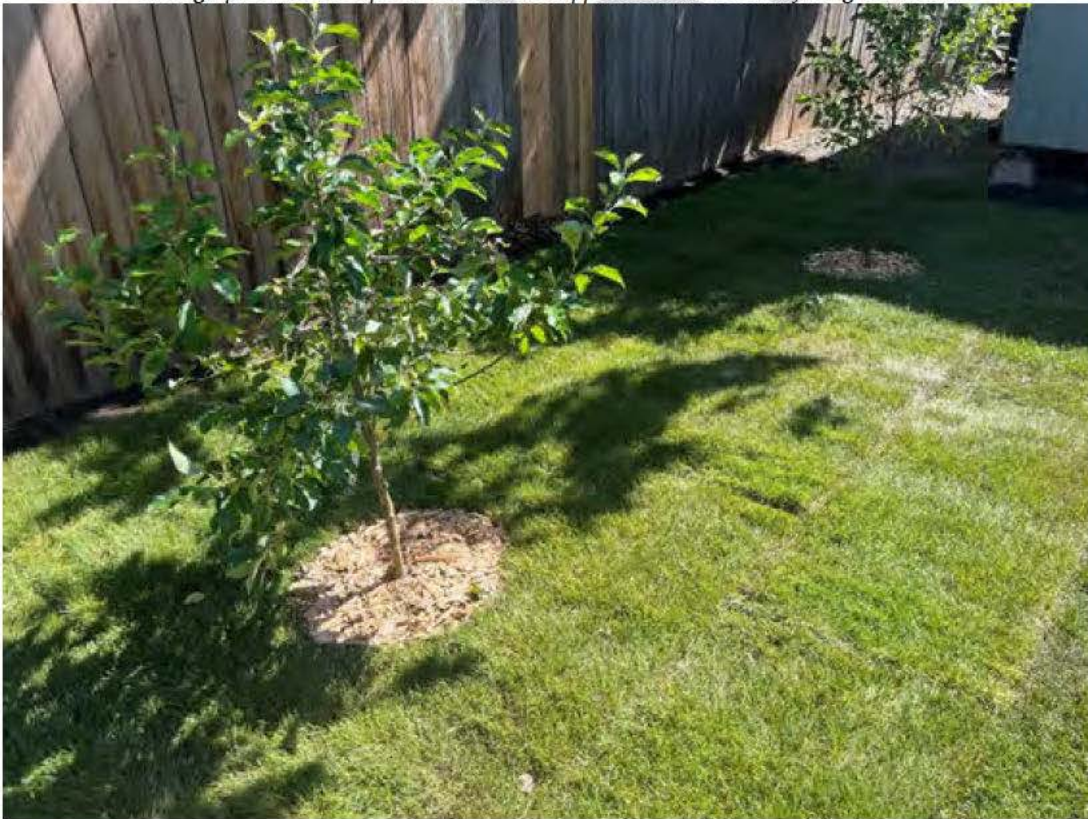
Photograph 8. Plants installed at [REDACTED] Baxter. Photo taken facing southwest.

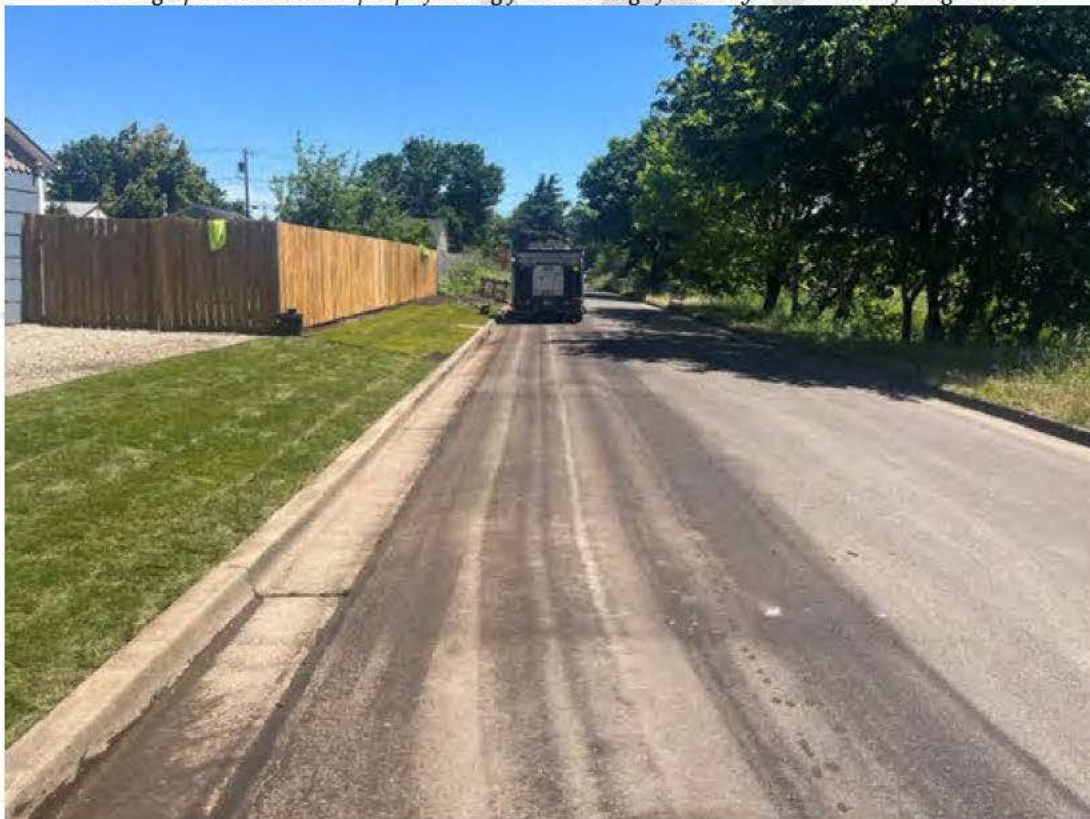
Photograph 14. Fence reinstall and sod installation along ROW south of [REDACTED] Baxter. Photo taken facing north.

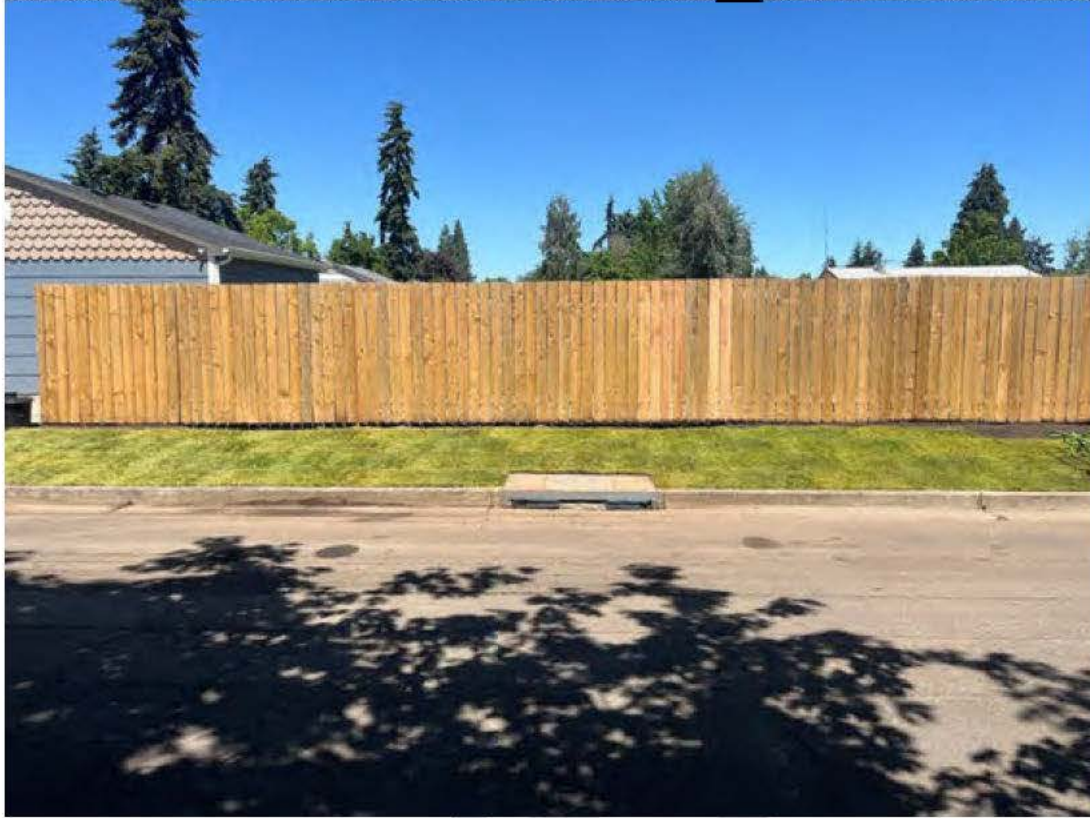
Photograph 15. Rexius planting rose bushes in front yard of [REDACTED] Baxter. Photo taken facing south.

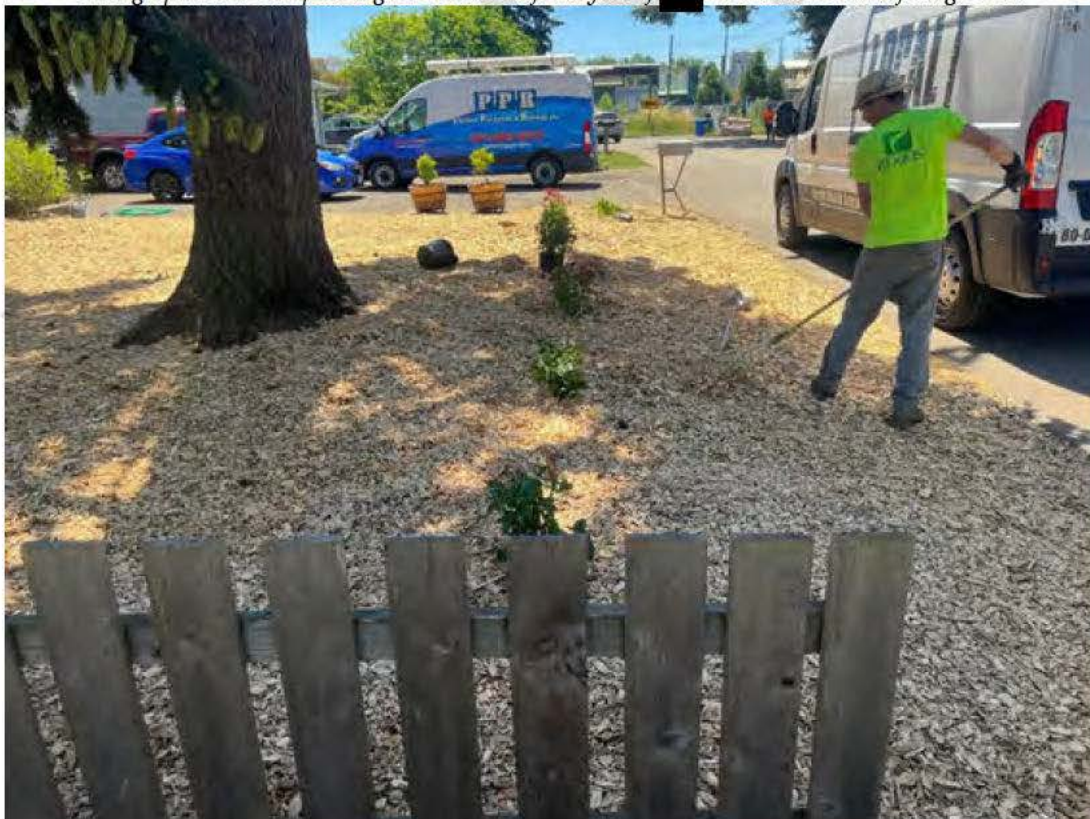
Photograph 16. Fruit trees planted in resident-requested locations at [REDACTED] Baxter. Photo taken facing east.
