APPENDIX B

Daily Field Reports Continued

Phase II RA

OFFSITE REMOVAL ACTION - DAILY FIELD REPORT
JH BAXTER OFFSITE REMEDIAL ACTION
EUGENE, OREGON

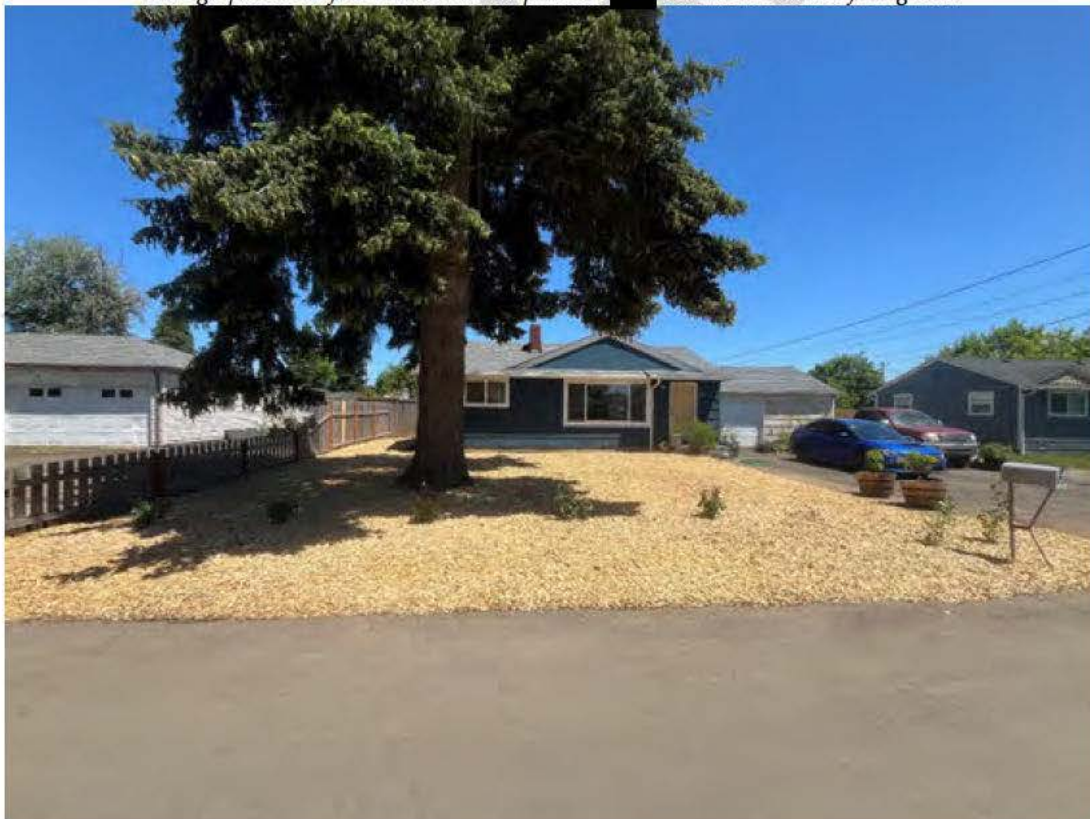
Photograph 21. Surface restoration completed at [REDACTED] Baxter. Photo taken facing east.

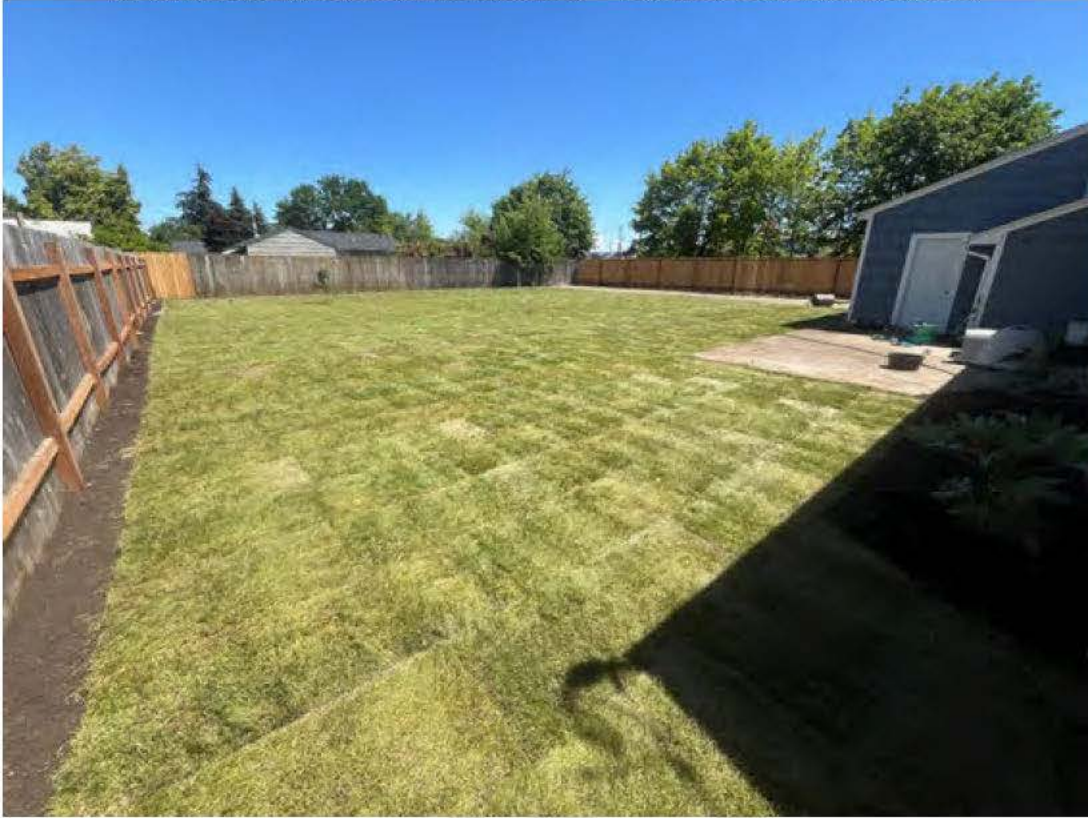
Photograph 22. Surface restoration completed at [REDACTED] Baxter. Photo taken facing southeast.

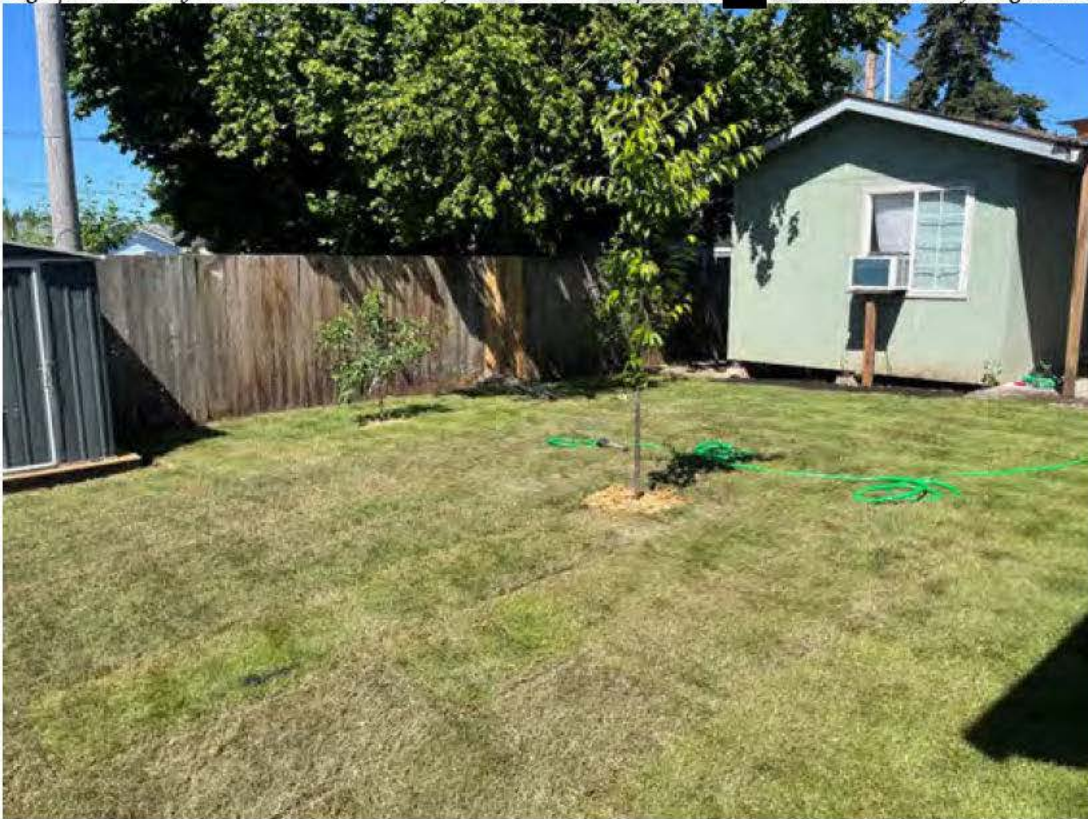
Photograph 23. Cherry blossom installed and surface restoration completed at [REDACTED] Baxter. Photo taken facing northeast.

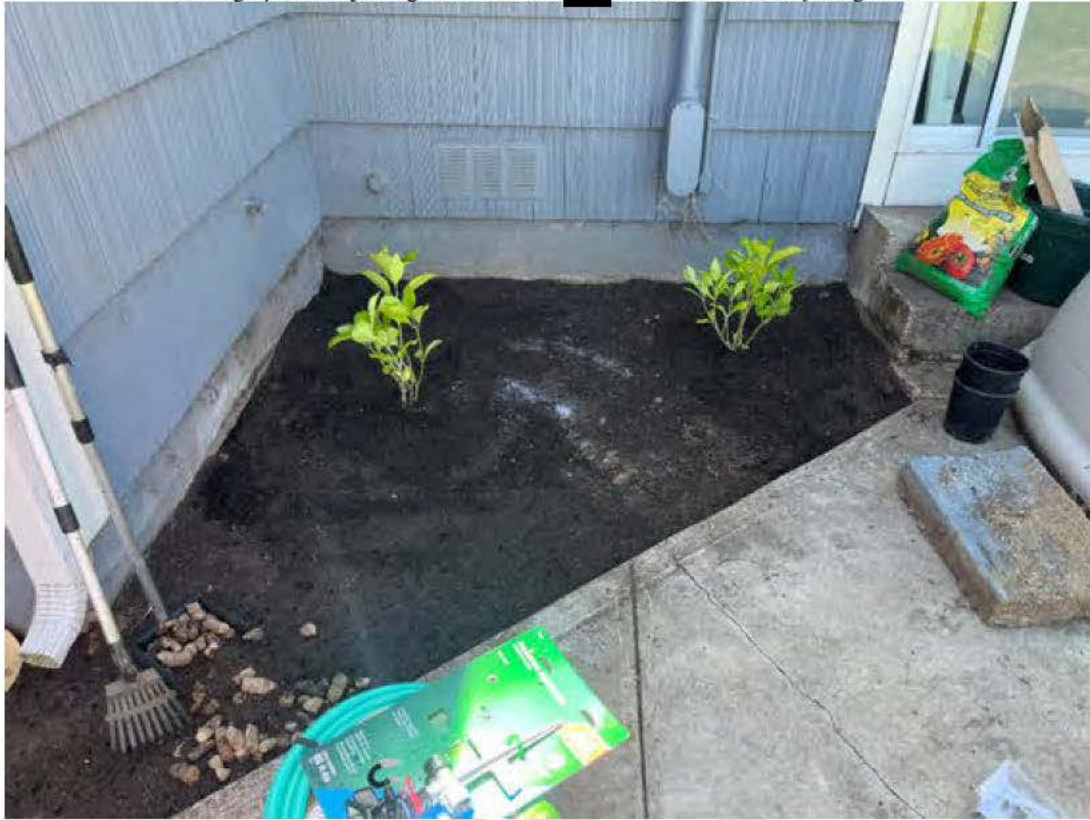
Photograph 24. Hydrangeas installed at [REDACTED] Baxter. Photo taken facing west.

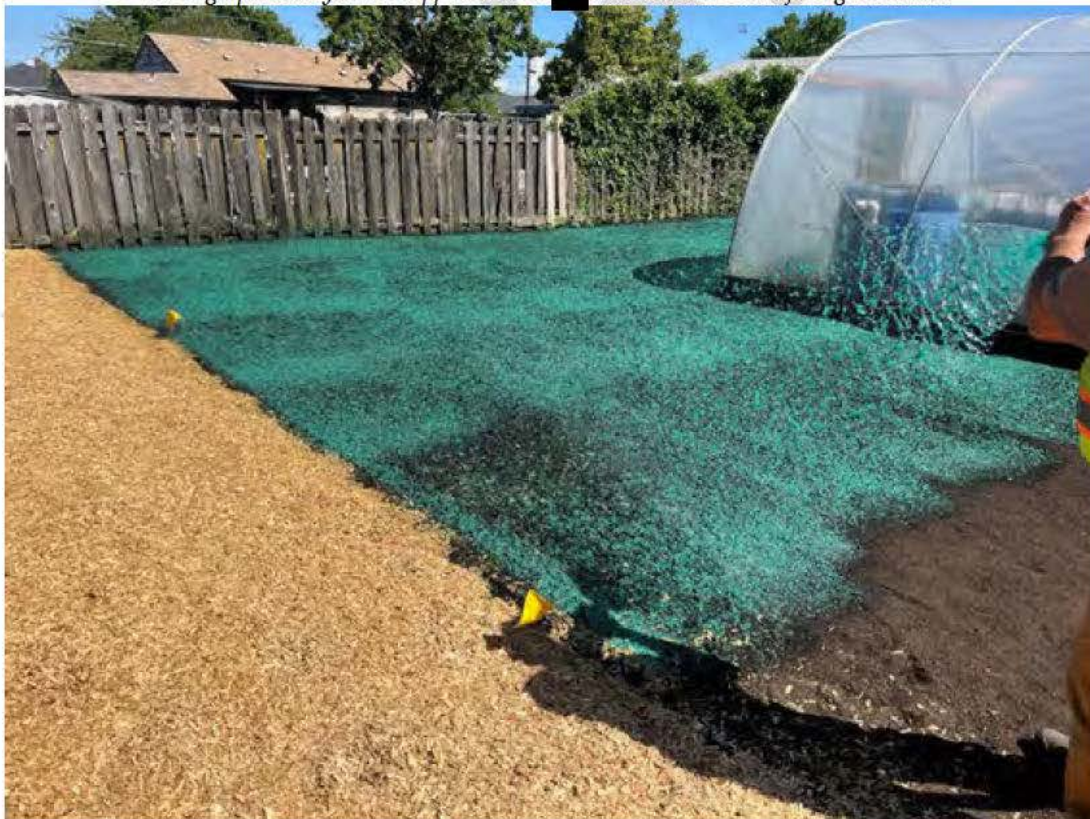
Photograph 25. Hydroseed application at [REDACTED] Baxter. Photo taken facing southeast.

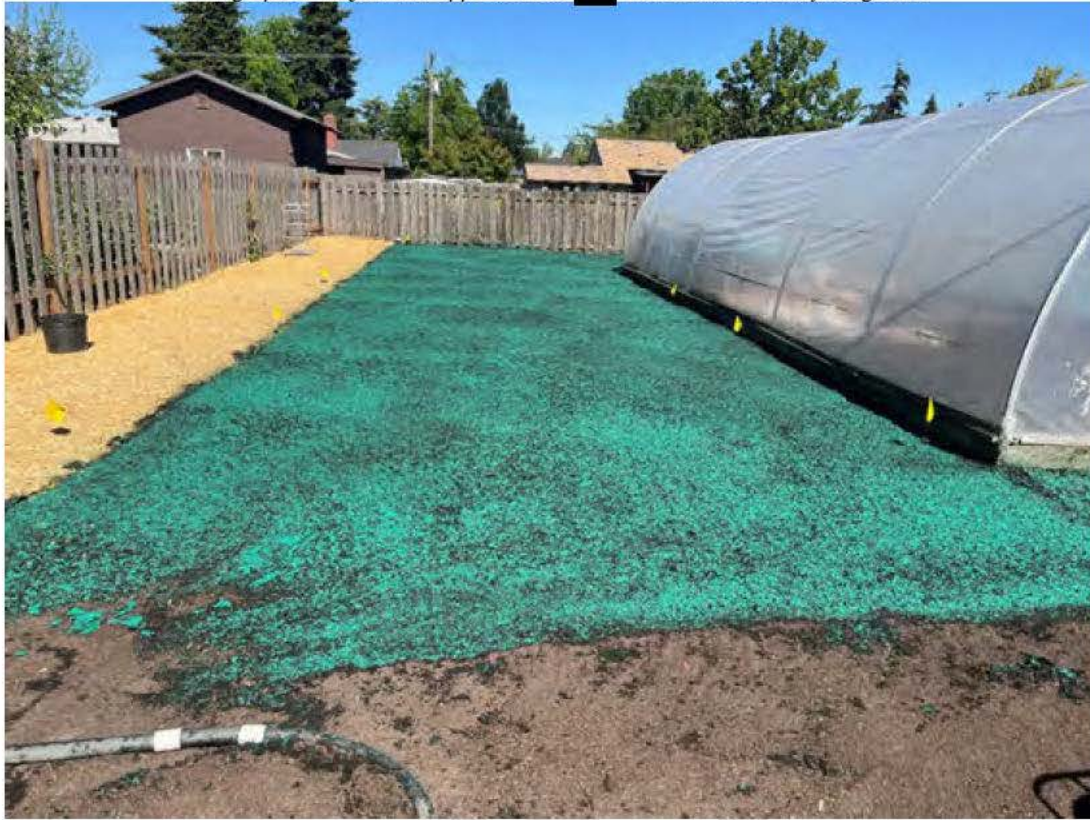
Photograph 26. Hydroseed application at [REDACTED] Baxter. Photo taken facing east.

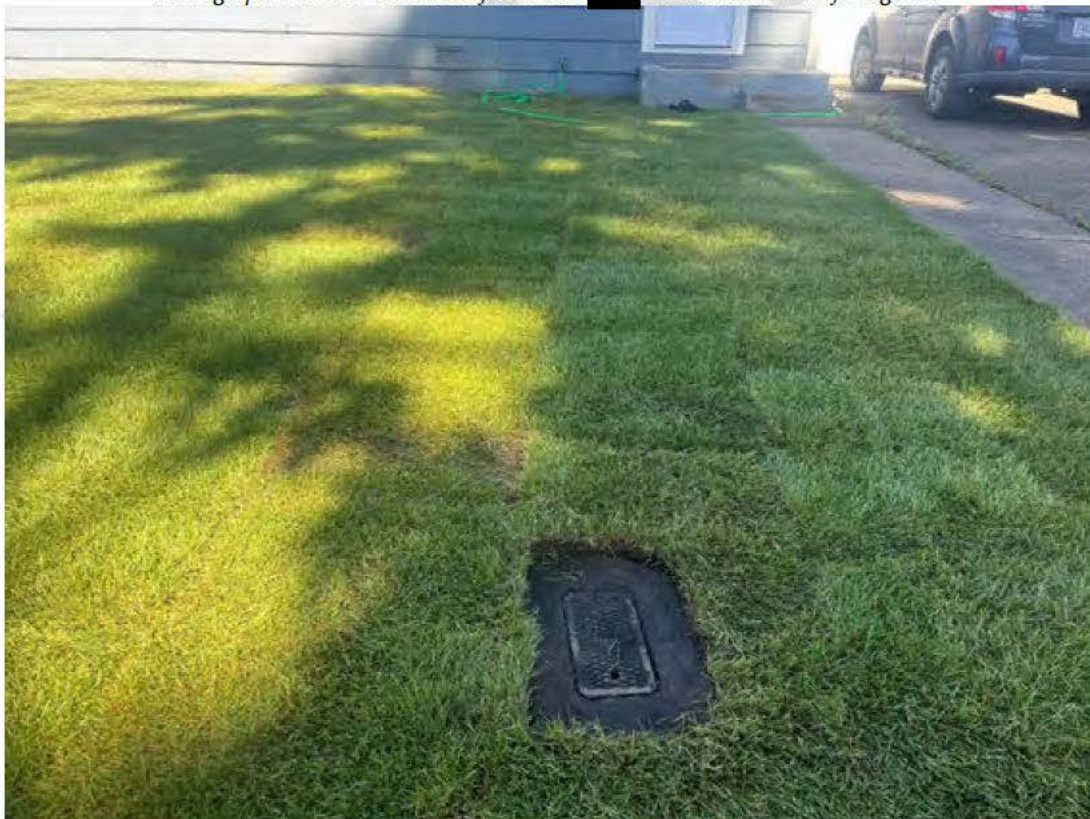
Photograph 27. Meter uncovered from sod at [REDACTED] Baxter. Photo taken facing east.

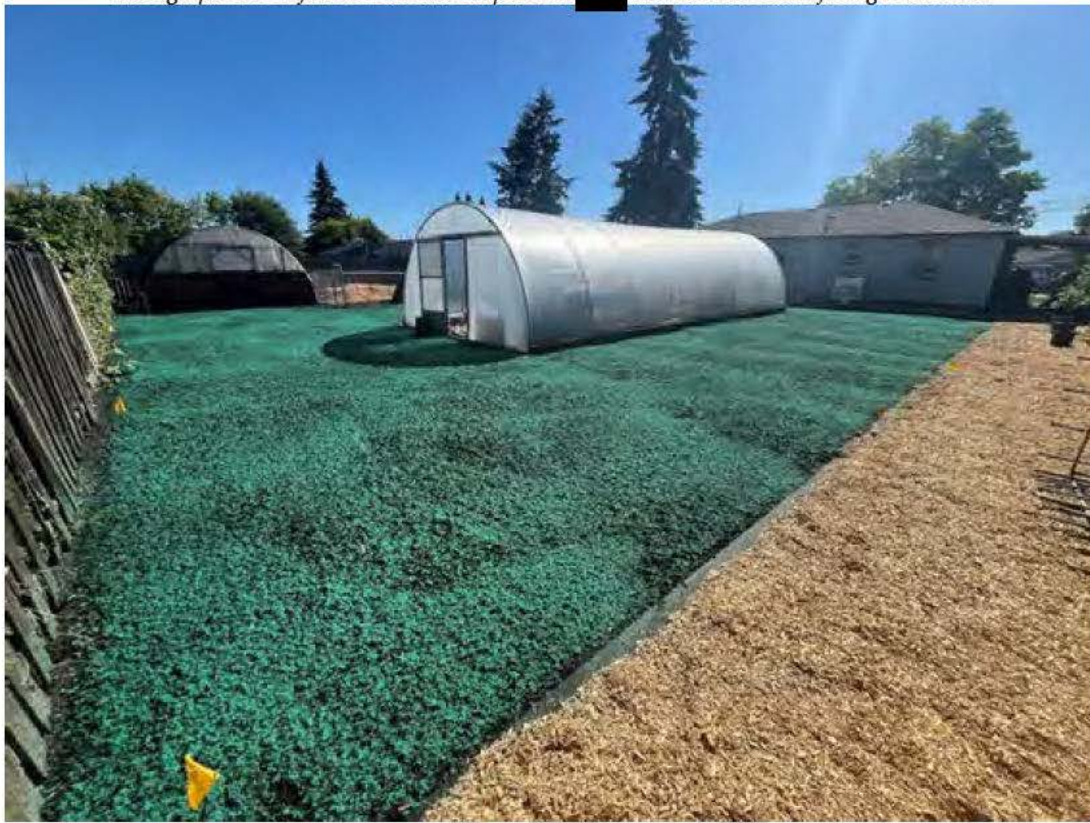
Photograph 28. Surface restoration completed at [REDACTED] Baxter. Photo taken facing southwest.

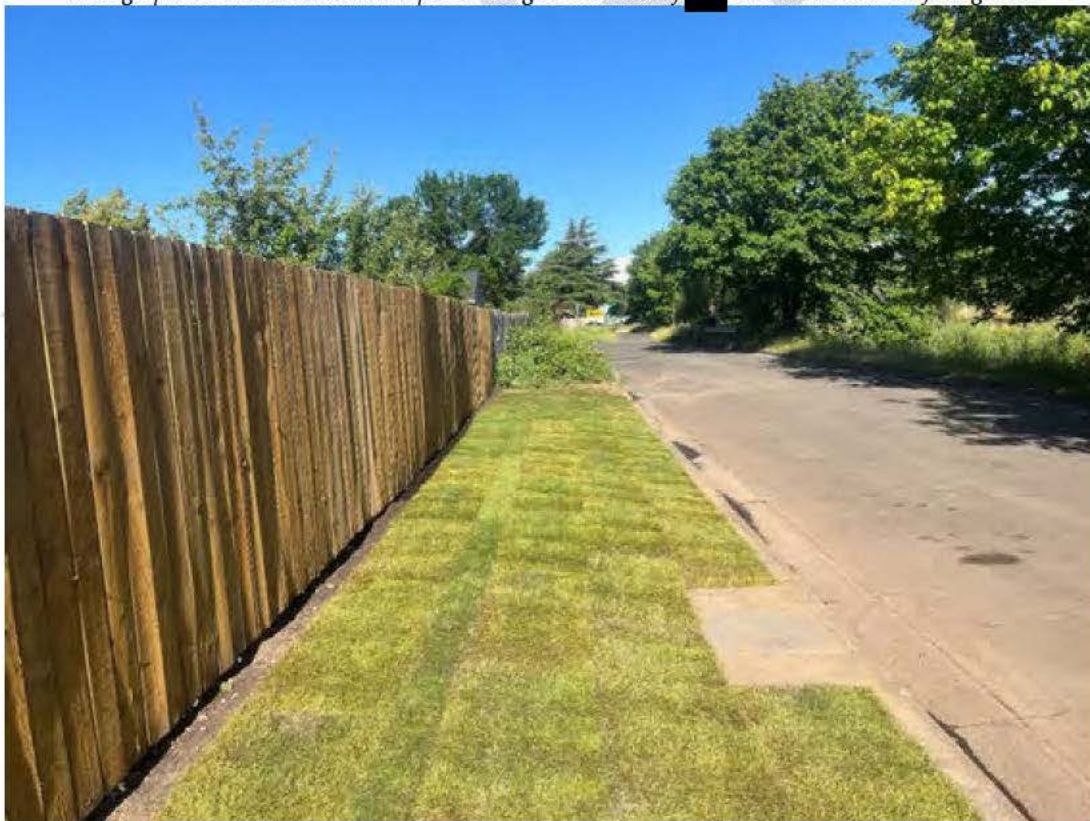
Photograph 29. Sod installation completed along ROW south of [REDACTED] Baxter. Photo taken facing east.

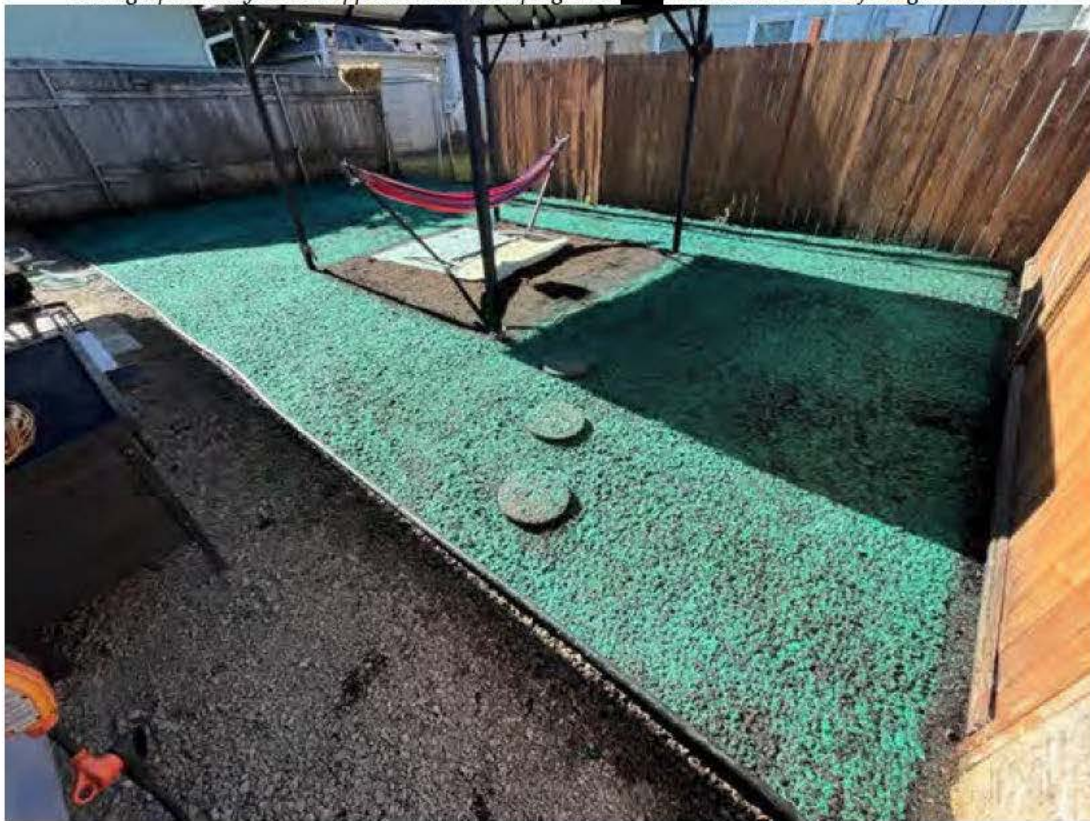
Photograph 30. Hydroseed application around pergola at Baxter. Photo taken facing northwest.

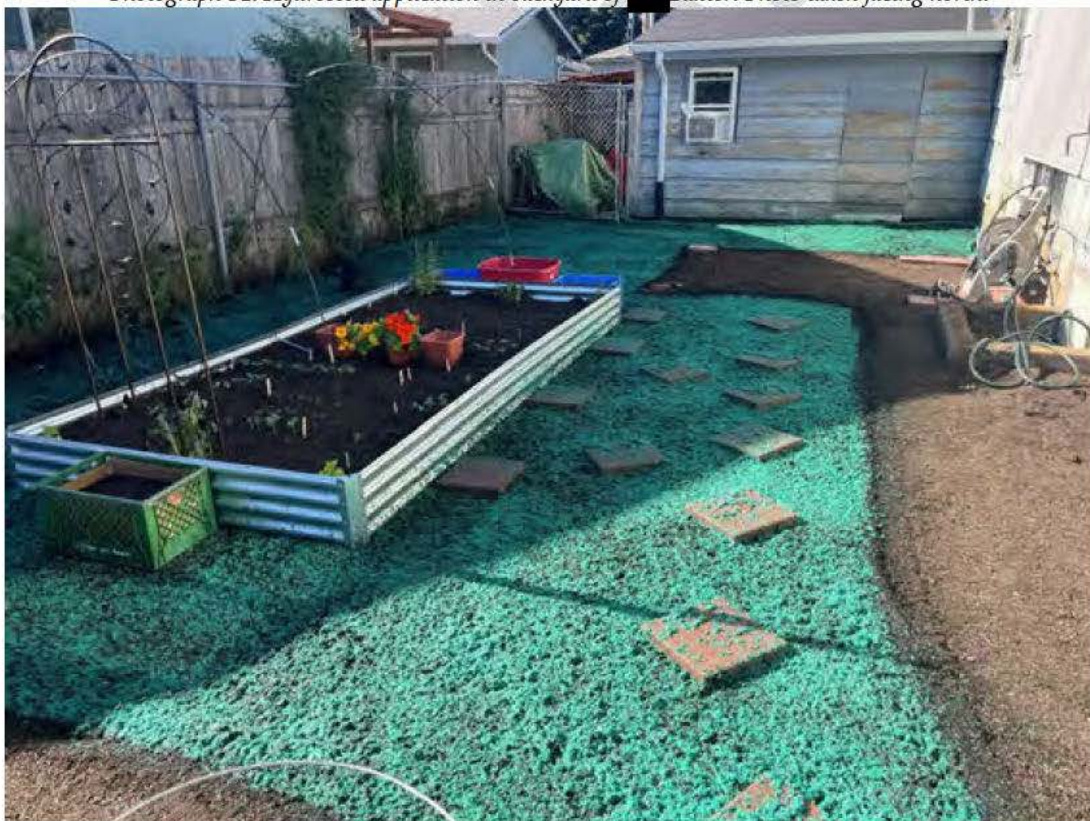
Photograph 31. Hydroseed application in backyard of Baxter. Photo taken facing north.

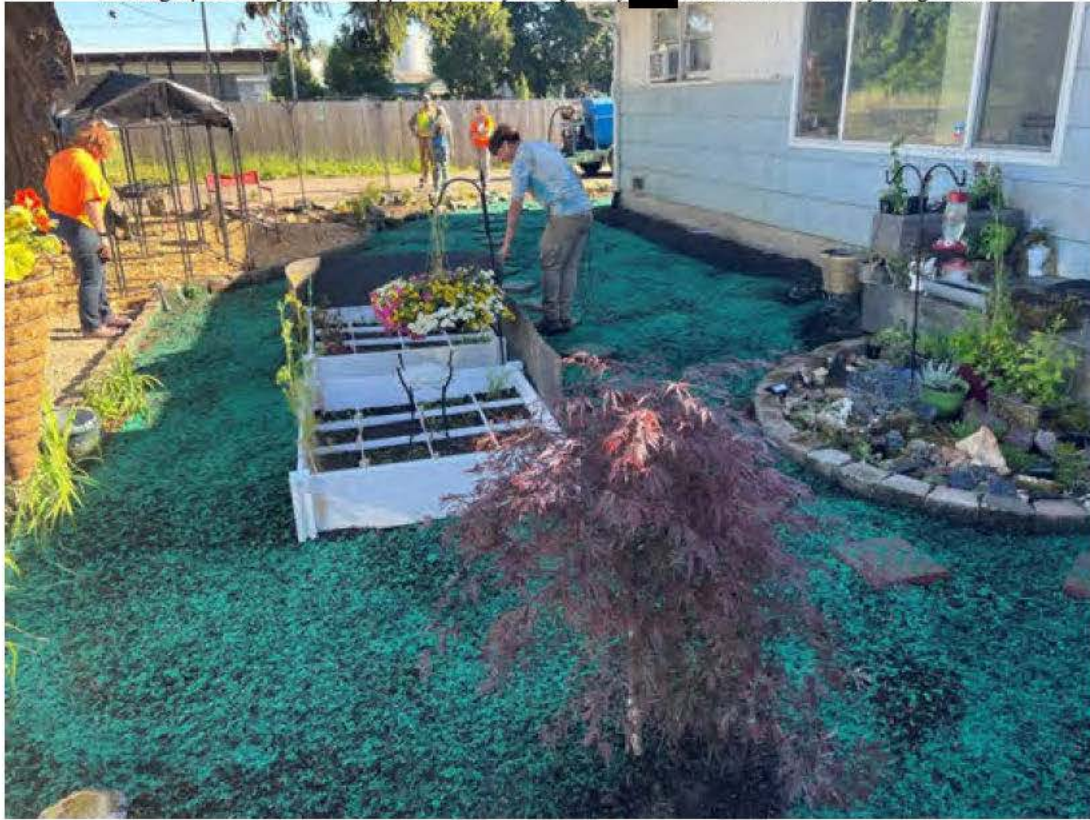
Photograph 32. Hydroseed application in front yard of [REDACTED] Baxter. Photo taken facing south.

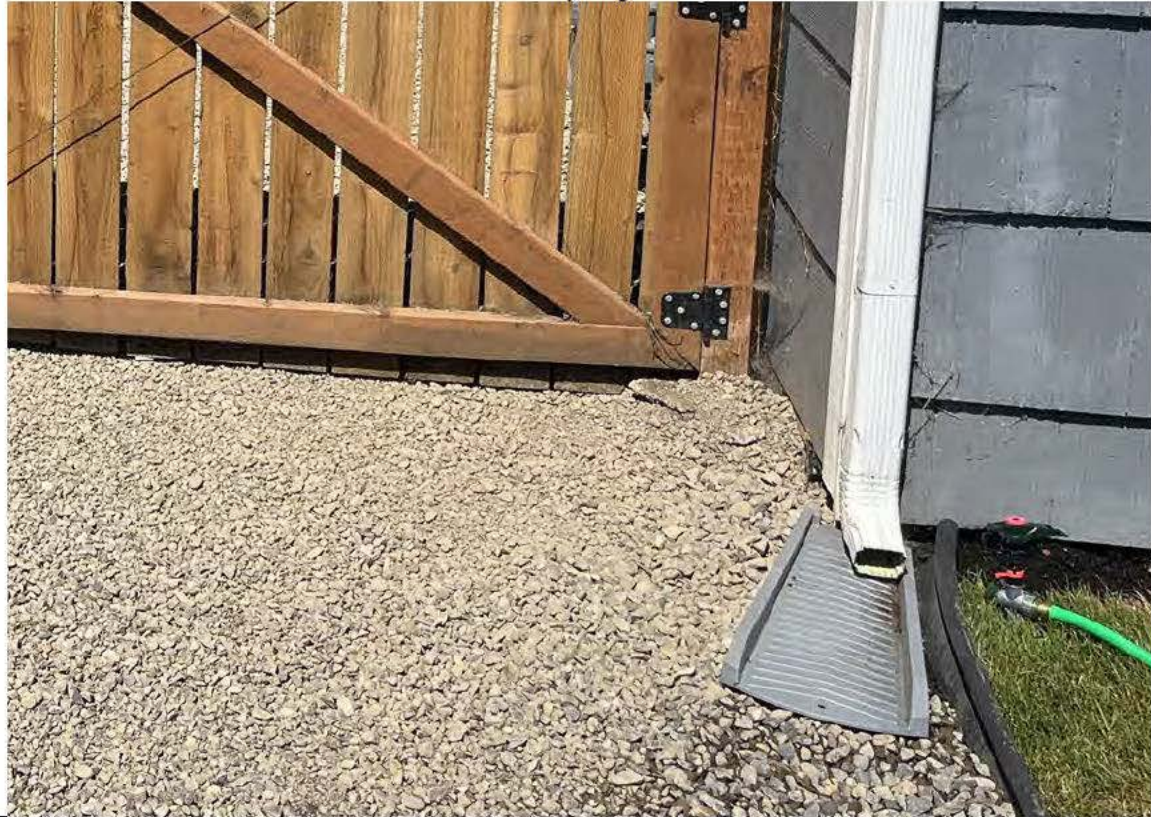
*Photograph 1. Landscape edginging lifted at [REDACTED] Baxter. Digging covered by downspout splash block in photograph.
Photo taken facing north.*
